# URBAN GEOLOGIC PROBLEMS ASSOCIATED WITH THE MIXCO FAULT ZONE

Sally Widhelm Bilodeau<sup>1</sup>

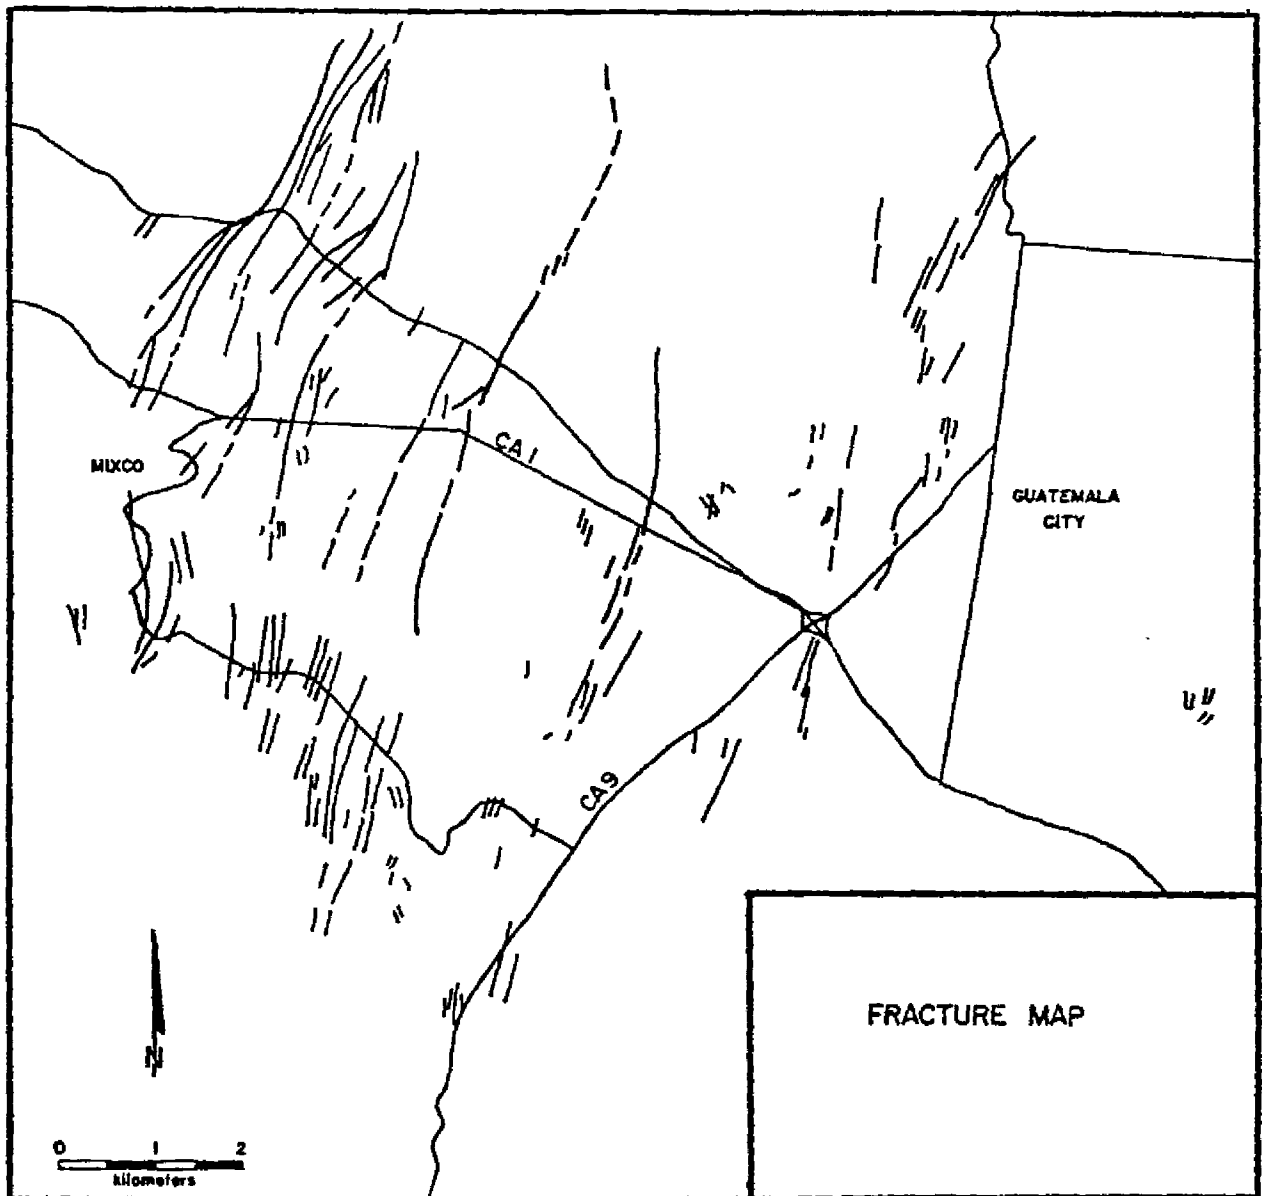
FIGURE 1- FRACTURE MAP  
 EARTHQUAKES OF FEBRUARY 1976  
 GUATEMALA VALLEY

One of the first programs the Guatemalan Government instituted, through the Emergency Committee and the Instituto Geografico Nacional, was the mapping of the fractures in and around Guatemala City and Mixco (Figure 1). The Mixco fault had been mapped prior to the earthquake and appeared on most modern published maps of the region as a 35 km long series of en echelon fault segments trending generally north-south. This fault bounds the western side of the Guatemala City graben and exhibits normal dip-slip fault displacements with the east side down (Bonis, et al., 1970). The Mixco fault is of particular interest from a seismic hazard standpoint because of its proximity to the highly urbanized areas of Mixco and Guatemala City.

As illustrated on Figure 1, the mapping done immediately after the earthquake was reconnaissance in nature, and many of the ruptures noted crossing the main roads were not followed or were not evident beyond the limits of the concrete and asphalt. The resulting map is therefore somewhat discontinuous and, in some places, nonrepresentative. In addition, there is no distinction on the map between true fault ruptures and simple ground cracking, which may not be related to fault movement at depth. Some ruptures are clearly aligned in such a manner as to suggest continuity; for example, those north of the main intersection of CA 1 and CA 9. Others are so randomly oriented as to suggest non-faulting origins such as those along the eastern margin of the map (Figure 1). Utilizing the rupture patterns and other topographic indicators, an interpretation regarding probable fault traces can be made, as illustrated on Figure 2. Previous investigators (Plafker, et al., 1976) have divided the fault ruptures into three broad zones, considered to be subsidiary fault traces to the master Mixco trace. These zones have been tentatively named the Mixco Zone, the Villa Linda - Castanas Zone, and the Incienso - Santa Rosa Zone. Interpretations of the subsurface projections of these fault traces are illustrated on Figure 3. As can be seen, they are all considered to be related to the main Mixco fault at depth, but due to the extensional nature of the faulting, they tend to branch near the surface and disrupt a broad zone. There is evidence in several areas that some of these subsidiary fault traces have moved repeatedly in the in the past. Fault scarps up to 15 meters high as well as offsets in excess of 7 meters in buried pumice layers are known to exist along some of the 1976 rupture zones, clearly indicating previous movements have taken place.

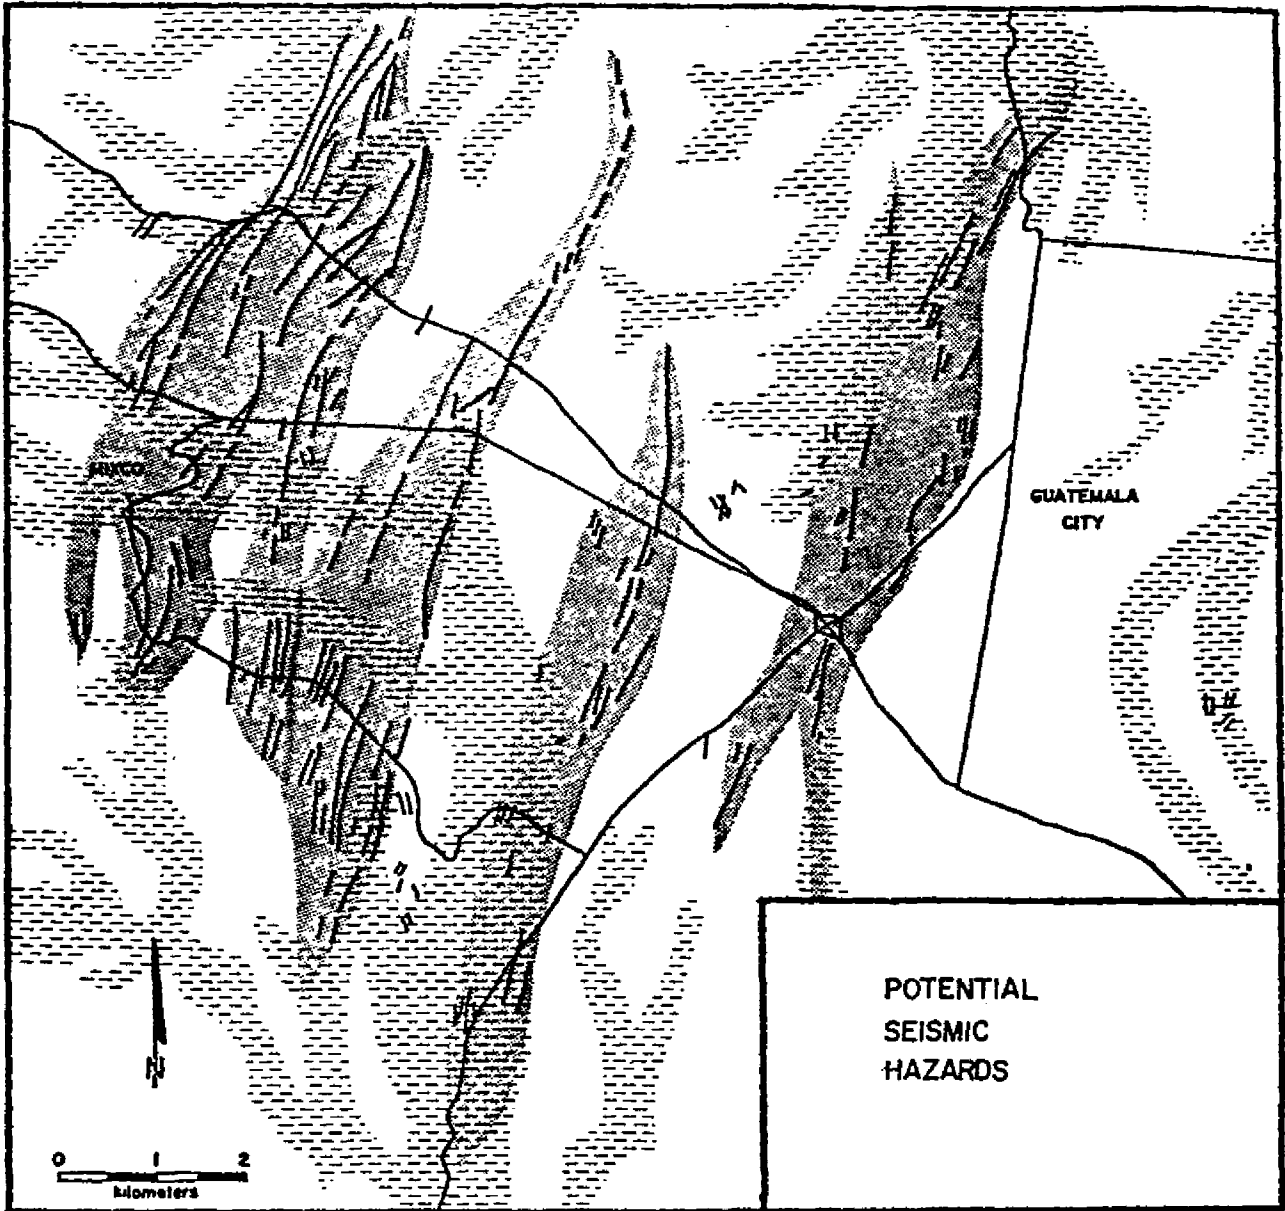
FIGURE 4

Utilizing the data available from the February 1976 earthquakes, a potential seismic hazards map has been prepared for the Guatemala City - Mixco area (Figure 4). This map is intended to identify in a general way those areas where ground shaking, fault rupturing, and seismically induced landsliding or lateral spreading may be a problem. Site-specific geotechnical investigations within these areas could serve to refine the specific nature and extent of the hazard for input into the final project design.

The hazard resulting from fault rupture is usually confined to narrow strips of ground along fault traces. Because the Mixco fault is a normal fault and because the Guatemala City graben is bounded on the east side by the potentially active Santa Catarina fault, fault ruptures may occur almost anywhere in the valley. However, there are some areas which are more likely to fail on a regular basis than others, in particular, those areas which exhibit evidence for repeated fault offsets. Although the area affected by such rupture is small compared to the area affected by ground shaking, the results of surface faulting beneath man-made structures is usually serious. To mitigate the problem, consideration should be given to avoiding these areas whenever possible. The potential fault rupture hazard zones, as depicted on Figure 6, define the three broad zones considered to be subsidiary fault traces to the Mixco fault. Although these zones are anticipated to encompass the majority of the future fault ruptures, some new or previously unrecognized fault traces may break the surface some time in the future. In addition, more detailed study of the mapped fault zones may serve to more accurately refine the rupture hazards. As a general guideline, the California Division of Mines and Geology usually assumes that the area within 15 meters of a mapped fault break to be also involved in faulting.

The hazard resulting from seismically induced ground failures within the Guatemala City - Mixco area is generally restricted to landsliding into the barancos and lateral spreading adjacent to barancos. No areas where liquefaction-induced failures were experienced are known to be present within the study area. Generally, the amount of landsliding and lateral spreading that occurs is related to the steepness of the adjacent slope, the water content and degree of cementation of the underlying deposits, and the joint patterns within the deposits. Without a detailed site-specific analysis, it is difficult to specify seismic safety setback requirements. Therefore, through analysis of drainage patterns and topography, a generalized potential landslide or lateral spreading hazard zone can be defined as shown on Figure 4. Within these zones, there are undoubtedly areas of stable slopes where no setbacks should be required. However, there are also other areas where landslides or lateral spreading may occur. Hence, these zones and for that matter all areas adjacent to barancos, could be considered as potentially hazardous subject to more detailed investigations.

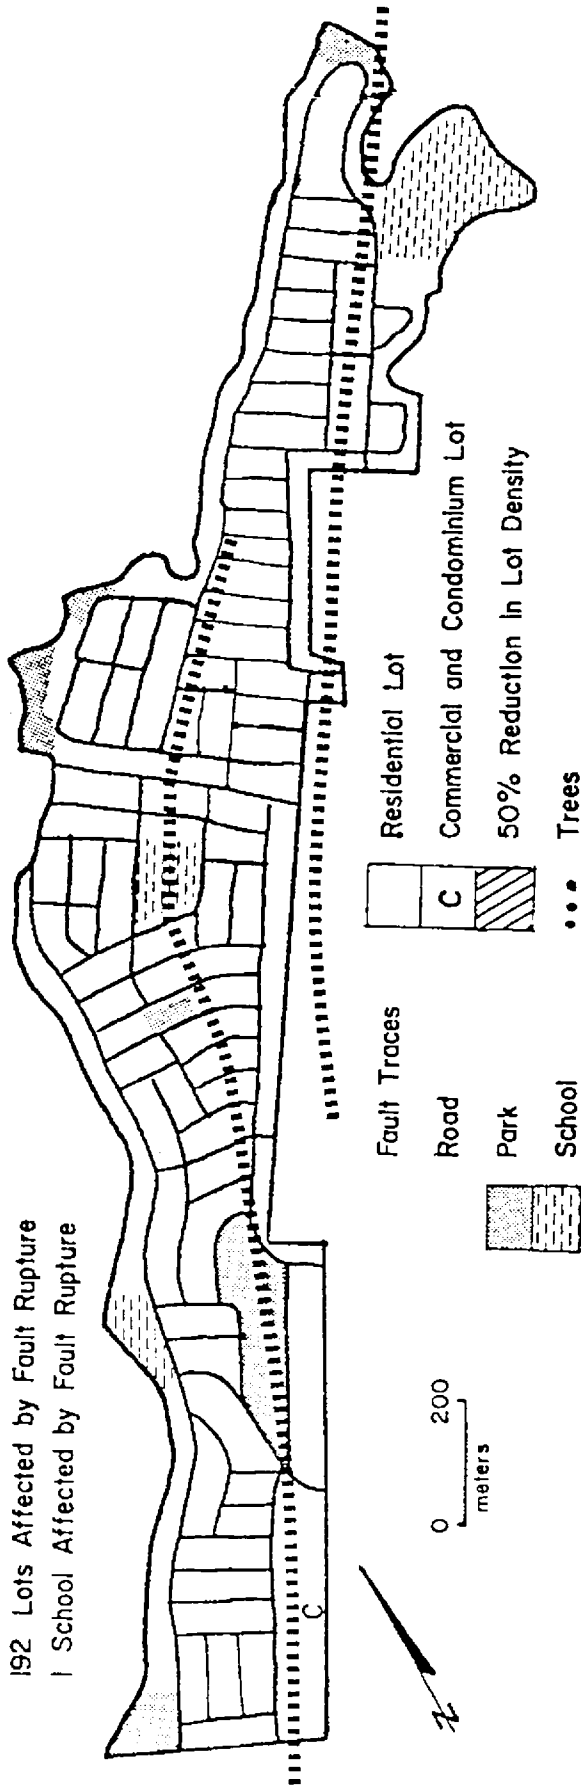
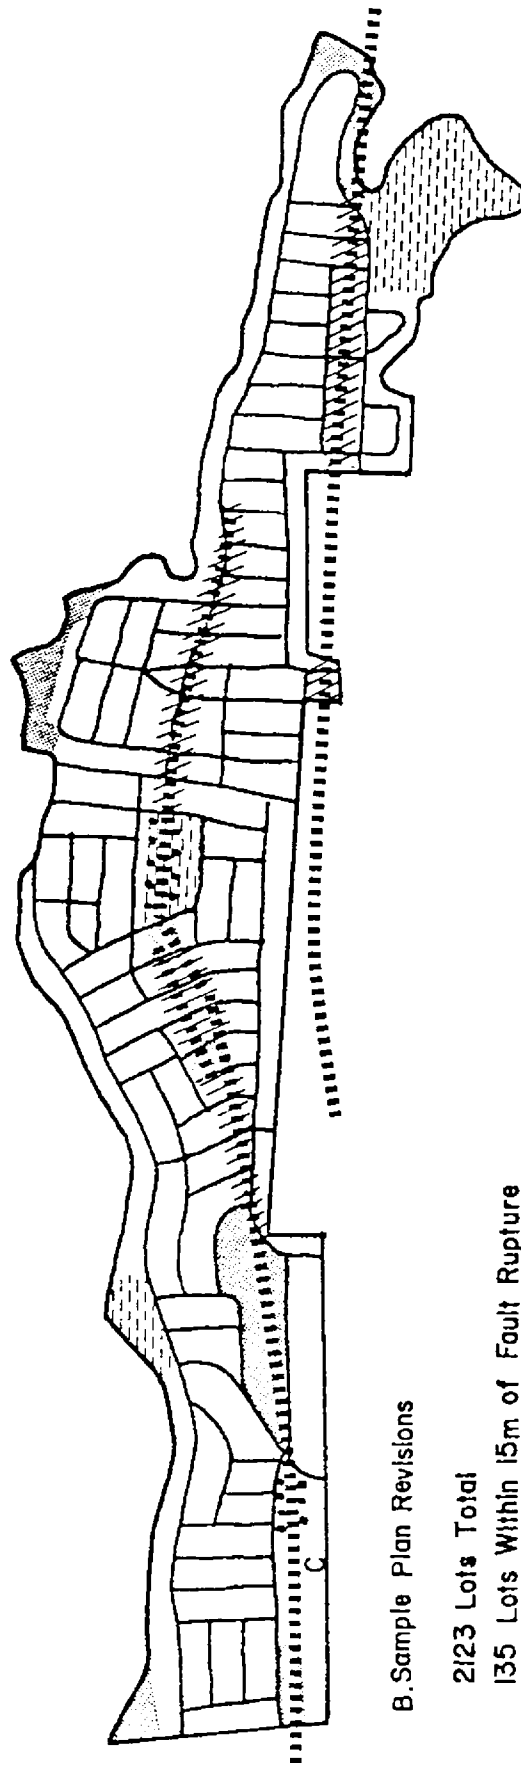
**FIGURE 8**  
SAN JOSE LOS ROSAS

The 2224 lot San Jose de las Rosas subdivision was also designed and approved prior to the February earthquakes (Figure 8a). The subdivider plans to sell these lots vacant. Improvements present at the time of the earthquakes included approximately 50 percent of the roads and pipelines. After the earthquakes, the project was crossed by two fault ruptures, one of which is at the base of a 15 m high existing fault scarp, indicating renewed movement along a pre-existing fault. A total of 192 residential lots, one school, and 15 commercial and condominium lots were adversely affected by fault ruptures. The existing roads and pipelines were severely disrupted where the fault traces crossed them. Although there was little incentive to change the existing plans, Figure 8b illustrates how some minor changes in the plans could significantly reduce the impact of renewed fault movement in this area. Three parks were already located along the fault scarps by the original plan. This type of land use is commonly considered to be compatible with high seismic risk areas such as fault zones. In the hypothetical or sample revised plan, four additional parks have been moved to the fault zone, and lot densities along the fault have been reduced by one-half. This density reduction can serve to break up the monotony of lot sizes and allows the home owner more freedom in locating their structures off of known fault

192 Lots Affected by Fault Rupture

135 Lots Within 15m of Fault Rupture

traces. In the event of fault rupture, only half as many dwellings are likely to be affected, if that many. A plan revision could include relocation of the school site well away from known fault traces. However, since schools commonly have playgrounds, athletic fields, and other open space areas, it was felt that a detailed site-specific geotechnical study would reveal areas on-site that are not affected by faulting and that would be suitable for well designed, earthquake-resistant school buildings. Clustering the structures in the relatively safe areas would leave the fault rupture hazard zones free for athletic fields, playgrounds, and other recreational uses. The commercial and condominium areas could also be developed similarly with minimal risk to occupants. A cluster development concept of locating the condominiums off of known fault traces and having common open space along the potential rupture zones is one method of coping with the problem without suffering undue economic loss. Restrictions on height, use, and occupancy of some of the commercial units would serve to reduce seismic risk in this area. For example, storage warehouses could be quite compatible along this zone; however, a theater would be inadvisable. The total impact of the revisions illustrated includes 1) the realignment of several roads, 2) the addition of several parks, 3) the restriction on arrangement of the condominium + school complex, 4) restrictions on use and occupancy of 50 percent of the commercial units, and 5) loss of 116 residential and 5 commercial lots through a reduction in density along the fault. The resulting changes cause a loss of approximately 5 percent of the residential and 6 percent of the commercial lots.

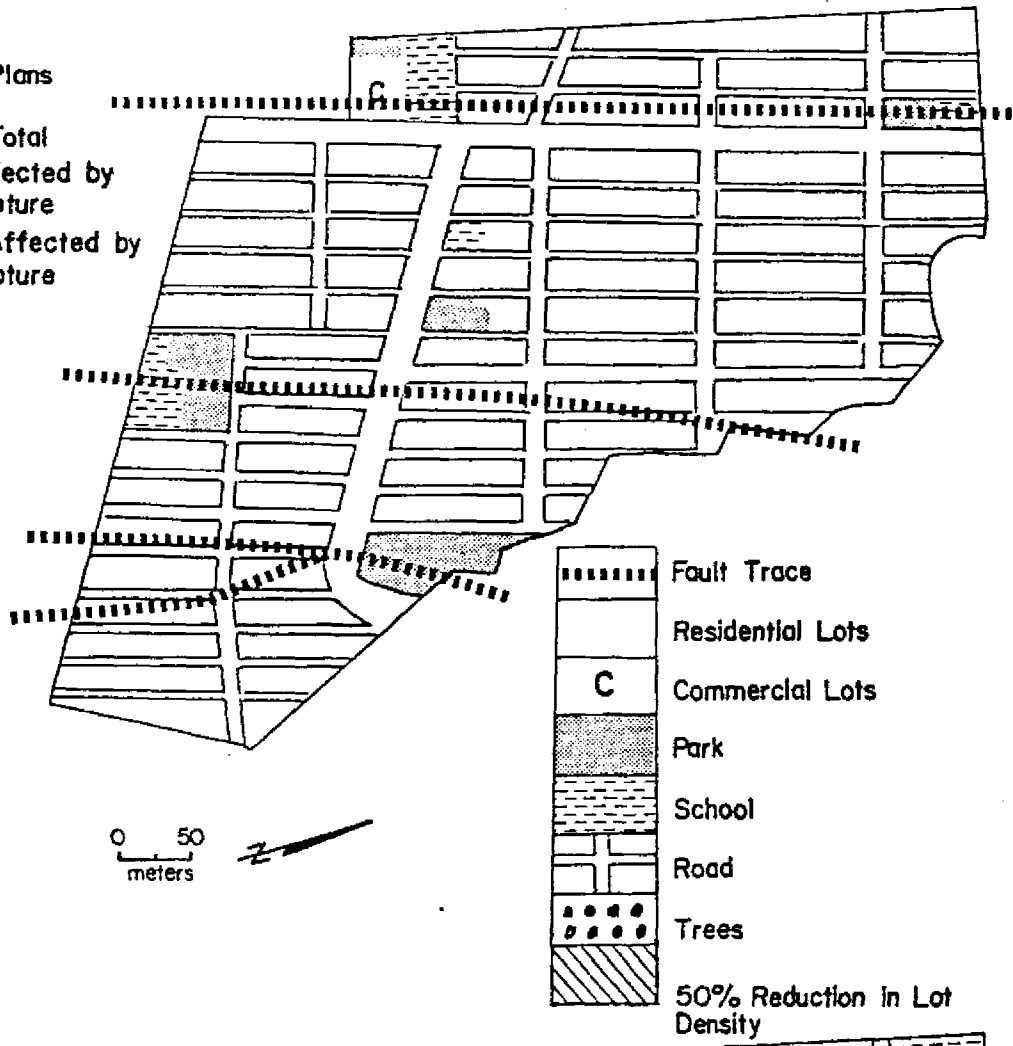
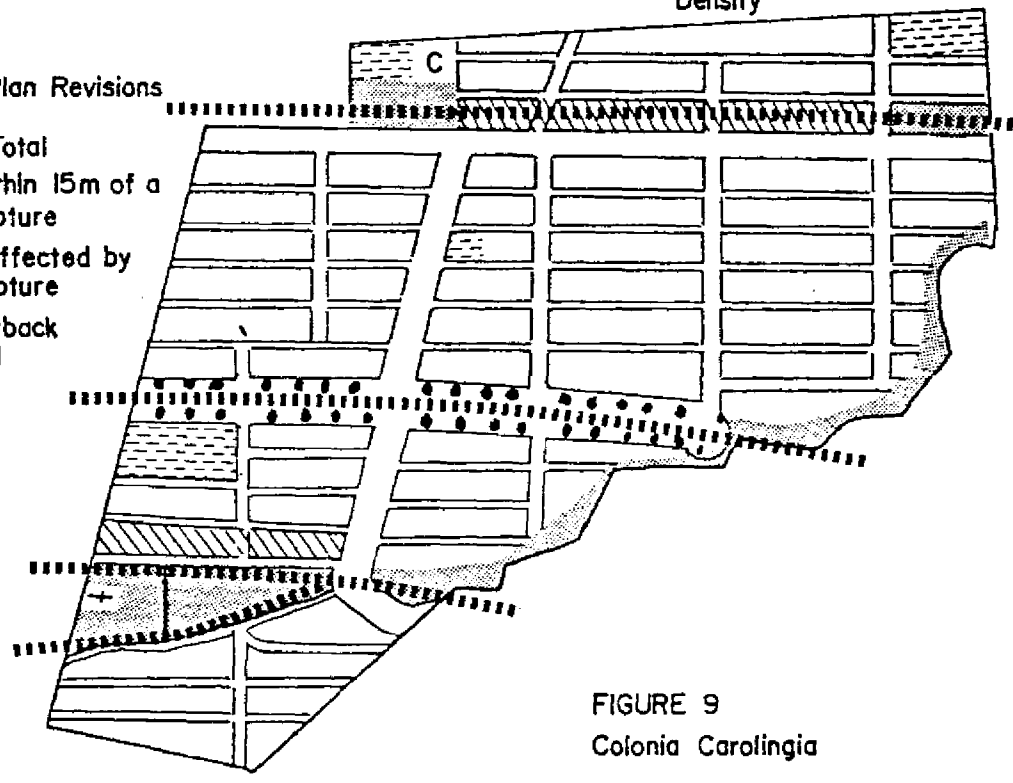
FIGURE 9  
Colonia Carolingia

Because of the high density of the development, any plan revision to accommodate the fault ruptures or baranco setbacks will result in the loss of some home sites. Tradeoffs of this sort are very difficult to assess; however, parks and open space can serve to enhance the environment of this otherwise somewhat congested development. One form of accommodation of the fault rupture hazard through land planning is illustrated on Figure 9b. It has been accomplished by realigning one of the roads and widening it into a boulevard with trees and a park-like border. Three of the existing parks have been relocated so as to buffer the fault rupture hazard zone. Densities within 15 m of fault ruptures have been lowered by one-half to encourage house sites to be situated as far away as possible from known rupture areas. A church with a cemetery is planned where two fault traces are branching. Although this church is located 15 m from each trace, it may experience

1400 Lots Total  
143 Lots Affected by  
Fault Rupture  
3 Schools Affected by  
Fault Rupture

1355 Lots Total  
30 Lots Within 15m of a  
Fault Rupture  
0 Schools Affected by  
Fault Rupture  
Baranco Setback  
Observed

foundation rupture anyway due to the fault's proximity. Because of the occasional high occupancy, it is proposed that the church structure be of sufficient aseismic design so as not to collapse in the event of up to 15 cm of surface rupturing through the foundation. A church is proposed for this area because of its community impact as opposed to individual impact. In the event of serious structural damage, the economic burden of repair can be shared by the community at large, and it will involve only one building, as opposed to the previous 22 home sites proposed for this area.

Portions of the Colonia Carolingia development are located near the tops of barancos. These home sites are often considered valuable because of the spectacular views often enjoyed. However, in the event of strong ground shaking, seismically triggered landslides can occur and take out entire home sites. Without a site-specific analysis, it is difficult to specify seismic-safety setback distances; however, to demonstrate existence of the hazard, a small strip of open space land is shown buffering the bluff top. The total impact on the development of the revisions illustrated includes 1) the re-alignment and widening of one road, 2) the relocation and expansion of two parks, 3) the initiation of a common open space buffer zone along the top of the bluff, 4) the introduction of a community church and cemetery, and 5) a loss of 66 lots through the plan changes and a reduction of lot density along the faults. At a cost of \$1800/lot, that represents \$118,000 of a \$2,500,000 project or a 5 percent impact.

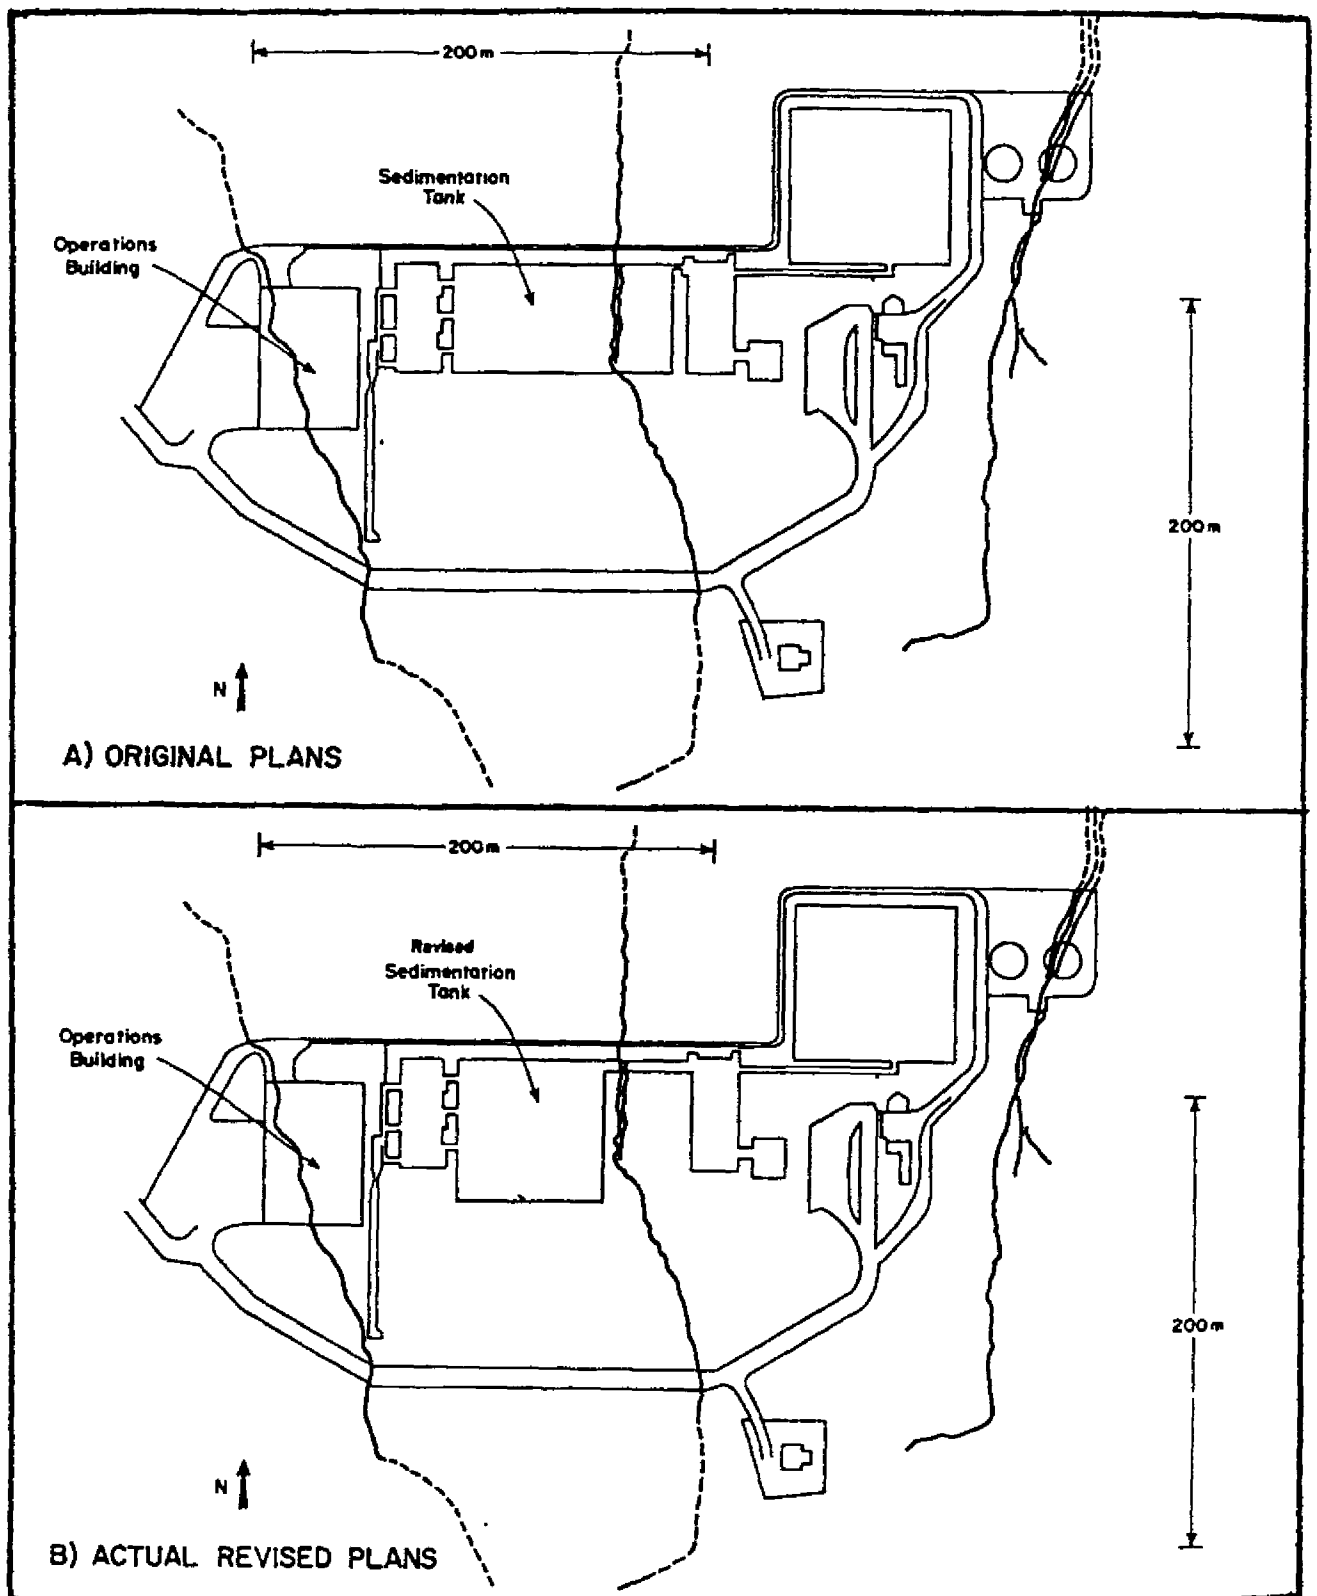
FIGURE 10 PLANT LO DE COY  
 Fault and Ground Rupture

The Xaya Pixcaya water filtration plant Lo de Coy was under construction at the time of the earthquake. This plant is the receiving station for water imported via aqueduct from the Xaya and Pixcaya Rivers in the volcanic highlands west of Guatemala City. This system is eventually expected to supply Guatemala City with approximately 25 percent of its water supply. At the time of the earthquake, the aqueduct was 90 percent completed; hence, they were already too far committed to the Plant Lo de Coy to consider abandoning the site. After the earthquake, the plant was crossed by three surface ruptures (Figure 10a). Geologists from the United States, Japan, and Guatemala inspected the site and determined that the middle trace was apparently the principal fault and exhibited evidence for repeated offsets during late Quaternary time in excess of 7 m. The maximum movement recorded in February consisted of 5 cm. It was therefore recommended that construction be avoided on the faults, in particular, the middle trace. The Xaya Pixcaya engineers examined several alternatives for the development and eventually decided to change the shape and design of the sedimentation tank (Figure 10b). The tank is now located 3 m off of the fault trace, and it was structurally redesigned to take higher seismic forces into account. The warehouse and other water-retention facilities are essentially unchanged; however, the filters are adjoined to the sedimentation tank via flexible, jointed pipes which have emergency shut-off valves at both ends in the event of a pipe rupture. The impact of these plan changes is to change the volume and retention time of the sedimentation tank, which reduces its efficiency to 75 percent. It is, however, still capable of purifying the water well within acceptable limits.
