Appendix 3

Photographs

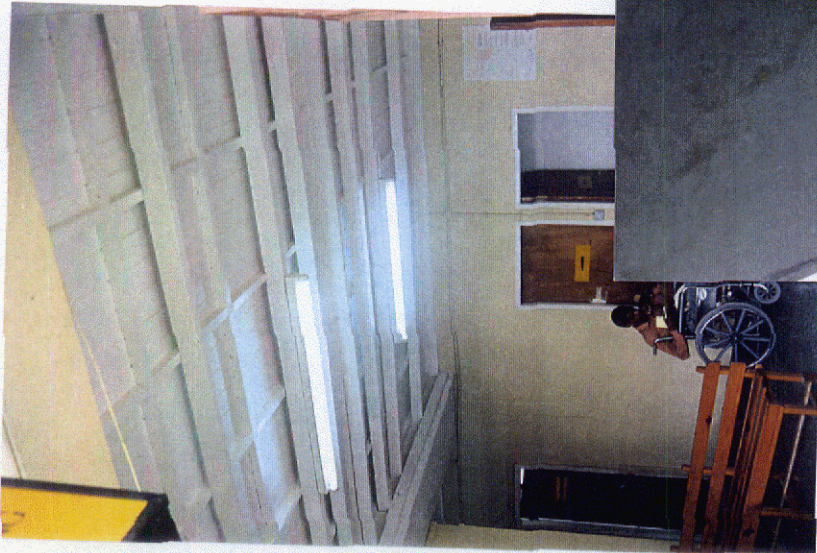
Photo 1:
 There was a partial collapse of the SB roof in this area. A timber ceiling has been erected here and on other floors to protect occupants from injury in any future collapse.

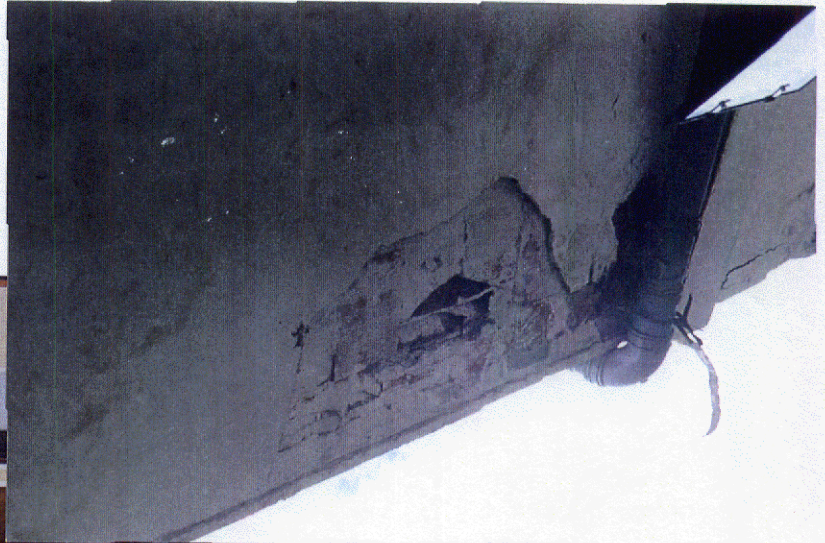
Photo 2:
 "Drop-out" at soffit of SB slab overhang outside building. Similar instances have occurred inside the building.

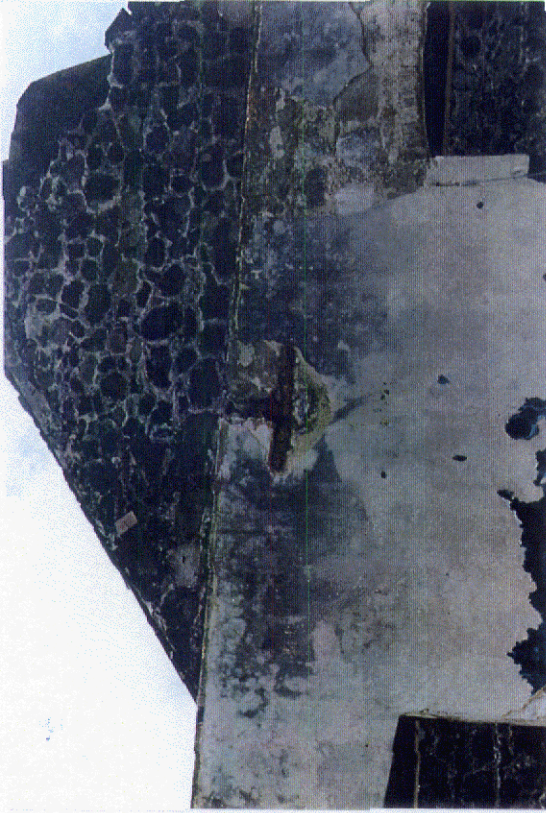
Photo 3:
 Typical hold-down arrangement at existing truss members on L-Block. There appears to be no connection between the timber and the underlying wall.

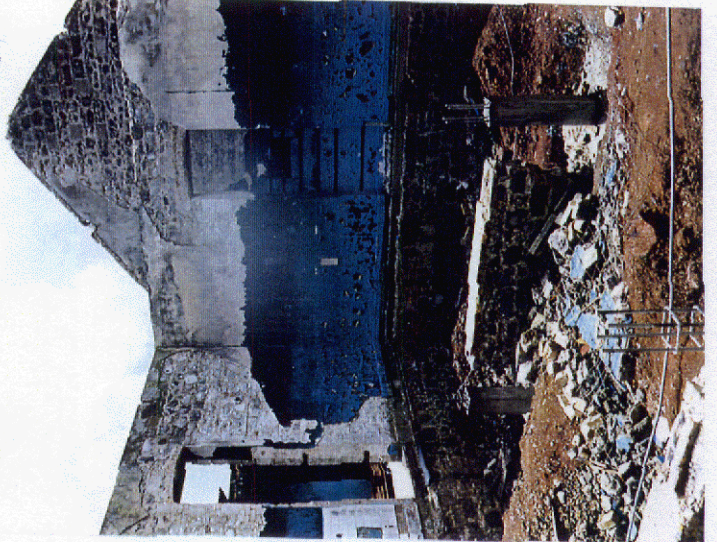
Photo 4:
 View inside burnt-out section of L-Block. Rubble walls are 16" to 18" thick.
