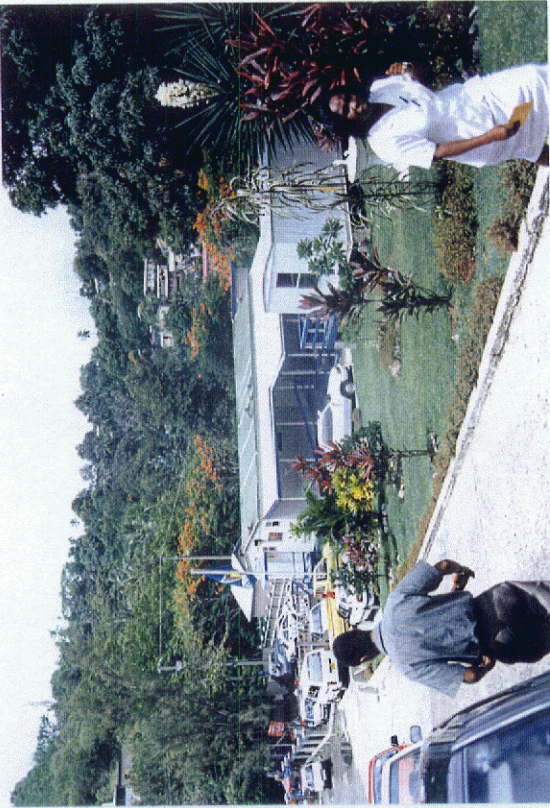
Photo 9: Similar view to previous.

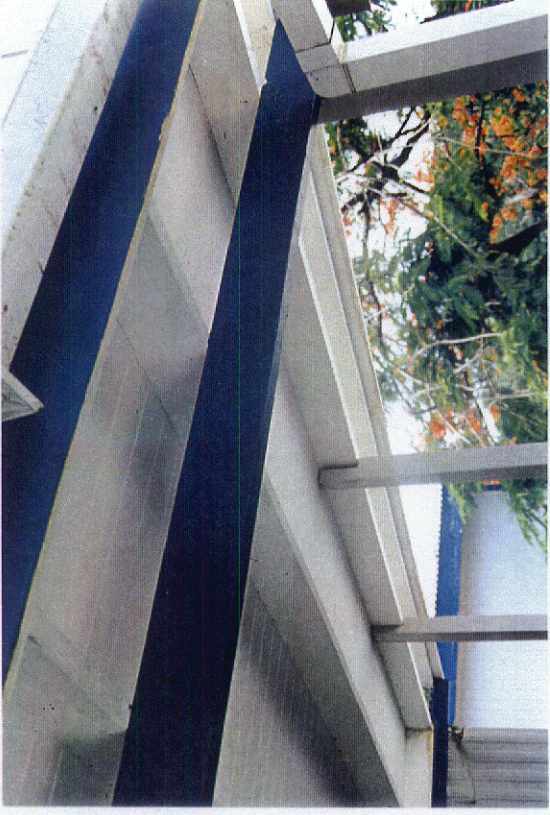
Photo 11: Verandah roof on (temporary) ward #6. All timbers are nailed. No hurricane clips or other fixings are present.

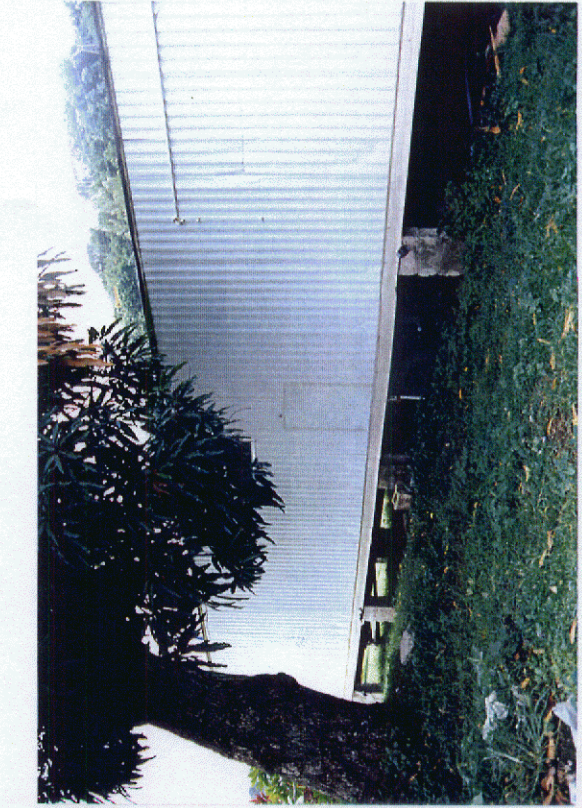
Photo 10: Close up of temporary facilities. There are no positive fixings holding the superstructure to the foundations.

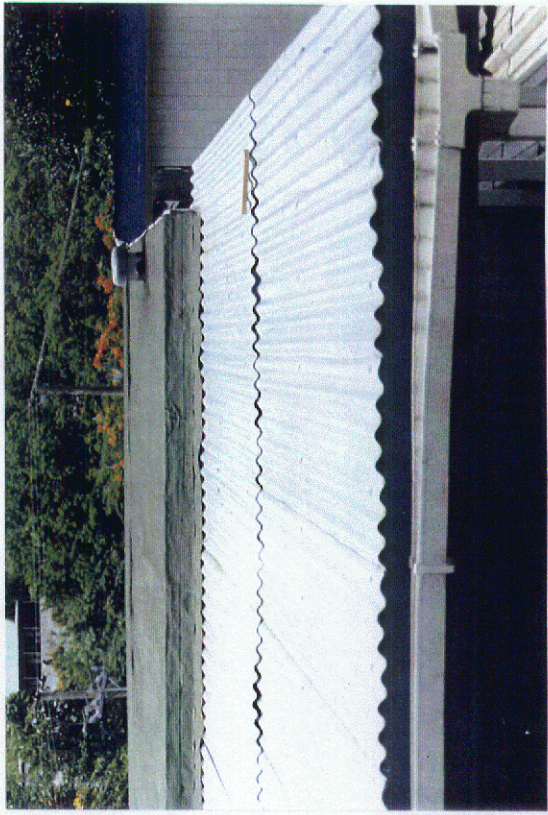
Photo 12: View of roof of temporary buildings. Drive screws are placed at 9" to 12" centres throughout over the verandah.
