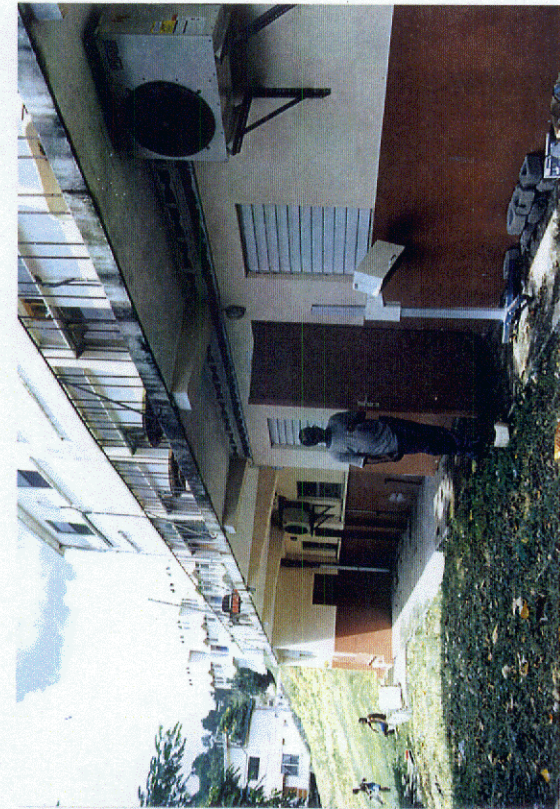
Photo 17: New infill walls constructed on the lower floor of the former nurses home.

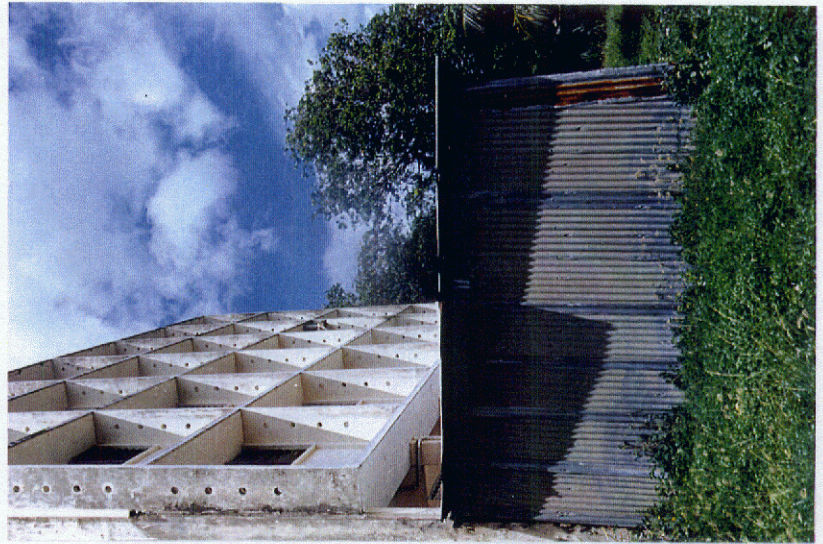
Photo 18: Dilapidated storage shed at rear of former Nurses Home is a hazard in itself.

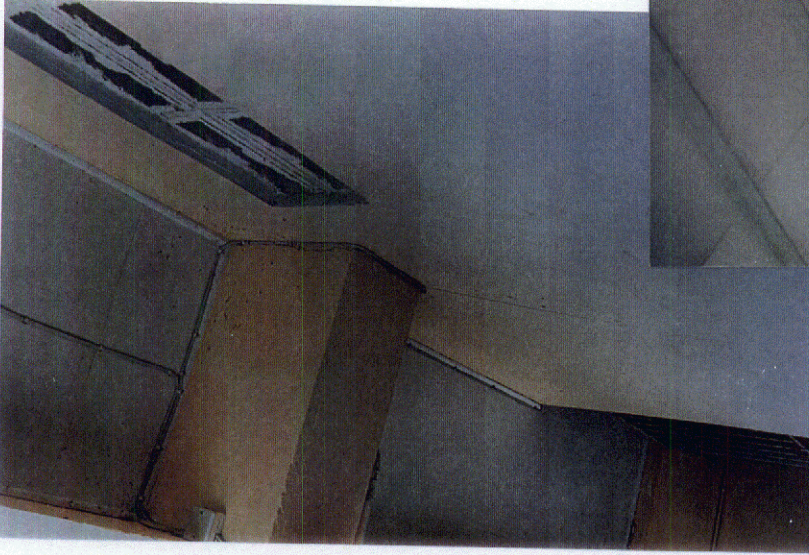
Photo 19: Diagonal crack in infill wall at corner of beam soffit.

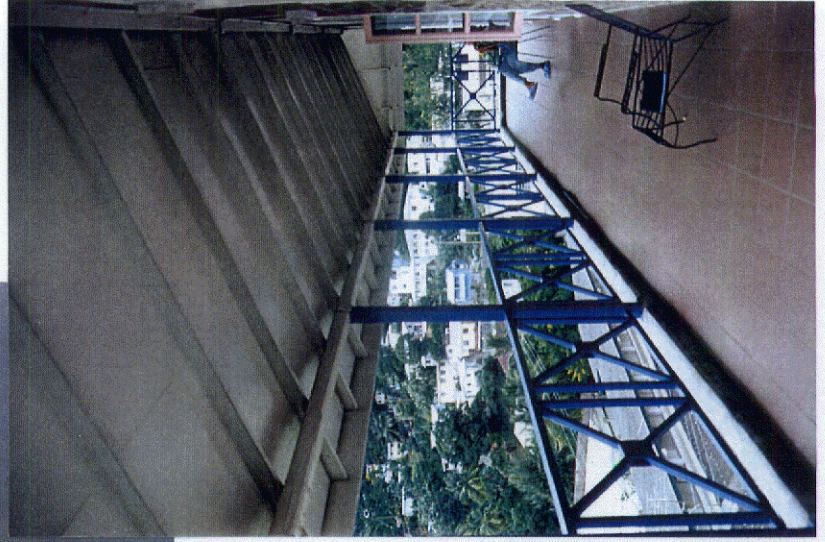
Photo 20: View of verandah of Baron Wing. The new railing is in structural steel, bolted to the concrete upstand.
