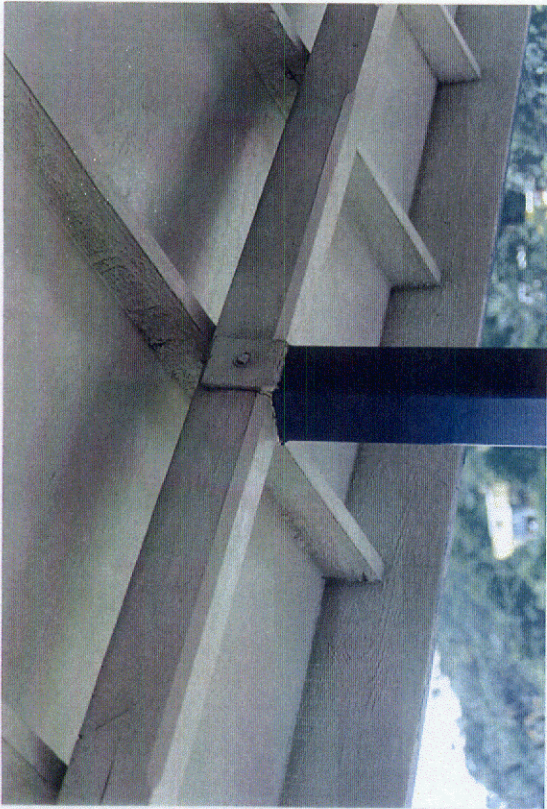
Photo 21: Inadequate hold-down detail on Baron Wing verandah.

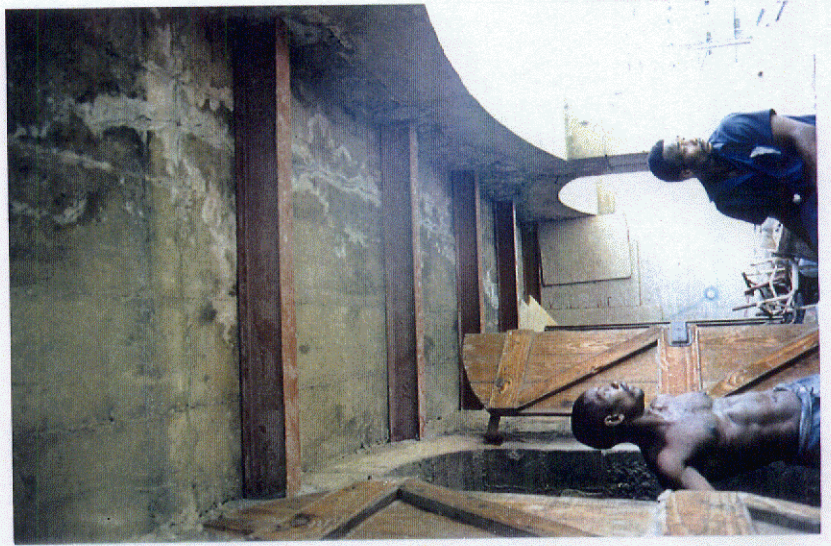
Photo 22:
Steel I-beam
reinforcement to
verandah slab.

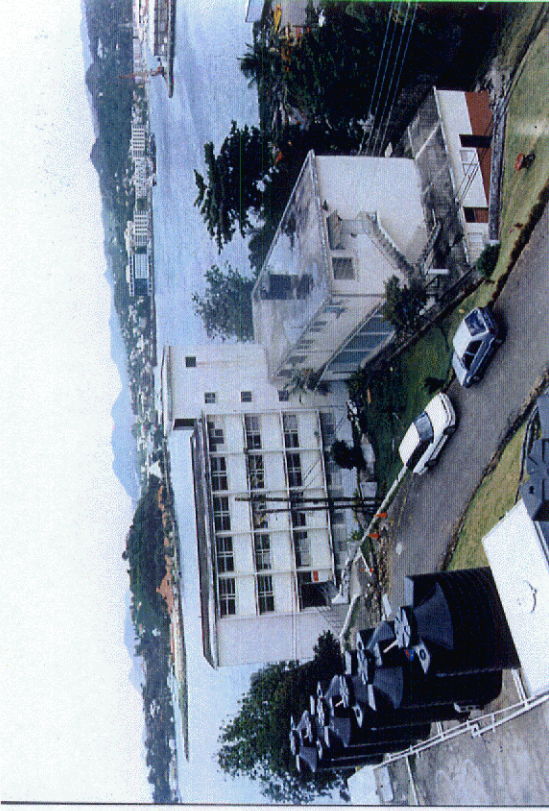
Photo 23: View of nephrology/cardiology building. Note water tanks sitting on roofs.

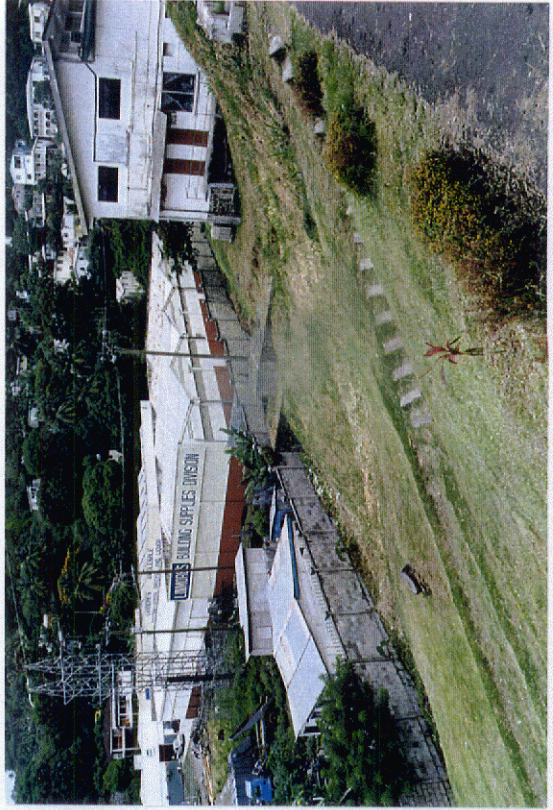
Photo 24: A new boundary wall has been constructed on the east of the compound. However, no allowance seems to have been made for the stormwater outfall here.
