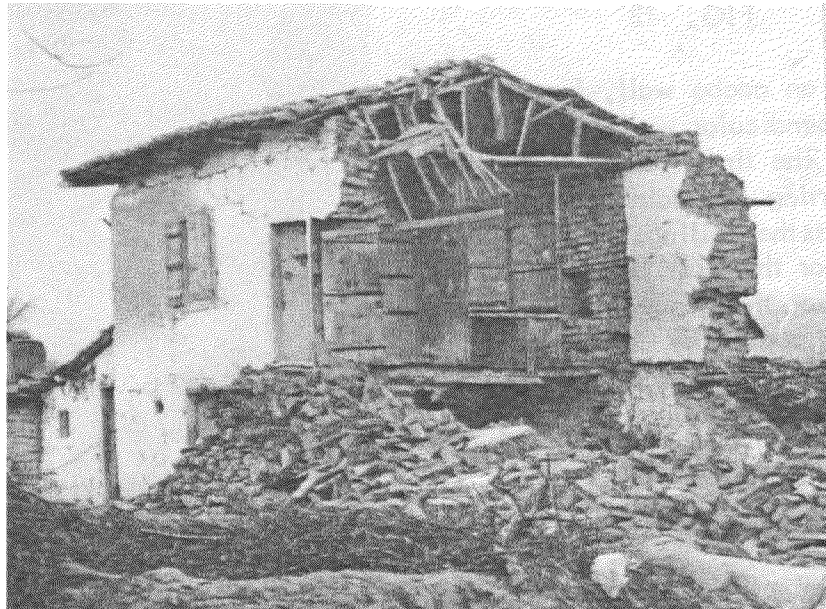
FIG. 10

Two storied adobe building with timber floor and ceiling. Timber bond beams are seen in the rear wall (right) , provided at two levels in the upper story, however of inadequate continuity. No lintel exists over the entrance door. Adobe blocks from the collapsed walls are seen in the foreground (right) .

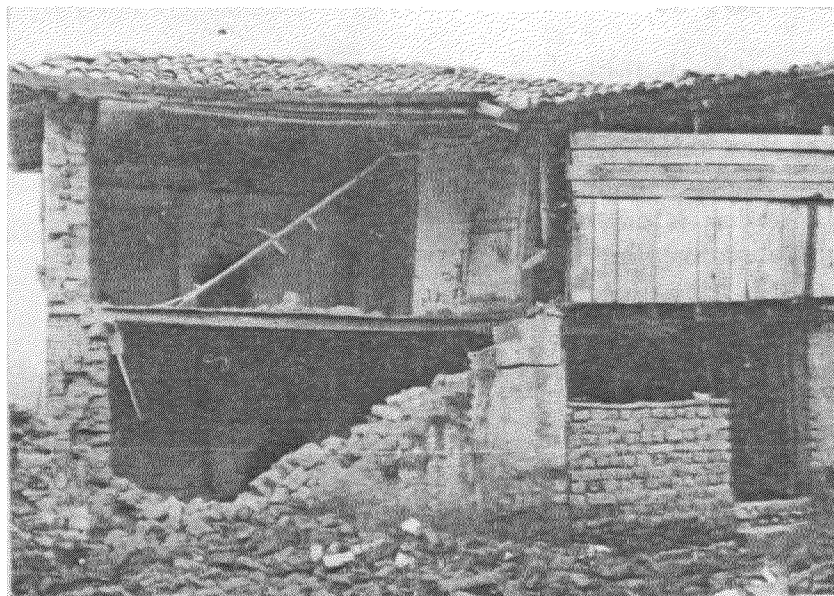
FIG. 11

Another two storied adobe building. Wall thickness of the ground floor is 1 1/2 times that of the upper floor. The upper floor is covered by a timber roof and tiles. Fireplaces are seen in both stories, indicating that the related spaces are for living. Timber floor and ceiling are able to provide sufficient diaphragm effect. However, the front walls neither had enough connection to the side walls, nor to the diaphragms. Cracks are observed in the non-bearing walls, over the fireplace arches.
