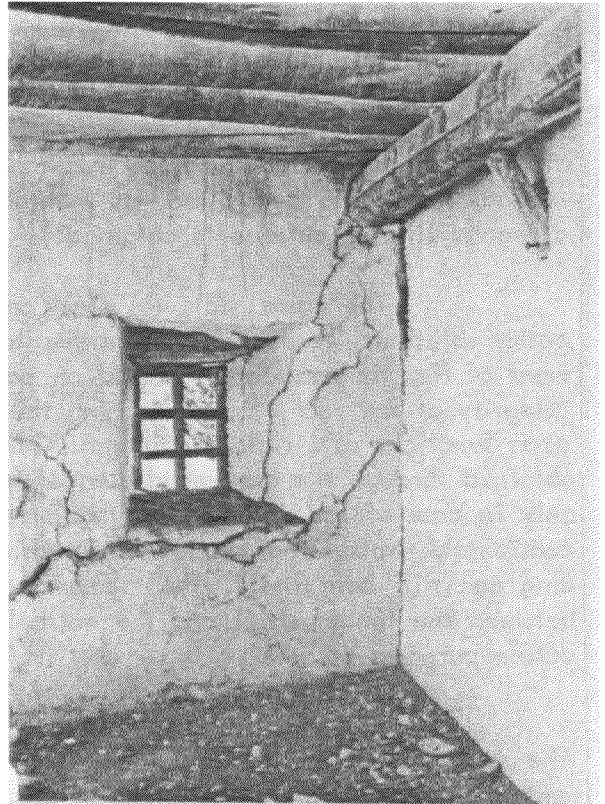
FIG. 15

Interior of a single storied, stone masonry building, in which the main beams, that carry the ceiling beams, are supported by vertical studs. As the studs are built in the wall, they are not visible to the reader. This relieved the wall from the vertical loads of the heavy roof, however, lateral (to left) deformation of the main beam caused some diagonal cracks.

Note that limiting the openings, the solid wall portion provided between the opening and the corner, and the horizontal bond beams (not seen in the photo) all contributed to the survival of the building at this major earthquake (Kiğıt, Eastern Turkey, 1968).

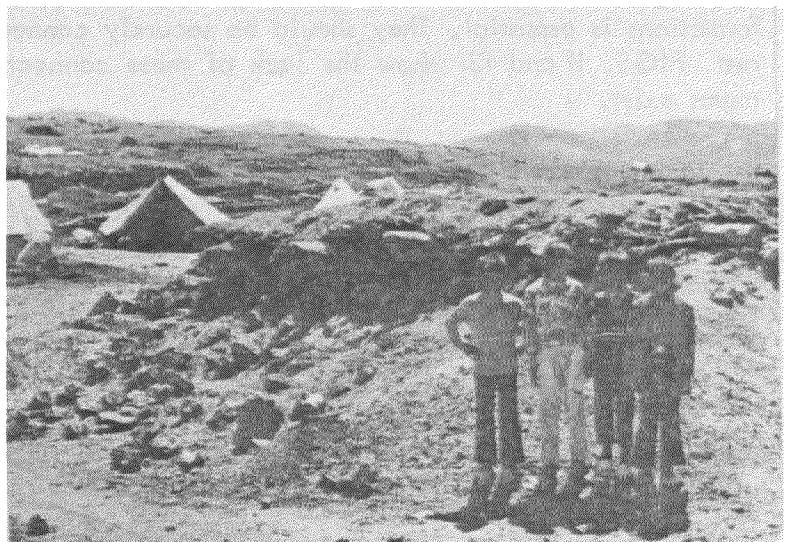
FIG. 16

A collapsed stone-adobe mixed building, after Çaldıran (Eastern Turkey, 1976) earthquake. The heavy earth roof, carried by thick and round wooden beams, now rests on the wall material, which has turned into a heap of soil and stone, after the rains, following the earthquake.
