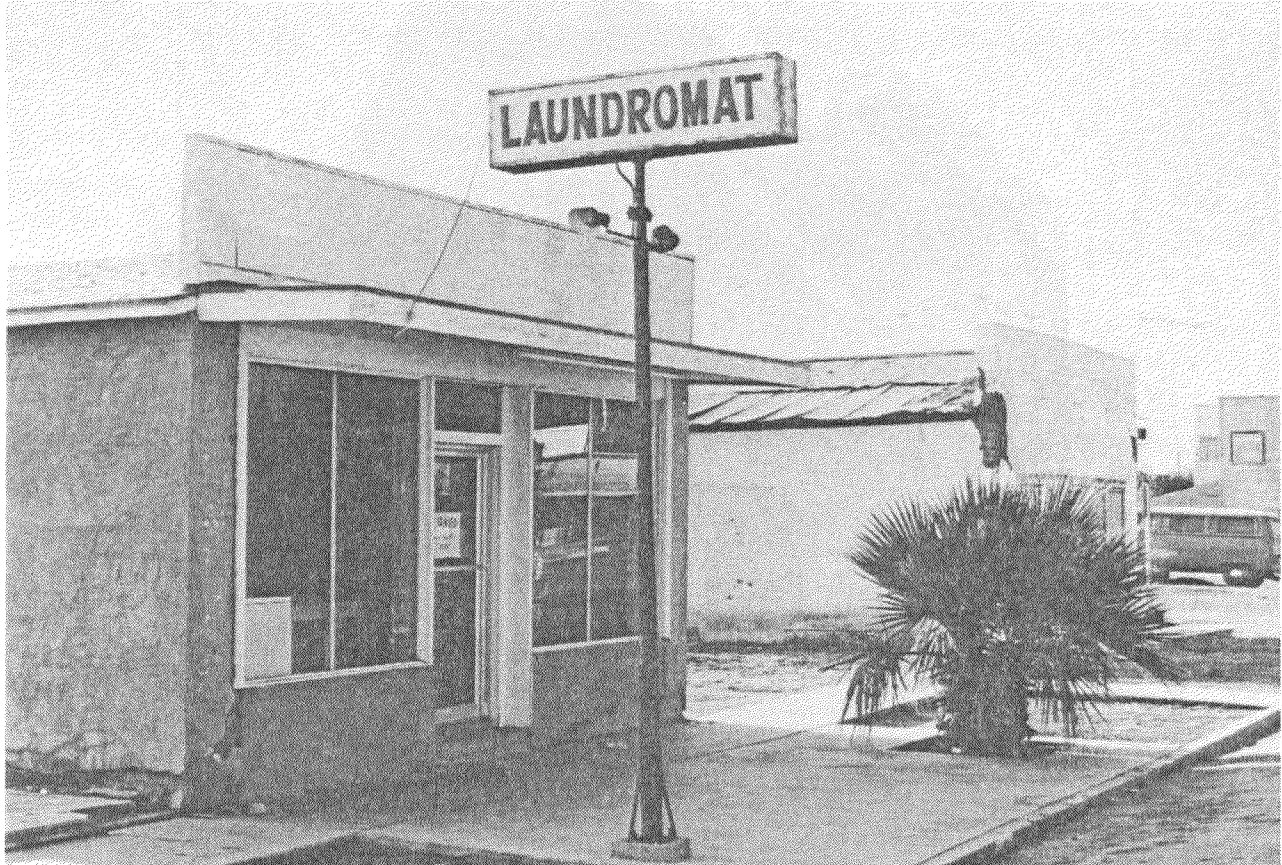
FIG. 4

Two adobe structures, the Laundromat and an adjacent Warehouse, were moderately damaged (FIG.4). Damage was confined to the front of both of these structures, to wall sections poorly braced adjacent to storefront openings of large dimension.
