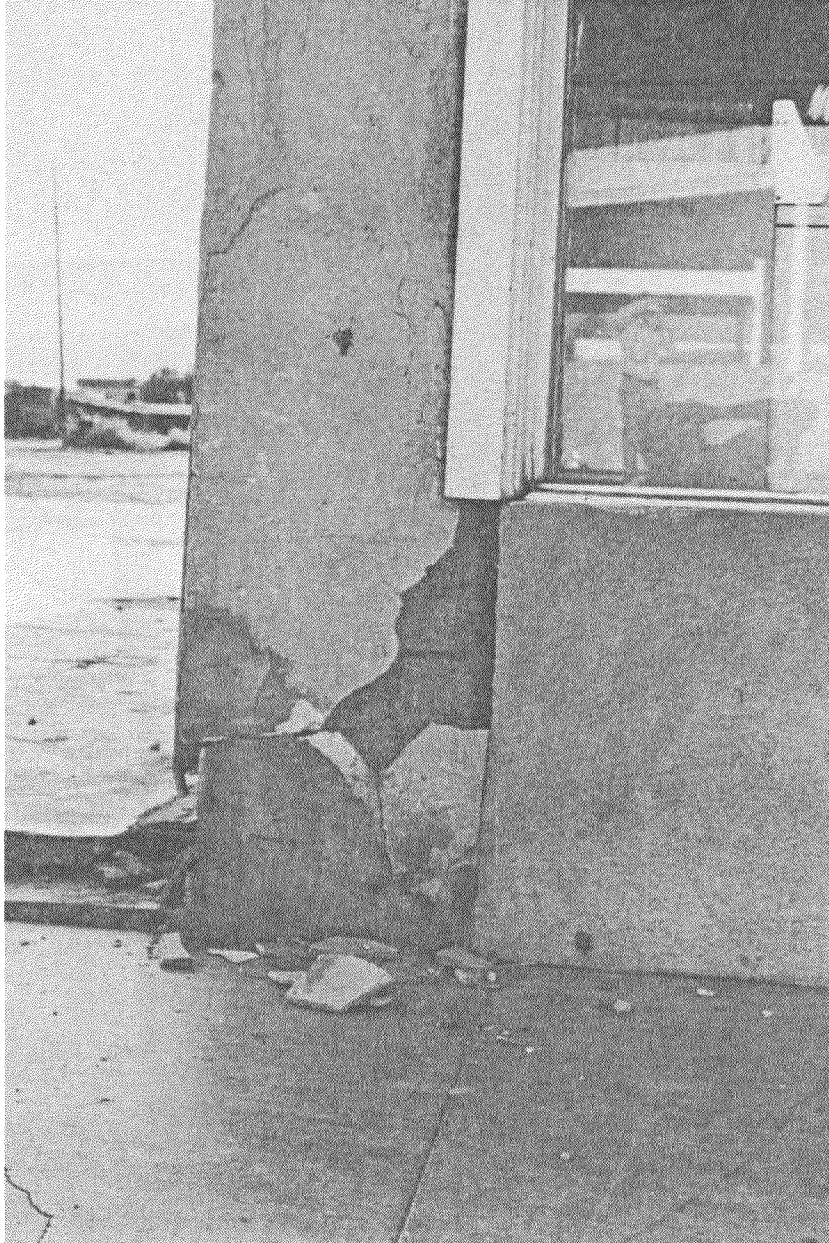
FIG. 5

The Laundromat damage (FIG.5) was confined to the lateral movement of an unbraced wall adjacent and untied to the front wall.
