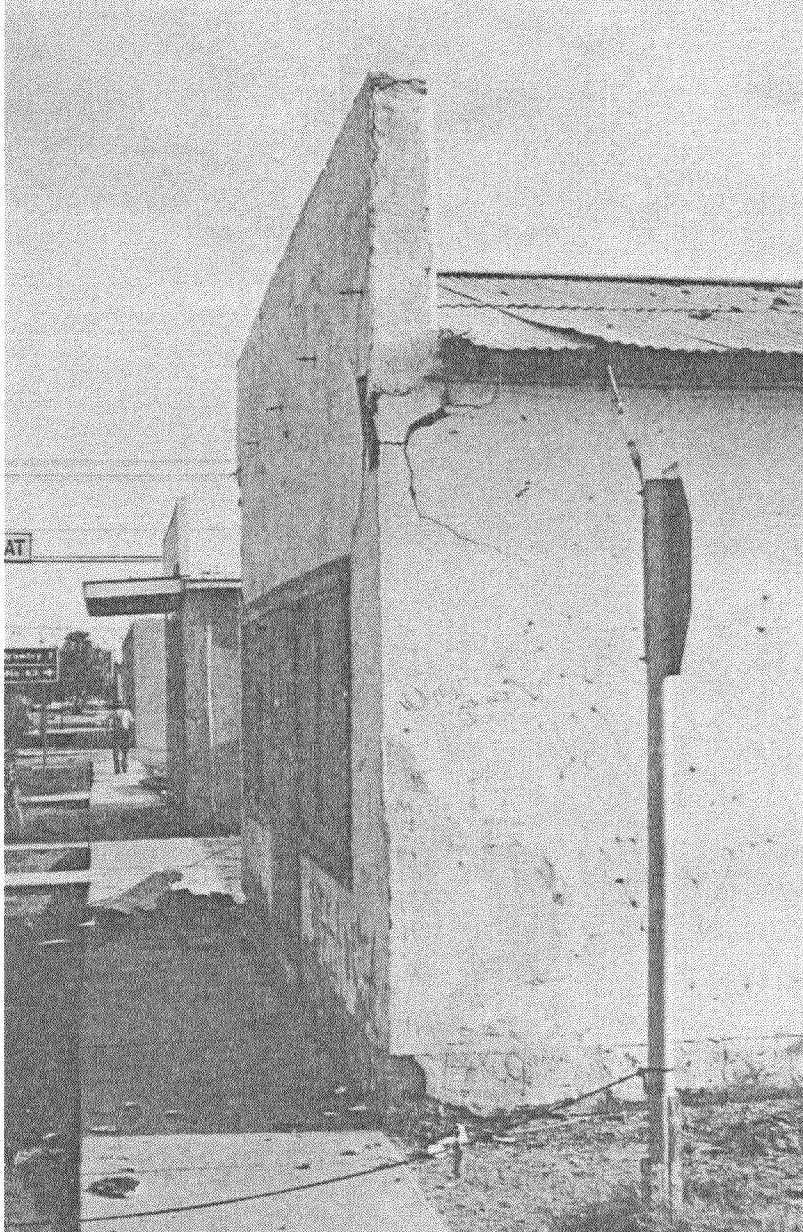
FIG. 6

Damage to the parapet wall above the storefront opening of the warehouse (FIG.6) appears to have been concentrated in the small cross sectional area at the connection of the front and side wall. No bond beam was evident on this structure.
