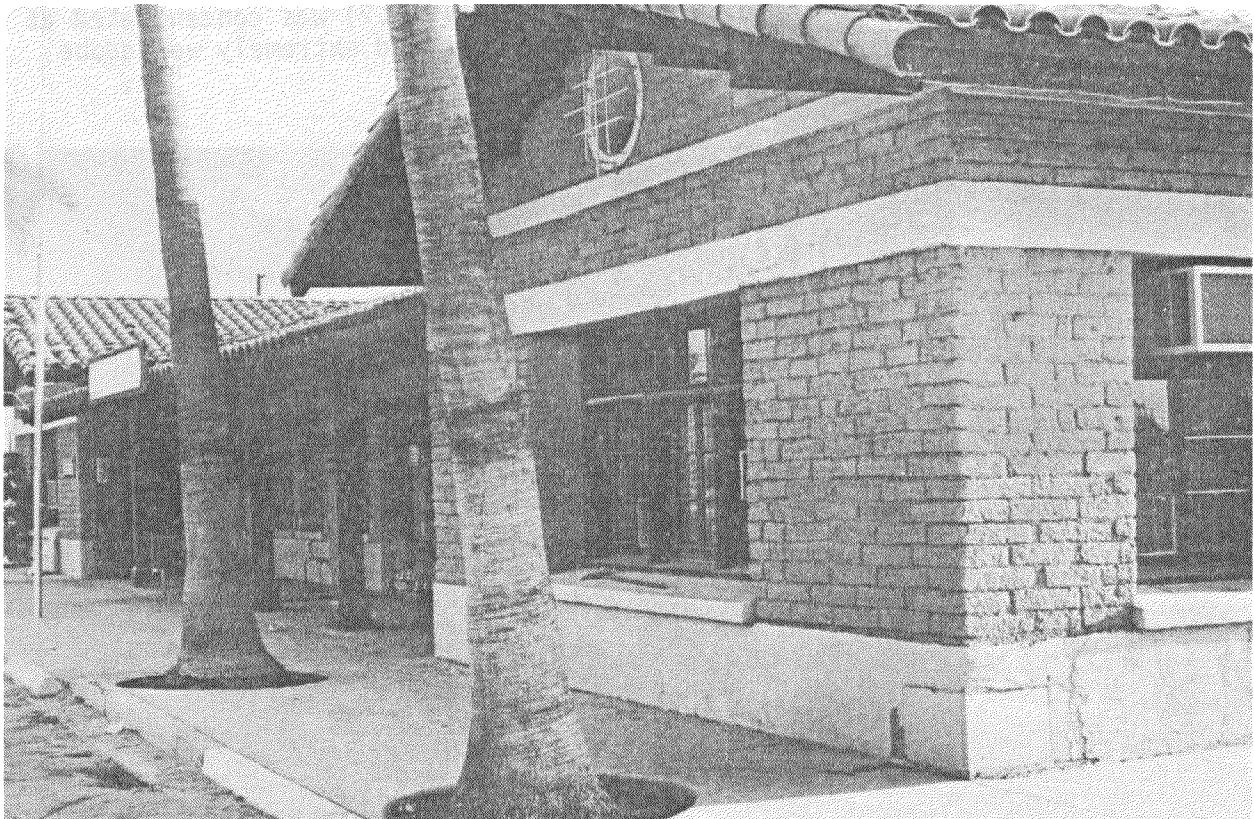
FIG. 9

An example of properly designed and maintained adobe structure capable of withstanding severe seismic movement is the Westmorland Town Hall (FIG.9, 10, 11). This structure built by the W. P. A. is constructed of unstabilized adobe with approximately two foot thick walls. A bond beam at the lintels and roof, high foundation wall and careful construction methods have produced a structure that has had no signs of structural failure since it was constructed in the mid 1930's.
