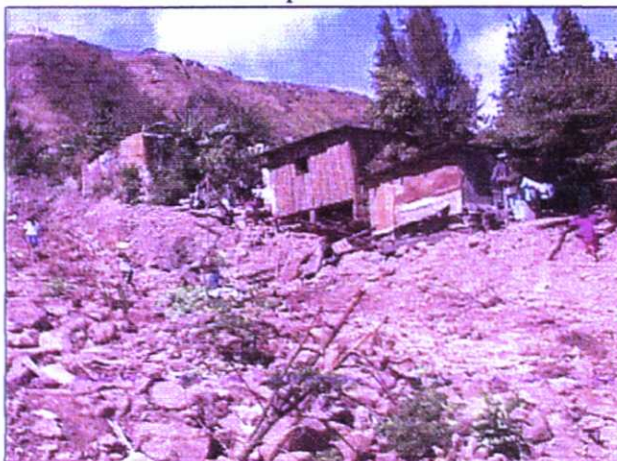
El Berrinche: Portions of two colonias, El Porvenir and 14 de Febrero, sit at the head scarp of the El Berrinche landslide on the upper right and upper left sides (looking upslope) respectively. Tension cracks from the head-scarp area of the landslide extend into each of these colonias near houses that are sitting adjacent to the head scarp. In the next rainy season, additional slumping from the head scarp area is likely to take place and result in the displacement of the areas where houses sit next to these cracks. Continued movement may take place for several years in which portions next to the head scarp area of the landslide may slump onto the present landslide mass in a retrogressive (progressing upslope) manner. Residences adjacent to the head scarp of the El Berrinche landslide might be evacuated and the occupants relocated especially if tension cracks now extend within the houses or within several meters of individual houses. If not evacuated, these areas of houses need to have survey markers established near them and monitored at regular intervals so that any renewed movement can be detected and the people warned of imminent movement and slope failure

Homes in Colonia El Porvenir perch dangerously close to the El Berrinche slide.

- *(Short Term)* In lieu of the above remedy to future landslide movement, inexpensive measures can be undertaken to decrease the risk of renewed landslide movement. Water continues to flow over the head-scarp area forming a pond on the upper reaches of the landslide near Colonia 14 de Febrero. Diverting the surface flow of water from the landslide mass would help to prevent saturation of the slide mass. Also, water emanating from the landslide mass should also be channeled off of the mass to remove as much water from the landslide as possible. Lined surface channels to divert and drain surface waters should be constructed to remove water from the landslide and prevent it from saturating other adjacent slopes.

- *(Short Term)* Regrading the landslide surface to seal open cracks as much as possible would also help to prevent rainwater from infiltrating the slide mass. Expenditures to accomplish the surface drainage, the sealing of fractures, and monitoring of future movement within colonias El Porvenir and 14 de Febrero would range from \$10,000 to \$50,000. Recommendations that relate to channel surface waters from the landslide have been described in a previous report by the U. S. Army Corps of Engineers to USAID.

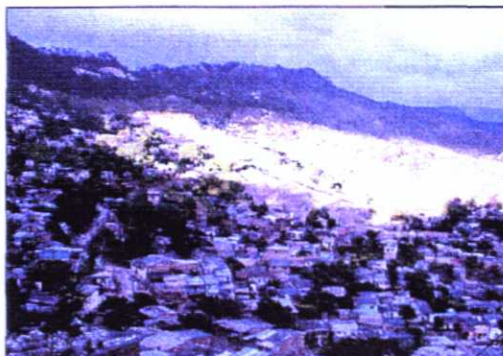
Colonia El Reparto: Several houses within Colonia El Reparto are located near the upper left side (looking upslope) of the head scarp of the El Reparto landslide. Similar to the situation in those colonias near the El Berrinche landslide, these homes in Colonia El Reparto are located within 10 meters of the landslide head scarp. No cracks are presently evident extending immediately adjacent to the houses, and the residences may escape involvement in renewed slumping from the head-scarp region of the landslide in the next rainy season. However, survey markers need to be

El Reparto landslide that destroyed numerous homes

placed above the head-scarp area near these houses so that any recurring movement can be detected and the people warned. People should then be evacuated at the first sign of renewed movement indicating that the houses are becoming part of retrogressive slumping that is likely to take place in the head-scarp of the landslide for several years.

- *(Short Term)* Inexpensive measures such as surface drainage and surveying and monitoring of any renewed movement within the head-scarp area of Colonia El Reparto would cost about \$5,000 to \$15,000.

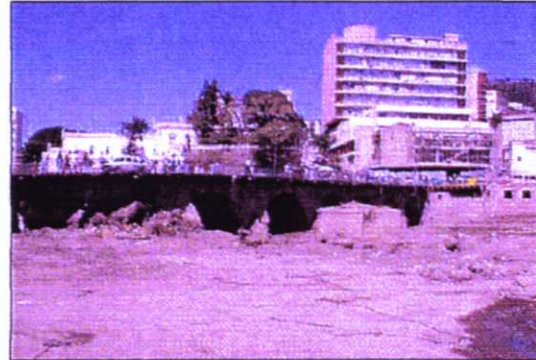
The major rivers in the Tegucigalpa area peaked in the late night and early morning hours of 30-31 October 1998. In addition to extensive flooding, the high peak flows caused significant scour and erosion of the streambanks resulting in the destruction of numerous homes as well as the destruction of several bridges. Along the Rio Choluteca and Rio Chiquito in Tegucigalpa, floodwaters engulfed dwellings located more than 3 city blocks from the rivers, where substantial damaged to homes and businesses occurred, as well as deposition of mud and debris several meters deep when floodwaters subsided. The downstream toe of El Berrinche landslide dammed the Choluteca River resulting in substantial aggradation of sediment in the river channel for approximately 1 to 2 km upstream of the slide. Due to the tremendous amount of sediment which has been introduced into the entire river drainage system, higher than normal rainy season flows/floods can be expected over the next few seasons. Sediment deposition will re-occur in the dredged rivers, resulting in additional channel maintenance costs in the future as the channel re-adjusts to the increased sediment availability due to Hurricane Mitch.

Extensive sediment deposition has greatly reduced the bridge capacities in Tegucigalpa

- *(Short Term)* It is imperative that the Rio Choluteca channel capacity be increased as soon as possible. This is required to ensure free-flowing water through Tegucigalpa for quality of water as well as to restore adequate conveyance or channel capacity for high-water flows. Removal and transport of sediments to higher ground and out of the floodplain should be accomplished. Sediment removed from the channel proper should not be placed in the floodplain areas immediately adjacent to the channel. The low-lying areas adjacent to the channel are important flow-conveyance areas, and should not be filled with spoil materials.

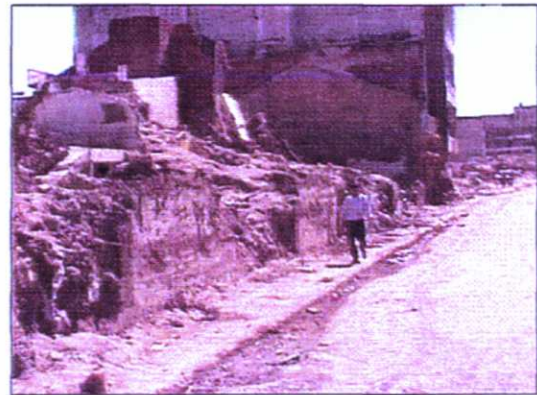
Heavy sediment deposition characterized the flooding in Tegucigalpa.
