Choluteca

Description of Problem

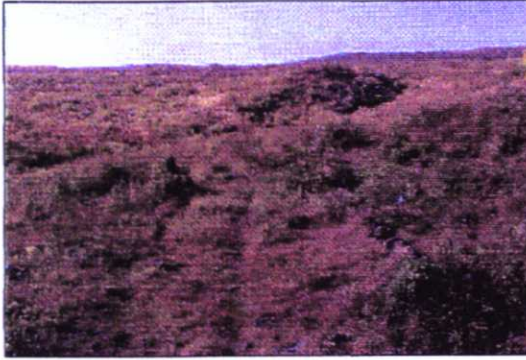
The Las Trancas site in Tegucigalpa.

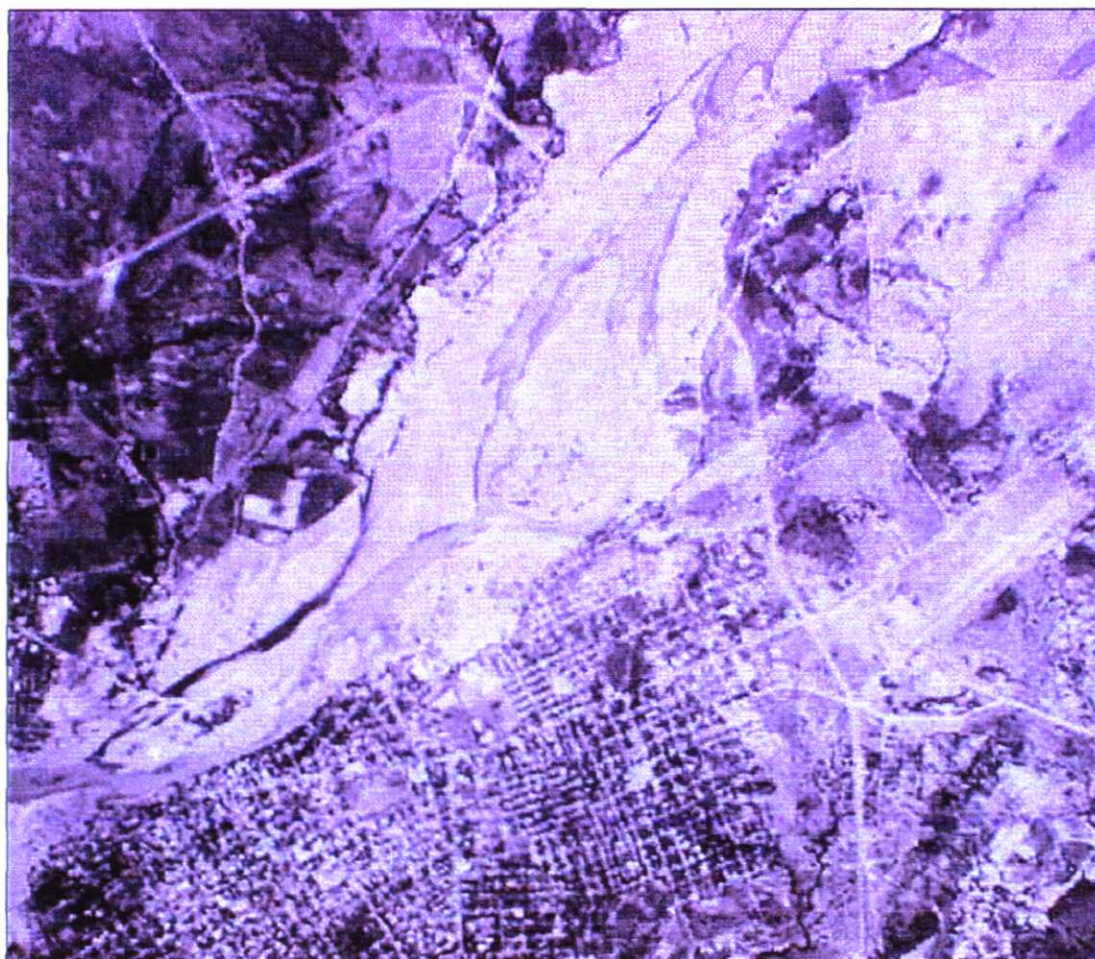
According to local authorities, the Rio Choluteca peaked sometime Friday evening, 30 October 1998. Floodwaters remained high for several days causing substantial lateral scour of channel margins, and aggradation of sediment in the Rio Choluteca, as well as the surrounding floodplain. In Choluteca there were 260 registered deaths, 400 persons missing, and approximately 2,500 homes destroyed, primarily along left bank of the River. Local authorities also estimate approximately 2-3 meters of sediment deposition throughout the Rio Choluteca channel. Two bridges cross the Rio Choluteca in the vicinity of Choluteca, and both were extensively damaged. The newer bridge located upstream of the city and built by the Japanese, lost both its right and left embankments when severe lateral erosion of channel boundaries occurred. The older bridge,

Clearly visible in this view of Choluteca is the extremely wide floodplain.

- *(Intermediate Term)* Both bridges should be re-built with provisions for additional flow relief openings for the safe passage of flood flows. Both bridges provide a clear span over the low flow channel only, and provide little or no overbank flow capacity for flood flows. When the river floods, water can back up on the upstream side of the bridges, such that when the

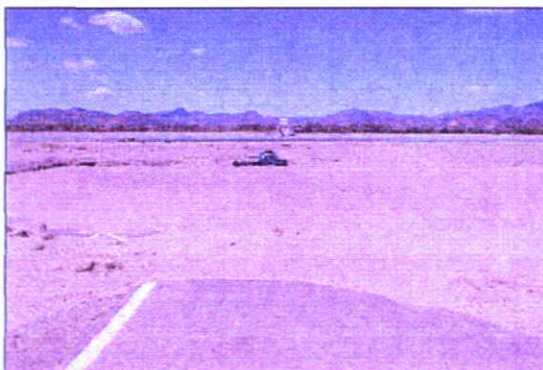
The entire left abutment of the bridge north of Choluteca was destroyed.
