Evaluation of Proposed Housing Sites

Nueva Choluteca

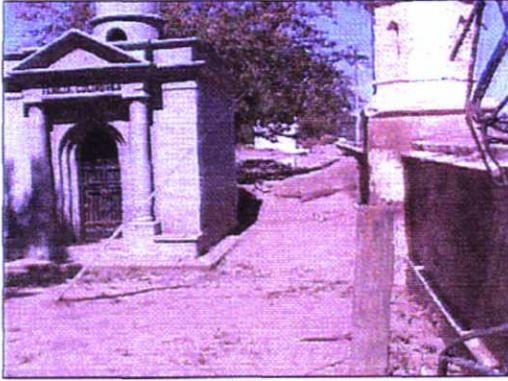
The area of Chluteca near and riverward of the cemetery should not be rebuilt.

- *(Short Term)* It is recommended that the area near and riverward of the cemetery located on the south side of town not be re-built. This area is located in the active flow area of the Rio Choluteca floodplain.

- *(Long Term)* For those low-lying areas of Choluteca which were flooded, filled with sediment, but not destroyed, a likely solution may be construction of a levee or floodwall to protect these areas. A levee may be feasible due to the relatively small area to be protected, minimal infringement on the floodplain, and the absence of significant interior drainage to account for. The map shown above illustrates a likely levee

alignment for the city. Hydrologic, hydraulic, geotechnical, and structural studies will be required to determine levee height, alignment, length, and structural design.

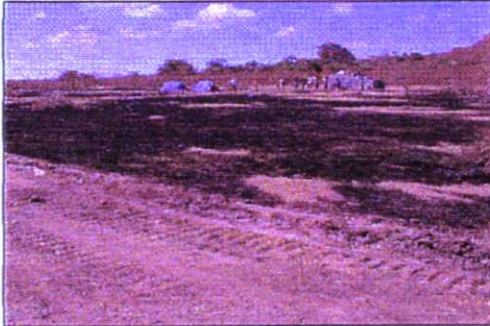
Flooding. The absence of river-transported sediment reveals that the site is not on the active nor

Site work has begun at Nueva Choluteca

ancient flood plain, hence flooding due to high river flows is unlikely. On the other hand, in the event that the rainfall rate exceeds the infiltration capacity of the soil, sheet flow may produce shallow (<0.10m) inundation. Moreover, the production of sheet flow will be enhanced by the conversion of fallow lands to urbanized lands. We anticipate that a local drainage system for the planned development will be required.
