Pespire

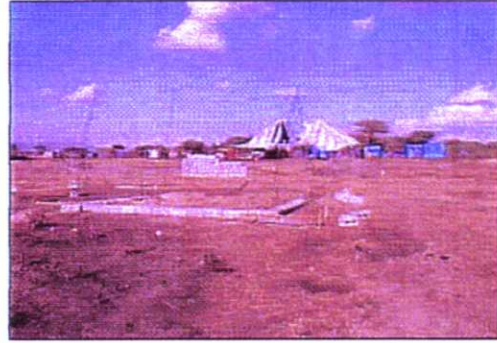
Construction has commenced at Nueva Eden

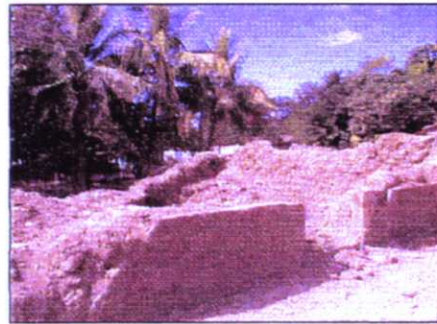
Extensive flooding and sediment deposition occurred in low lying areas of Pespire along the Rio Nacaome and Rio Chiquito.

Sediment deposition was severe in Pespire, as it was in most of Honduras following Hurricane Mitch.

- *(Short Term)* It is recommended that those areas closest to the river which were destroyed during the flood not be re-built. These flat areas showed evidence of extremely high velocities and flood depths, and as an active part of the floodplain should not be re-inhabited.
- *(Short Term)* Those housing areas located on the lower slopes of Pespire and damaged by the flood may be repaired/rebuilt. These areas should expect to be flooded periodically, but the flooding should occur infrequently
- *(Short Term)* It is not recommended that any dredging of the river channel be accomplished at Pespire.

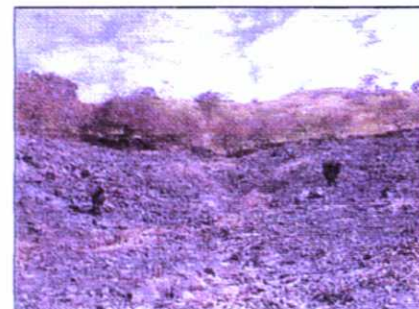
Flooding: The lowest point of the proposed site is approximately 2 meters higher than the maximum flood stage of the Rio Chiquito. Hence, it is unlikely that flooding due to high-river flow will occur. The site is relatively steep and will require a local drainage system to prevent both erosion and localized flooding.

The proposed housing site at Pespire is located above the floodplain.

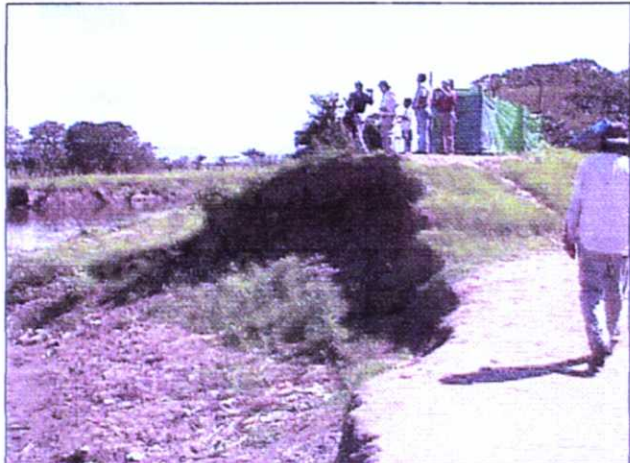
The levee along the Rio Chamelecon overtopped and breached in several locations.
