LANDSLIDES ASSOCIATED WITH THE LUZON EARTHQUAKE

6.1 Introduction

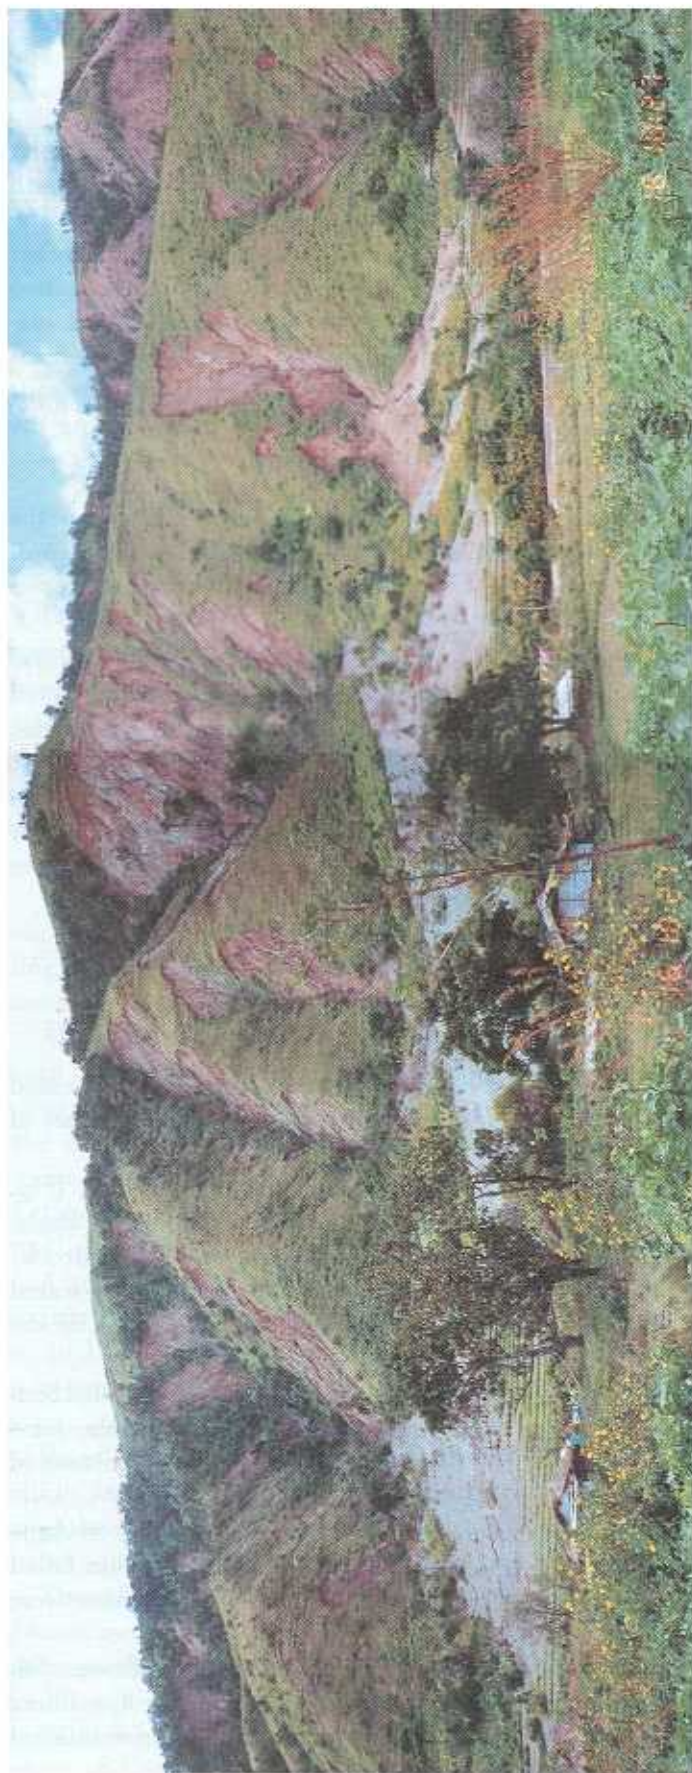
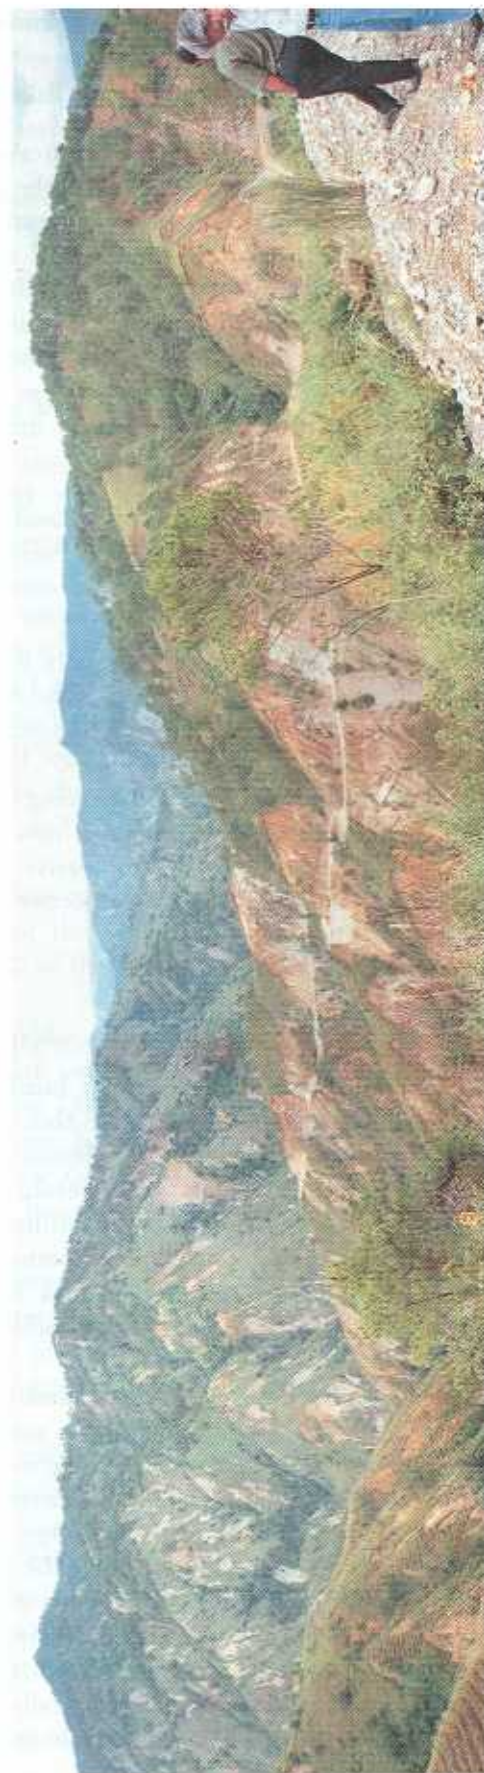
The first group is typical of moderate to steep slopes with limited differences in elevation (Fig. 6.2). The height of the slope has no influence, failure being basically controlled by the slope angle. Sliding occurs along the contact plane between the 0.5 to 2 m thick weathered zone and the bedrock.

The joint pattern of the mother rock is marginally involved in slides of this type. Shallow-seated slides occurred extensively in the Caraballo Mountains (Dalton Pass Road) and in large areas of the Central Cordillera.

Fig. 6.2 Hilly landforms of the Caraballo Mountains with the typical shallow-seated landslides (debris slides) along the Dalton Pass Road (top). Shallow debris slides near the road leading to Ambuklao Dam (Cordillera Central), NE of Baguio (bottom).

- a) debris slides (33%) and debris flows (14%). Debris slides in hilly landforms are shown in Figures 6.2 (bottom) and 6.7, while Figures 6.8 and 6.9 illustrate debris flows and some debris slides in shattered rocks forming steep-sided slopes near Baguio.
- b) rock flows (6%) and debris avalanches (7%). A number of rock flows and debris avalanches associated with other types and accelerated erosion occurred on steep slopes in the Central Cordillera (Fig. 6.4).

- a) debris slides (55%). Shallow debris slides are dominant and their main characteristics are (Figs. 6.2 top and 6.11 bottom):
 - moderate to steep slopes (35 - 55 degrees). The critical slope angle above which failure occurred is in the 35 to 38 degree range, depending on the type of regolith, bedrock, and the quantity and type of fines; slope height is usually moderate and the topography is predominantly hilly. The thickness of the slides is between 0.5 and 2.0 m.

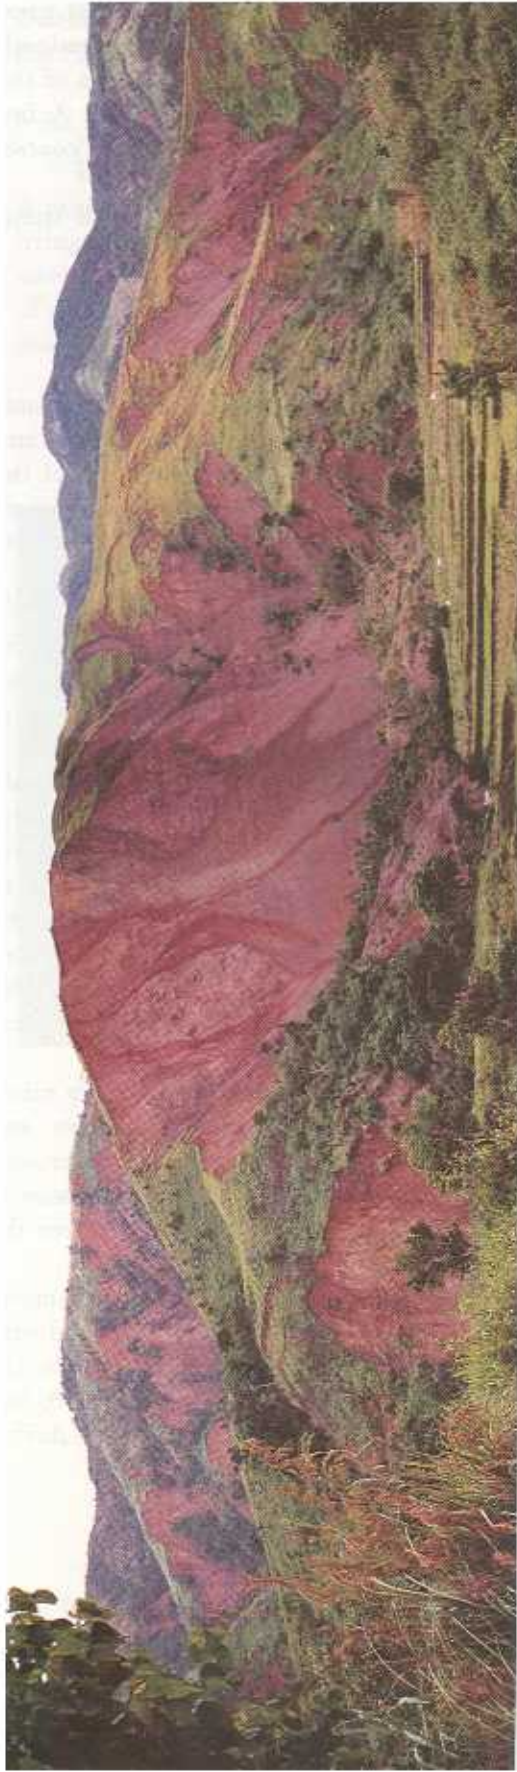
In the second group, deep-seated landslides, the failure involved the weathered zone and the bedrock (Fig. 6.3). Critical slope height, in general, is a major controlling factor together with the joint pattern, probably combined with the degree of weathering of the bedrock. Numerous slope failures of this type were observed in Cordillera Central and a few cases in the Caraballo Mountains.

Fig. 6.3 – Huge deep-seated complex landslide (debris avalanche and rock slide) in the Caraballo Mountains. The failure involved the weathered zone and the bedrock.

- the detachment area is variously shaped depending on local geological and topographic conditions, but generally marked by a sharp line.
- b) debris flows (15%) and debris avalanches (3%). Some occurrences were observed along the Dalton Pass Road. The huge debris avalanche (and rock slide) in Figure 6.3 is thought to have been reactivated by the quake.

- e) rock fall (3%). Very few rock falls were observed along the Dalton Pass Road.
- f) complex (7%). A number of slides combining two or more types of movement were observed along the Dalton Pass Road (Fig. 6.3).

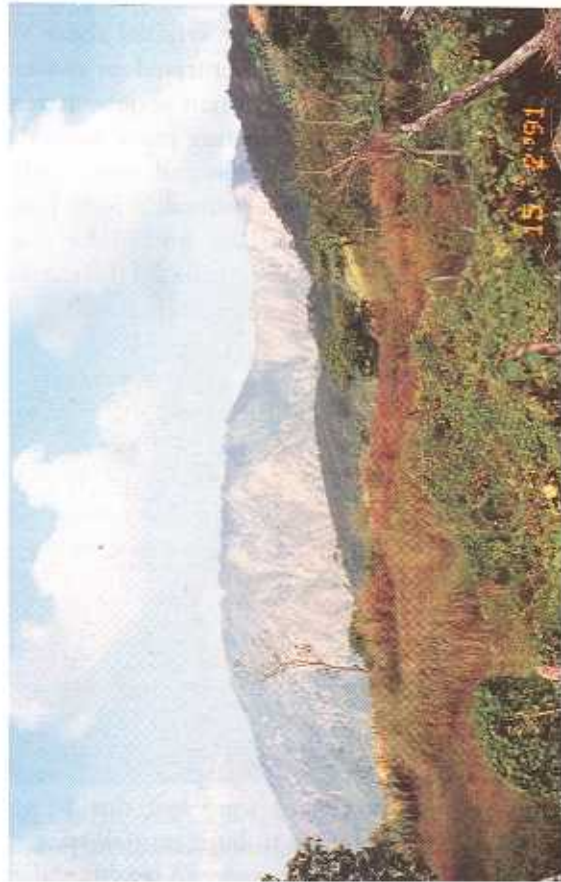
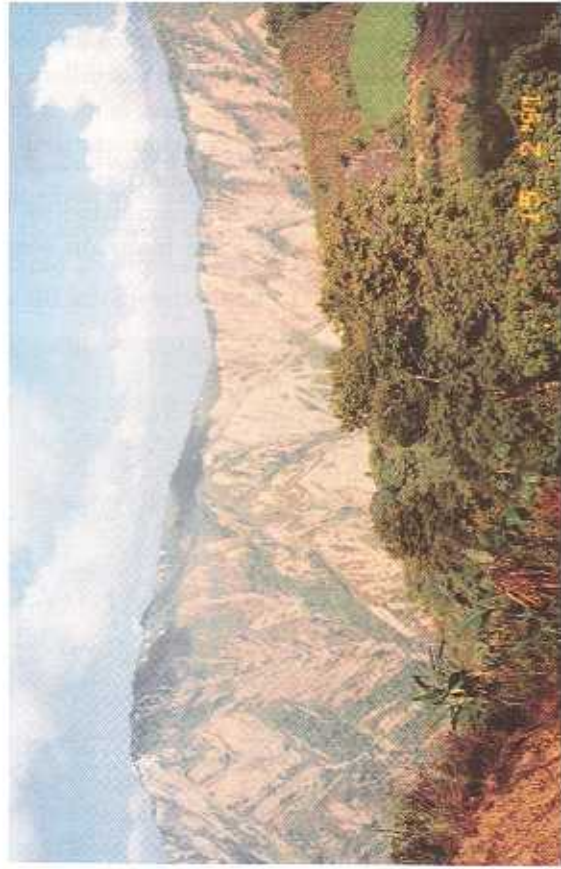
Figure 6.4 shows in sequence the ridge opposite the slope along which the road leading from Agoo to Baguio (Marcos Highway) is located. The two pictures clearly illustrate that the steep slope has failed for kilometers. Debris slides, debris flows and avalanches, rock falls and rock slides in this area were associated with large-scale accelerated erosion.

Fig. 6.4 – Generalized failure of very steep slopes across the valley with debris flows, debris slides, debris avalanches, and many rock flows and some rock slides, seen from the Marcos Highway near Baguio. The two pictures are in sequence.

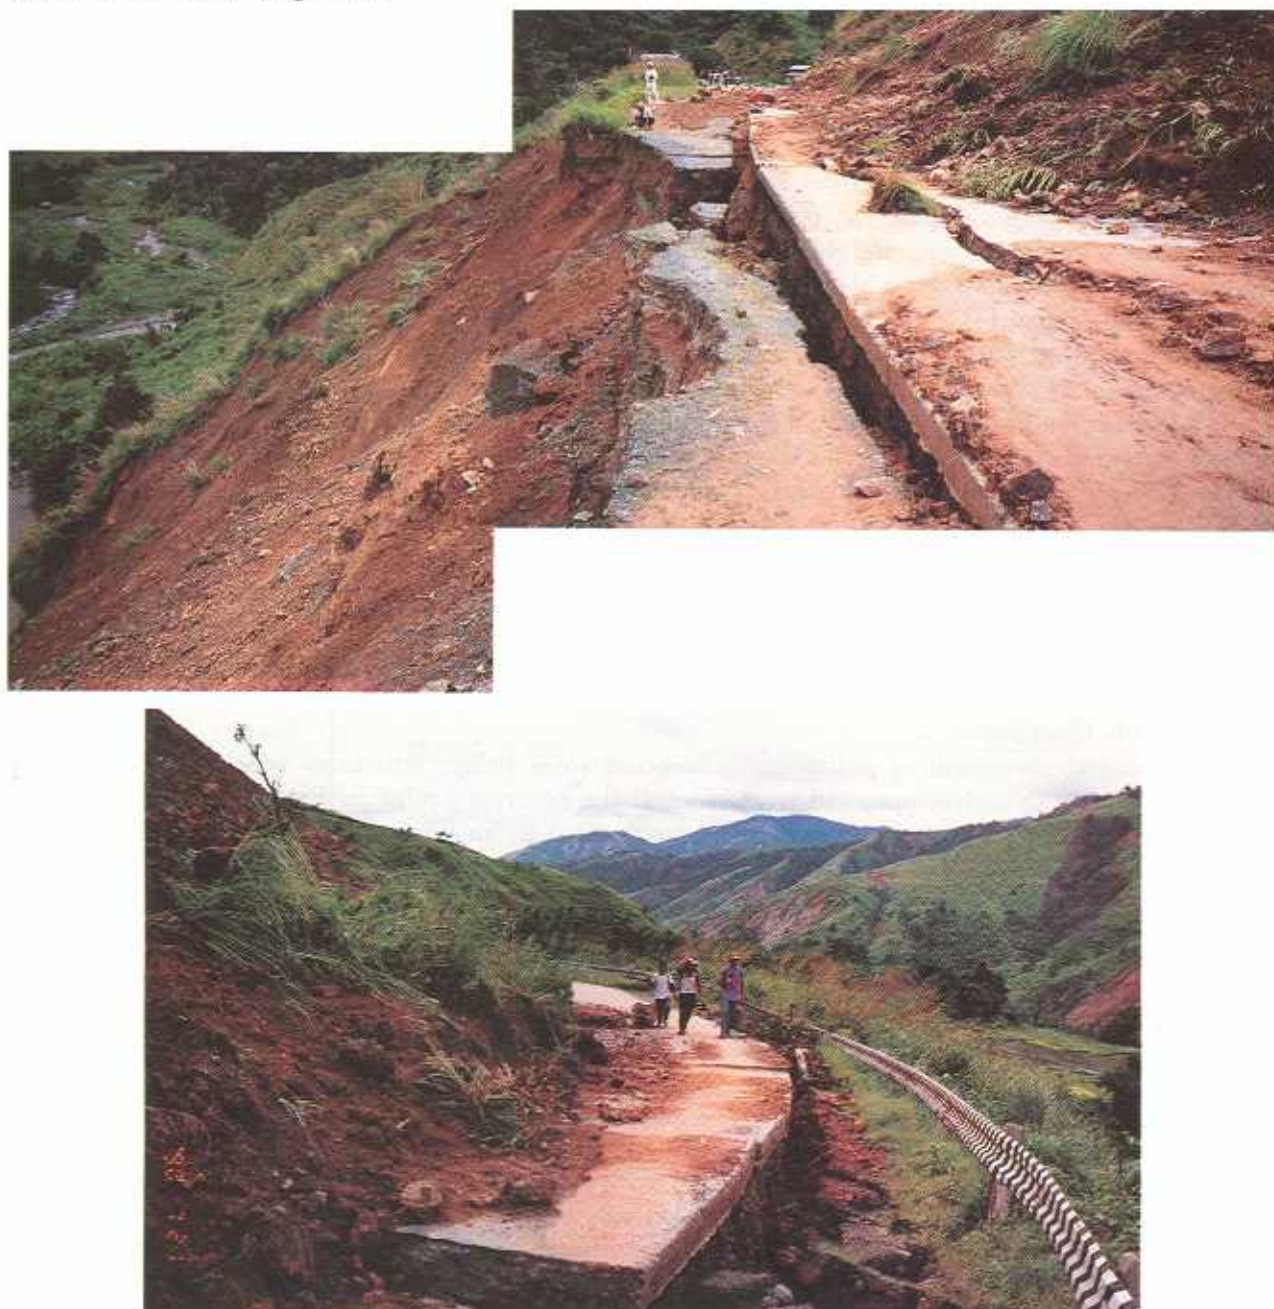
Fig. 6.5 – Debris slides along the Dalton Pass Road. Pavement, side slopes, drainage and often the entire road platform were badly damaged. Fissures induced by the quake affected the rigid pavement (top) and the shoulder (bottom), often with irreparable damage of the road surface. (Courtesy of DPWH and Katahira).

Roads were affected by an enormous number of shallow debris slides (Fig. 6.5) and some rock falls, with consequent damage to cut slopes, retaining walls, side drainage, pipes and culverts, as well as to road surface.

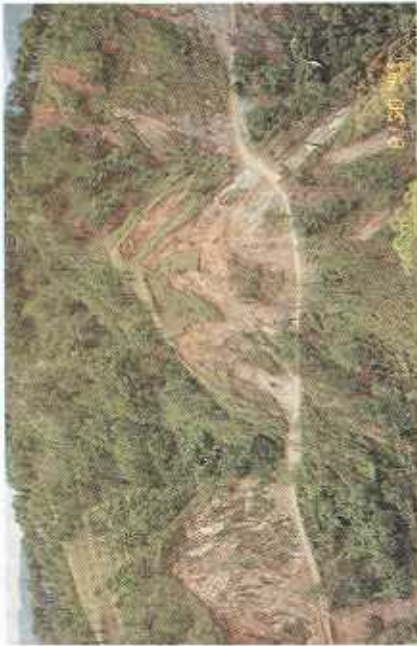
Fig. 6.7 – Shallow-seated landslides (mainly debris slides) along the road leading to Ambuklao damsite.

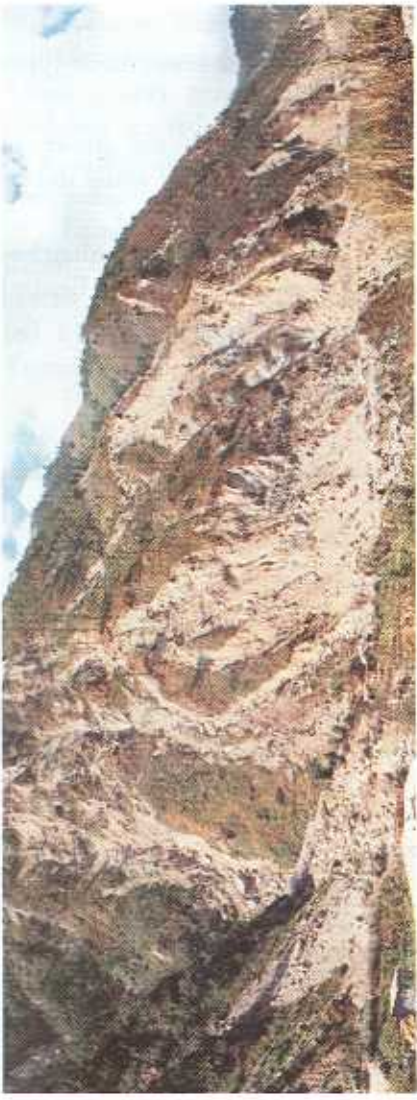
Fig. 6.8 – Debris flows, debris slides and accelerated erosion along the steep slopes of the Marcos Highway near Baguio.

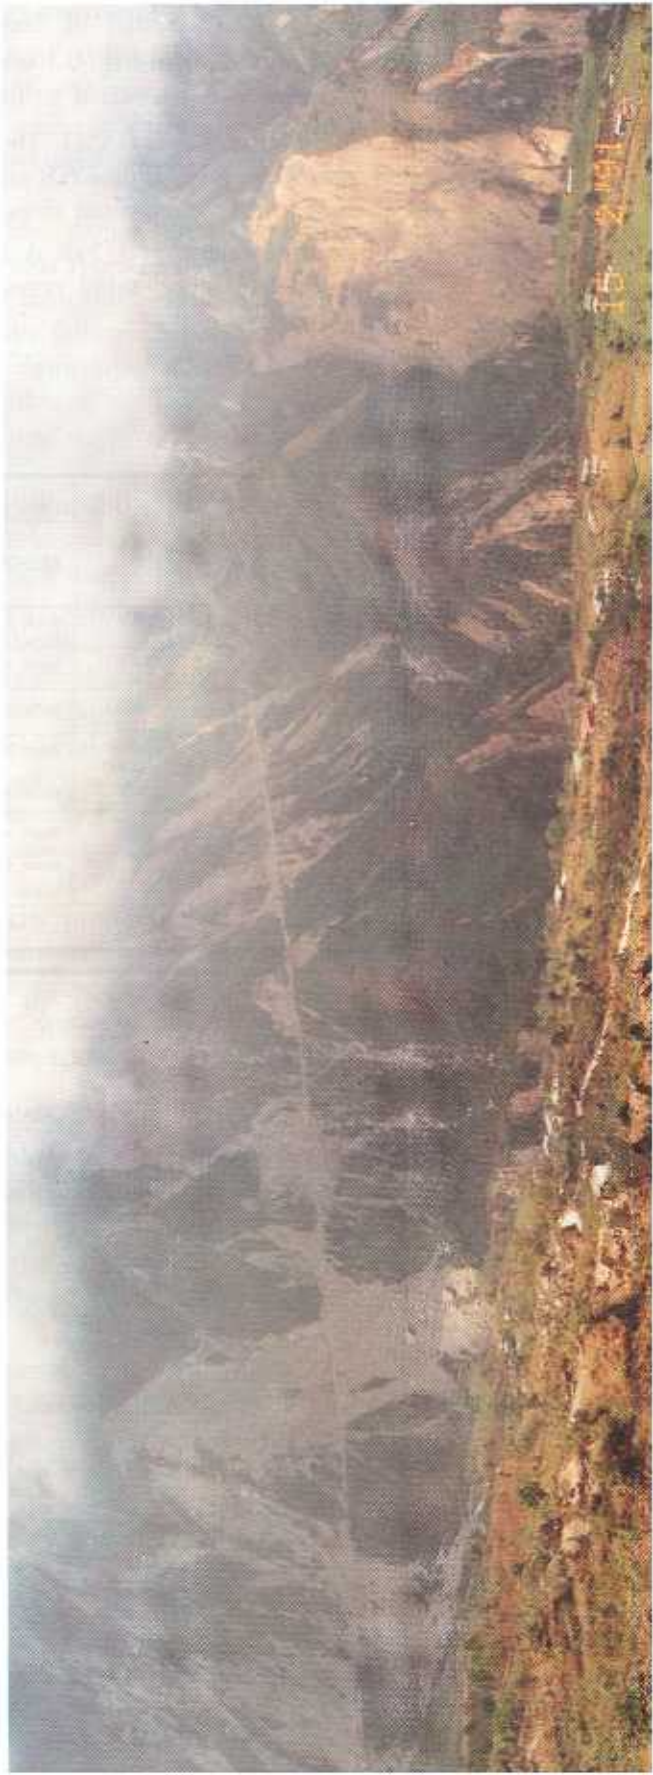
Fig. 6.9 – Debris flows, some debris slides and accelerated erosion along the Marcos Highway, near Baguio. The deep-seated slide on the far right is interpreted as a complex type of movement combining falling, sliding and flowing.

- f) complex (9%). Figure 6.9 (Marcos Highway near Baguio) shows a complex slide on the right due to the combination of rock fall, rock flow and some cutting through the intact rock material.

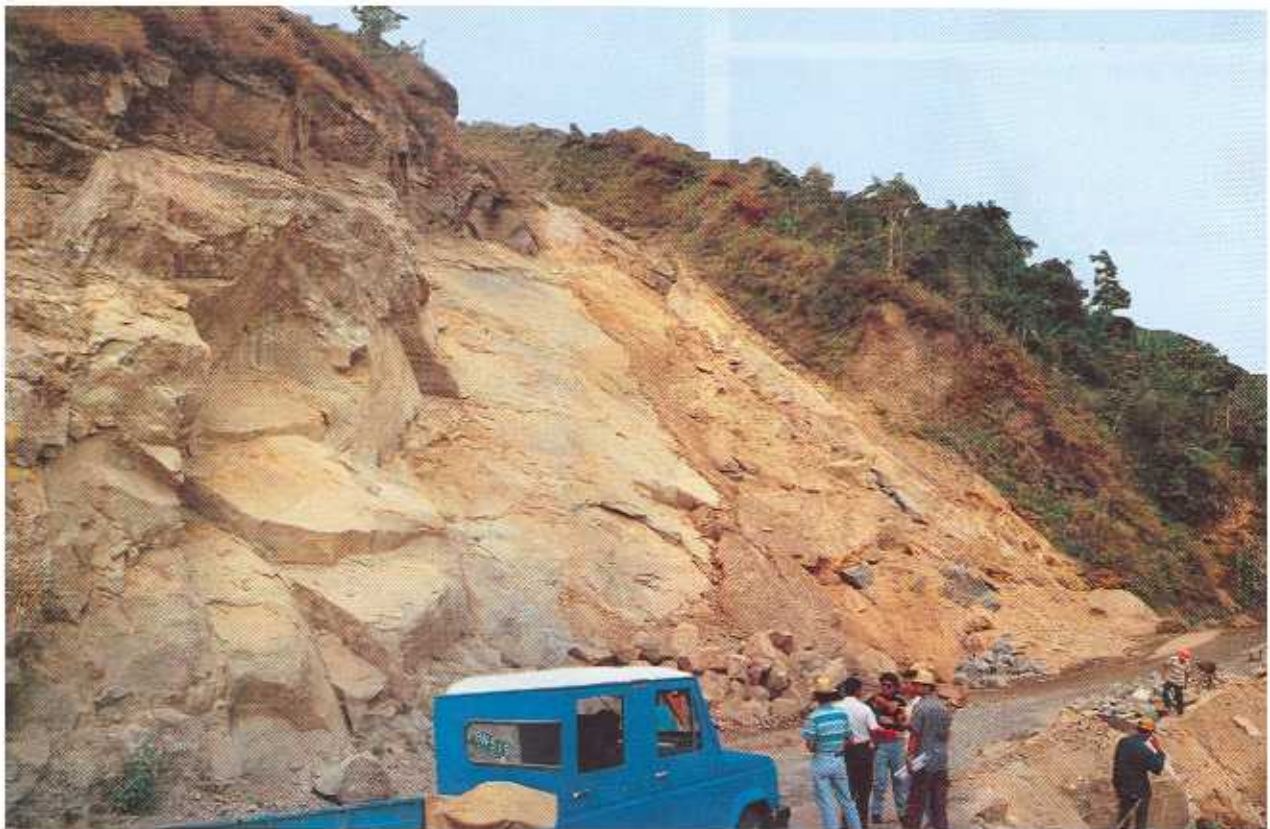
- e) rock block slides (5%). Typical cases of plane failure along bedding planes occurred along the Halsema and Kennon Roads. This joint-controlled type of slide involving the bedrock is quite common in folded sedimentary rocks. Figure 6.10 shows an example of sliding along inclined sandstone layers near Baguio (Halsema Road). The angle of the natural slope coincided in this case with the dip of bedding planes. The construction of the road, however, contributed to the sliding by bringing the bedding planes to daylight through the slope face.

Fig. 6.10 – Plane failure along the Halsema Road north of Baguio in sandstone rocks. Beyond the ground shaking, the two factors that affected the pulling force were the angle of slope and the daylighting of the bedding planes

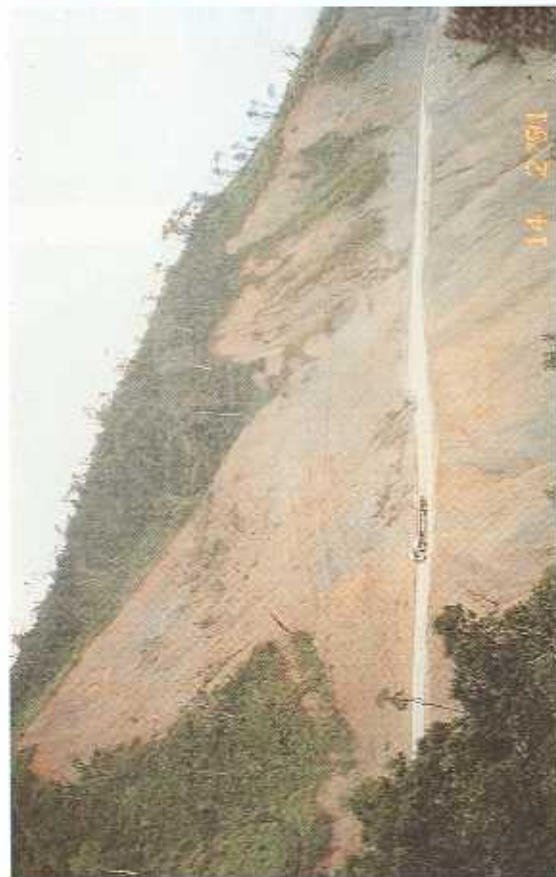
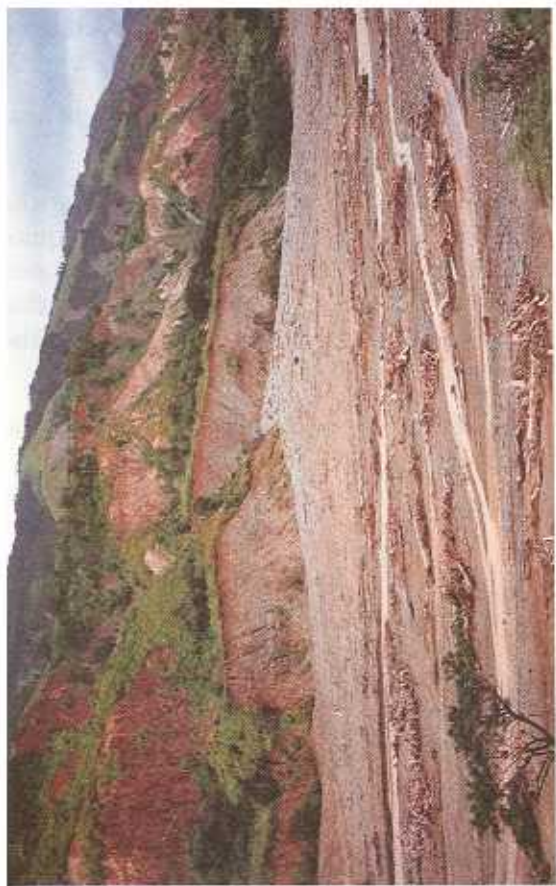
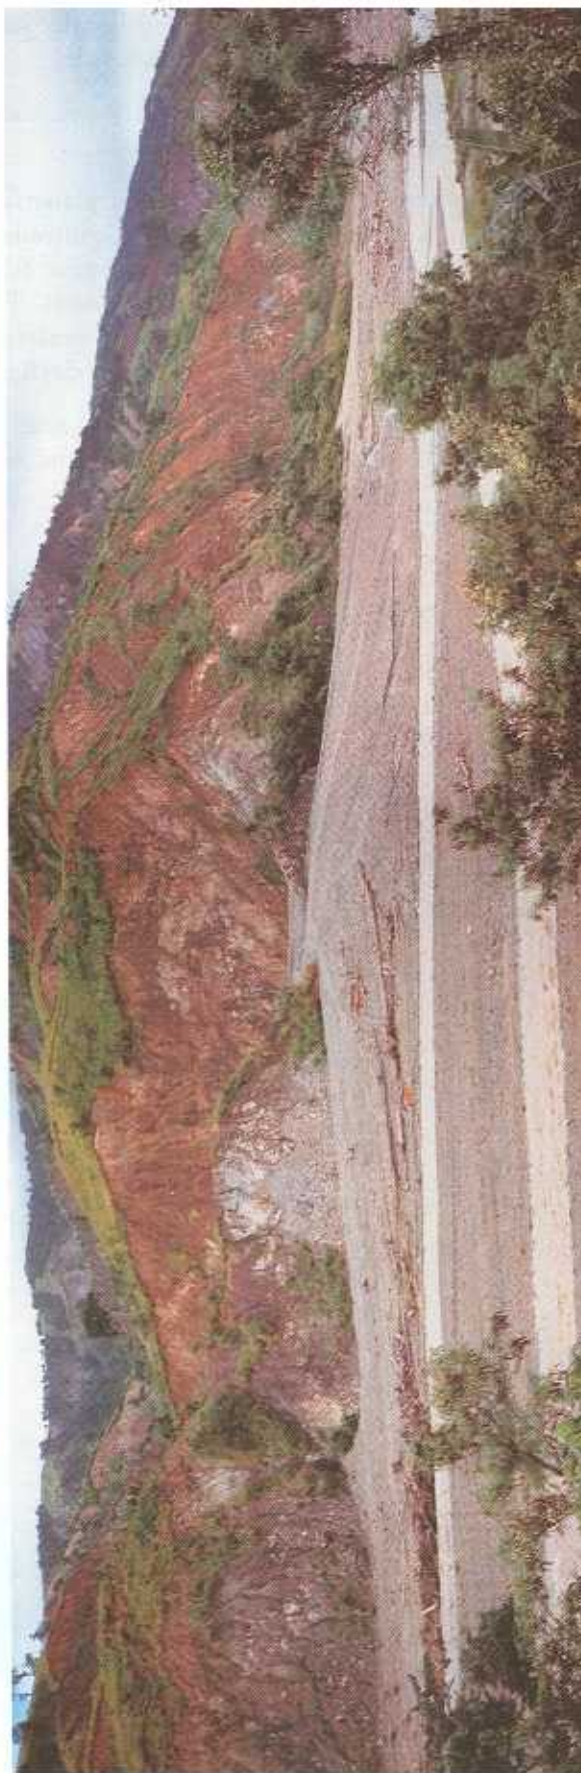
Fig 6 11 Typical area of debris and earth slides along very steep slopes near Dalton Pass (top left) Earth block slides induced by undercutting along Digidig river (top right). Debris slides along the Digidig River (near Capintulan) and the huge fan created during the 1990 rainy season (bottom).

- the most common type of slide material is a light-brown mixture of partly weathered angular rock fragments, ranging from 2 to 15 cm in size, sand and silt; some large debris slides with a predominant light-gray fine matrix occurred south of the Dalton Pass (Fig. 6.11 top left);

- d) earth block slides (4%). The slides of this type along undercut banks of streams were mainly activated by the rains which followed soon after the quake. Examples of downcutting along the Digdig river are shown in Figure 6.11 (top right). The material is composed mainly of sandy gravel.

The slide material reworked and transported during the July-November 1990 rainy season created spectacular alluvial fans (Fig. 6.11 top right and bottom) near the Dalton Pass road.
