A REINFORCEMENT METHOD APPLIED TO A SHALY  
ROCK SLOPE FAILURE IN LIEGE, BELGIUM

Ch. SCHROEDER

Laboratoire de Géologie de l'Ingénieur, d'Hydrogéologie  
et de Prospection Géophysique.  
Université de Liège.

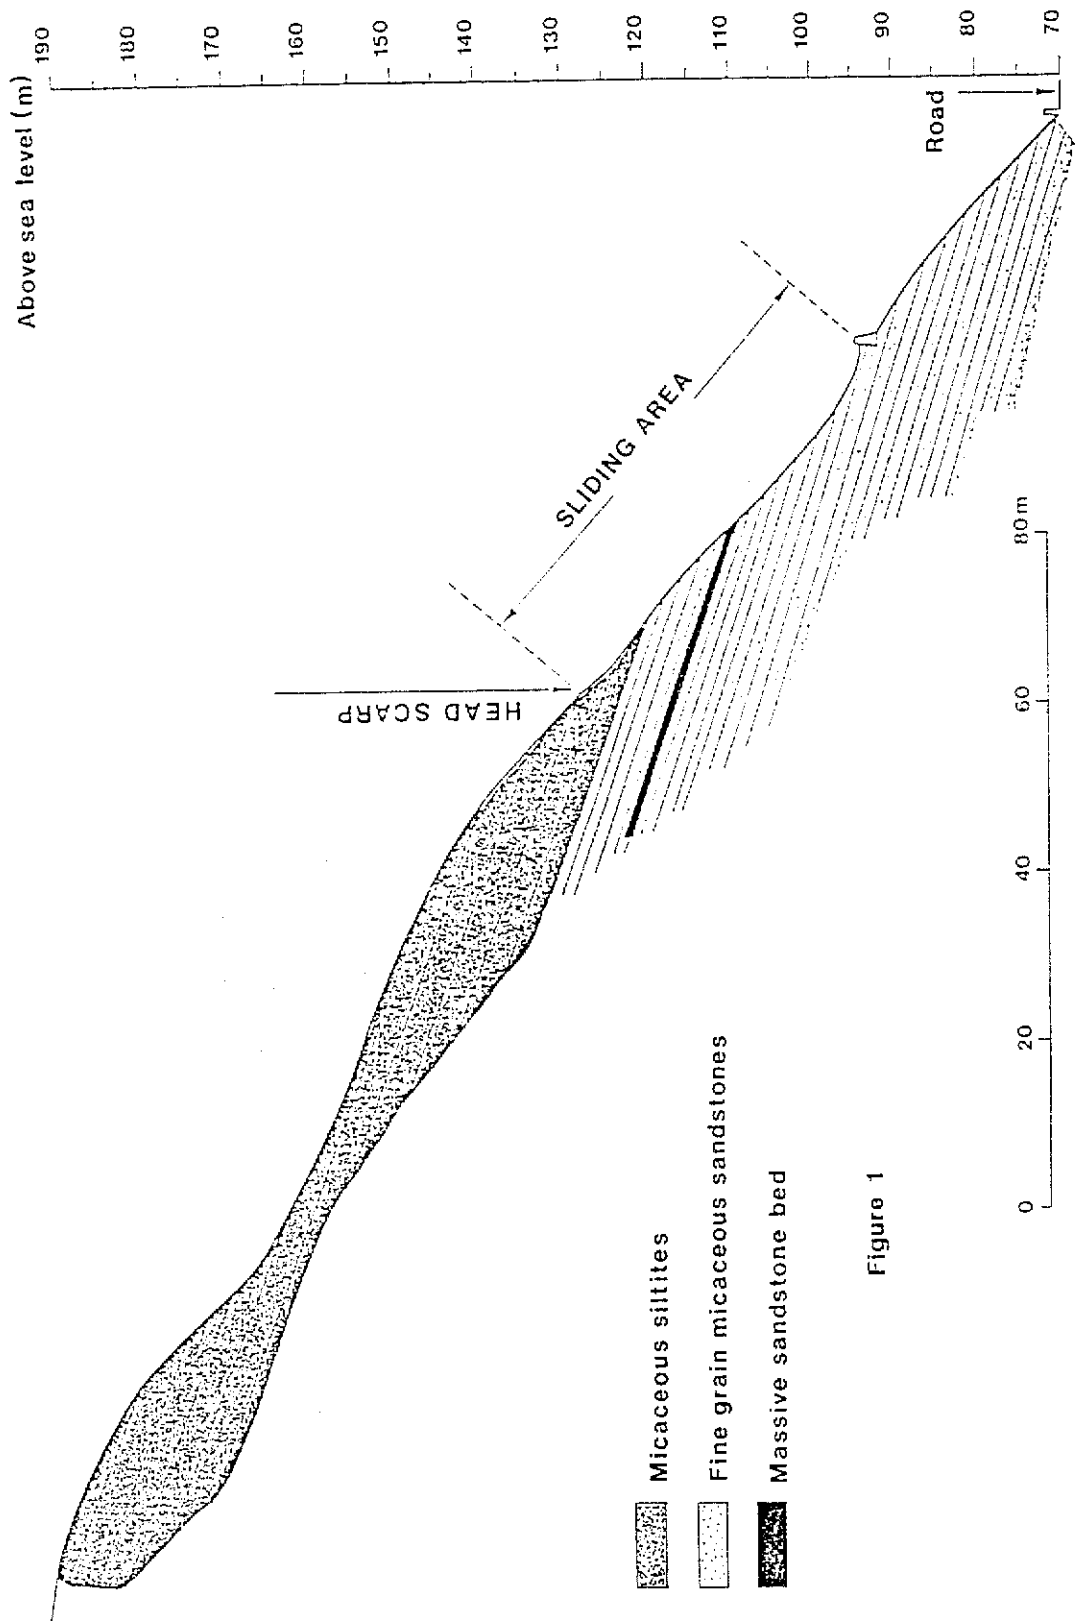
Figure 1

The present sliding area is about 2000 m<sup>2</sup> wide. The slope, oriented W-E dipping to the South, is rather steep (40°-45°). It is composed of primary (Famennian) sedimentary rocks. The stratification dips in the direction of the valley (figure 1).

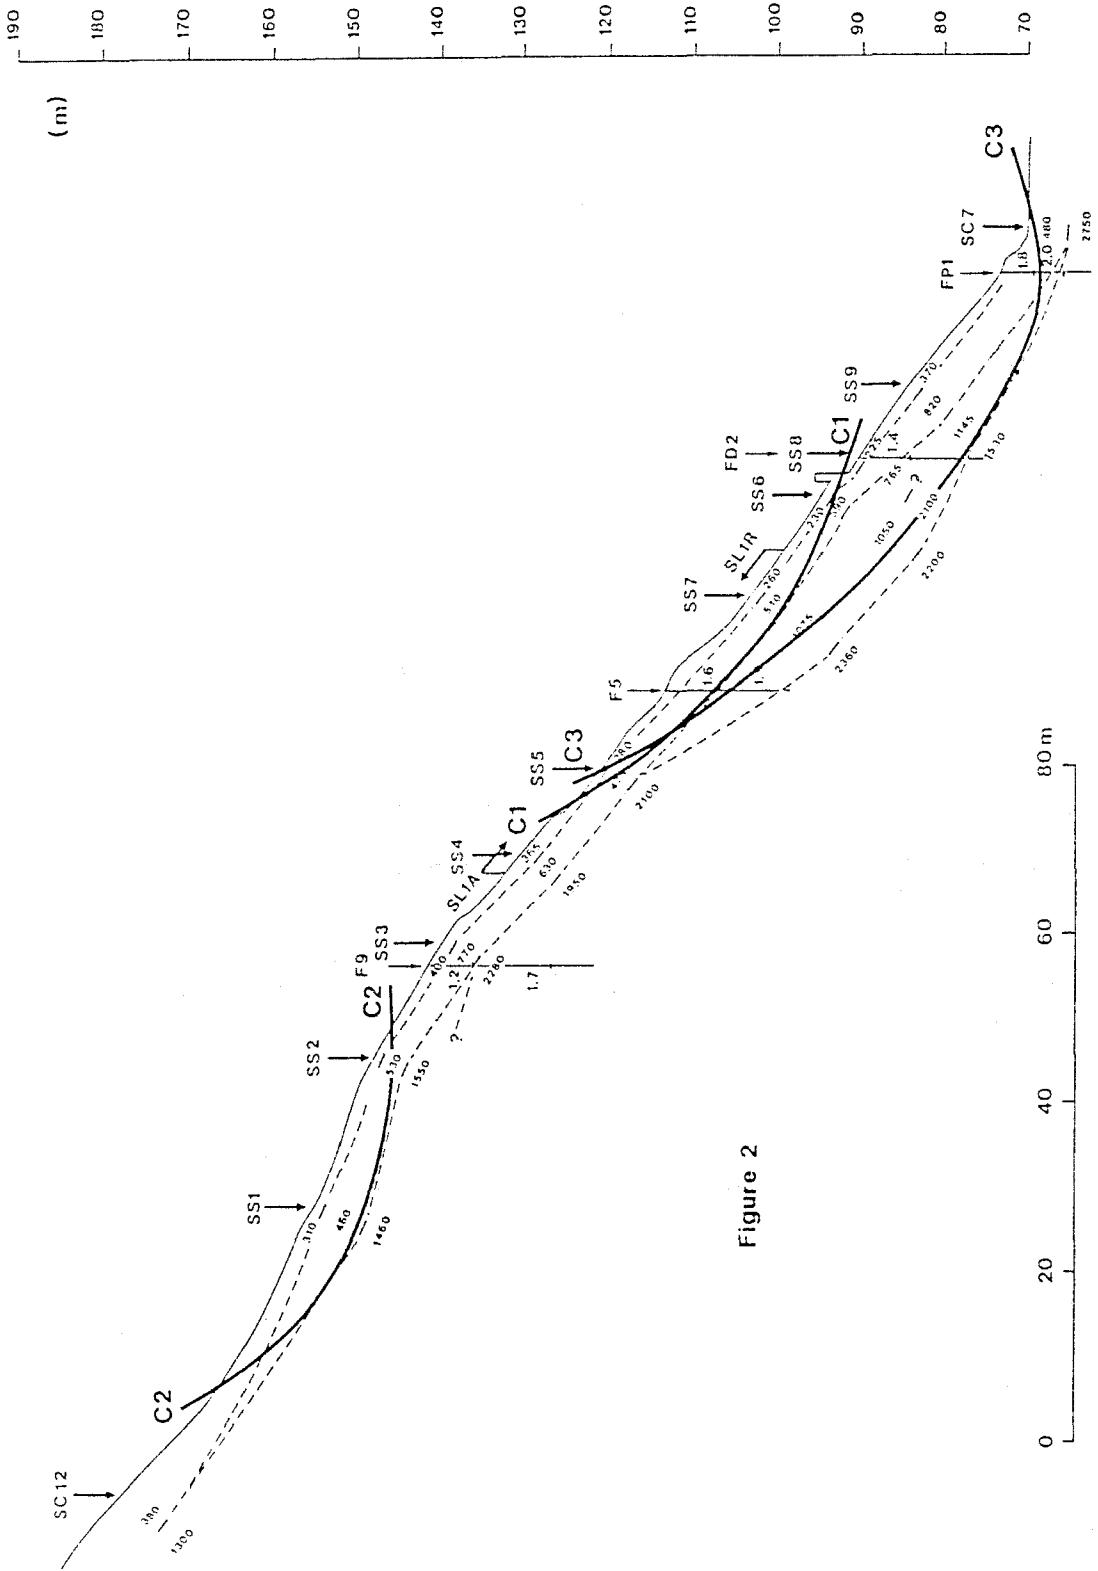
Figure 2

The results of those investigations are reported on figure 2 which shows one geophysical cross-section of the slope. They could be summarized as follows.

Under the top soil whose seismic velocities are in the range 150-450 m/s, the superficial weakened layers (colluvium and weathered bed-rock) have seismic velocities smaller than 800 m/s for the colluvium and under 1200 m/s for the weathered substratum. The sound bed-rock has velocities less than 1500 m/s in the upper part of the slope, what means that the compact bed-rock hasn't been reached by the seismic survey in this zone. The compact bed-rock seismic velocities, above 2000 m/s, are measured in the lower part of the slope.

For the back analysis, the failure surface, C1 on figure 2, is well defined with the head scarp for the starting point. The failure surface is tangent to the basis of the colluvium and its emergence is defined by the extend of the sliding zone. For this failure line, the assumption of a safety factor equal to 1 gives the cohesion-friction pairs which could be considered in the future calculations.

The feasibility of a stabilization by anchoring has been studied, using, a.o., the failure surfaces C2 and C3 of figure 2.

From the stability analyses, it results that only the zone located above present sliding area could have an almost satisfactory safety factor, though rather small ( $F = 1.37$  for the C2 line) without anchors. It comes from the smaller steepness of the slope at this location. For the lower part of the slope, the computations indicate that a safety factor of 1.2 could be obtained by an anchor stress of about 1.7 T/m<sup>2</sup>, what represents one 15 T anchor each 25 m<sup>2</sup>.

A global solution, giving enough safety, could consist of a network of reinforced concrete beams extended up to the toe of the slope, bearing upon a retaining wall and anchored at required depth as a function of the thickness of the weakened zones.

In a first phase of the stabilizing works, for insuring the immediate safety, the reinforcement has consisted of 22 anchors disposed in alternate rows with a 5 m mesh, located in the sliding area, in the zone of the thick sandstone beds. The anchors have a strength of 15 T and are 10 m long. They are binded by a network of reinforced concrete beams. No gunite or plantation are foreseen between the beams. The natural vegetation should normally assure the afforestation within a couple of years.
