3. KULEKHANI HYDROELECTRIC PROJECT

Jurikhet Khola

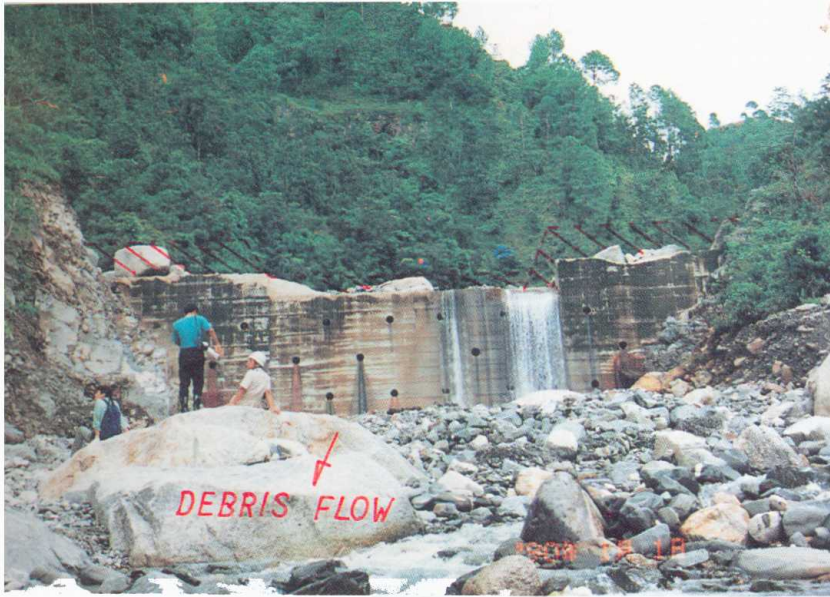
Damage to check dams of Jurikhet Khola by debris flow.

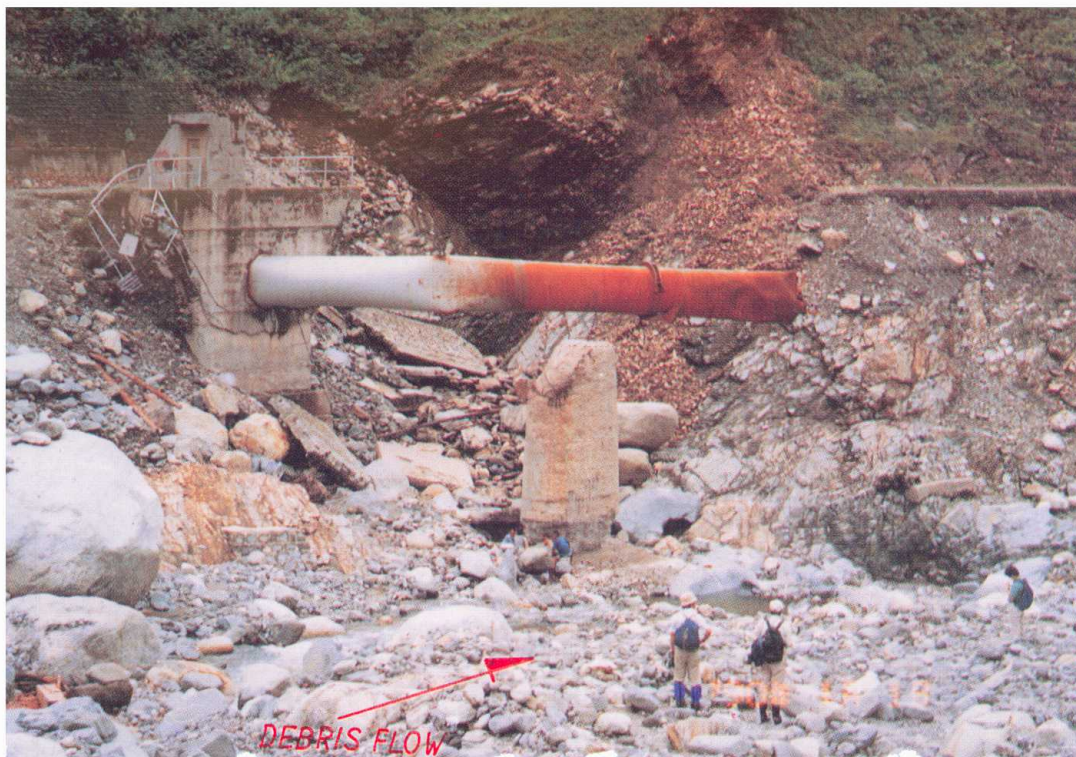
About 100 m long penstock pipe was damaged by debris flow at Jurikhet. Upper portion of the pier has been cut off by abrasive action of debris flow.

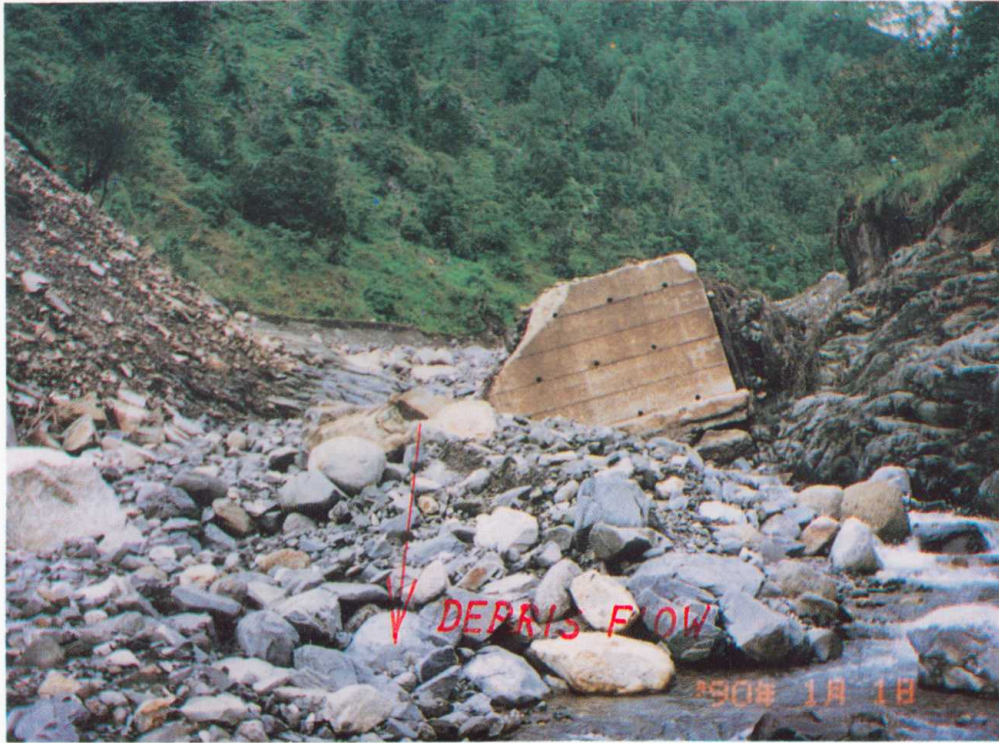
A collapsed check dam in Jurikhet Khola

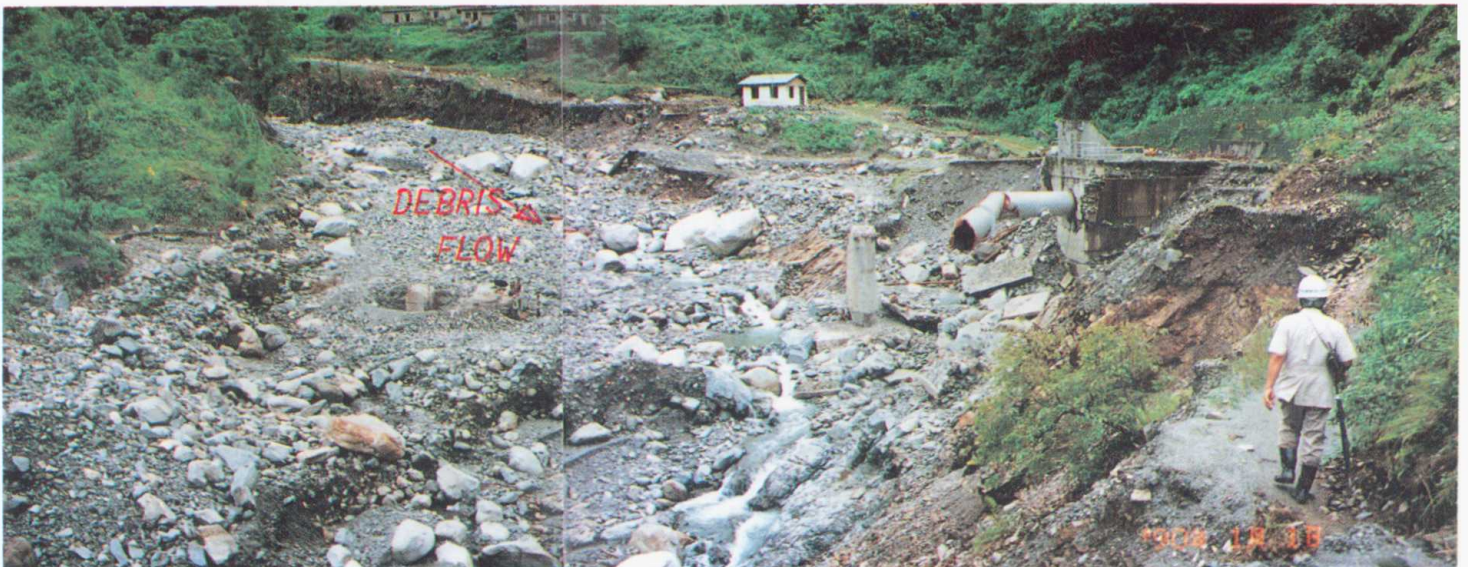
Damaged portion of penstock pipe and anchor block causing shutdown of 92 Megawatts of Hydroelectricity generation.
