### **Coastal Damage**

## **Airports**

### **Seaports**

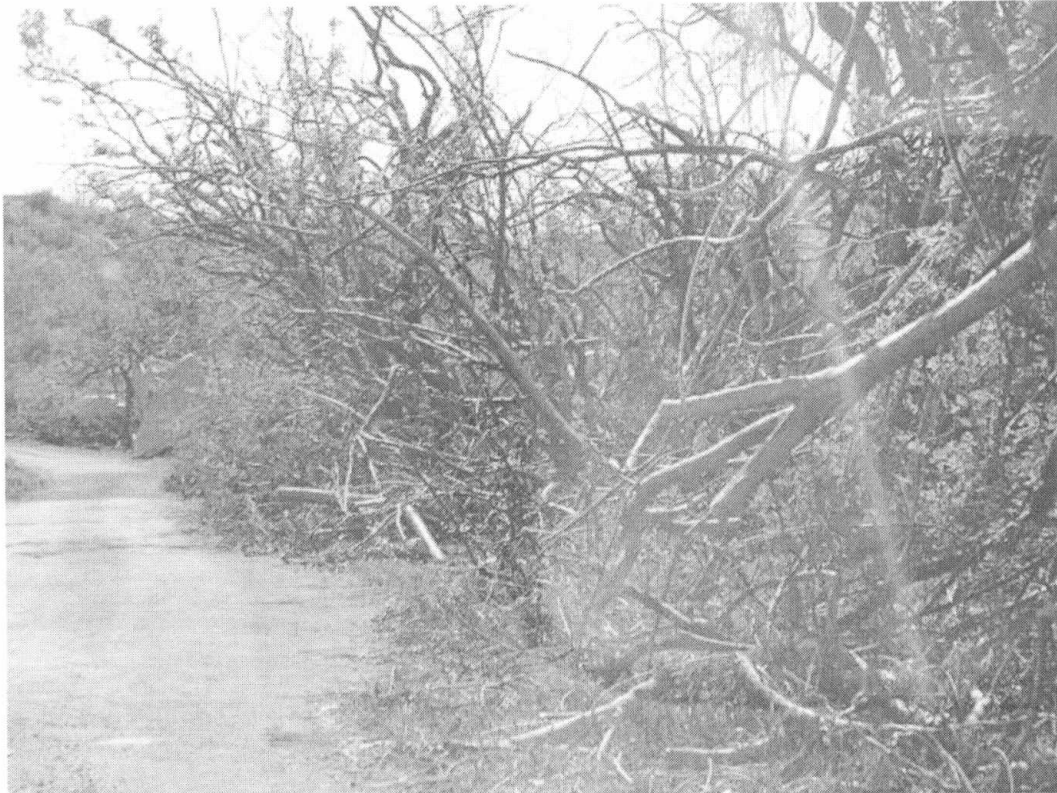
**Photo 10** Typical Example of Fallen Trees

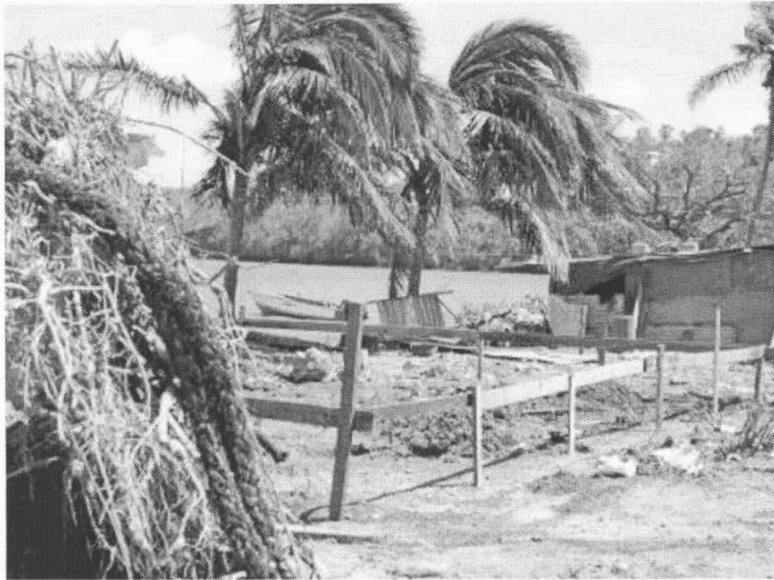
The area from Soubise to Marquis was severely impacted by storm surge and wave effects. As a result of this, almost of all the houses and boats on the seaward side of the road were washed over to the landward side of the road, thereby blocking the road. After the passage of the storm, residents of the area cleared the demolished housing. Many of these residents have started to rebuild homes on the same lots that were affected by the hurricane storm surge and wave action (Photo 11). Mitigation action for this low lying area should ideally be relocation/resettlement of this community. Failing this, some form of coastal protection works (e.g. breakwaters) should be implemented, so that widening and increase in height of the beach lands may be achieved. The cost of construction of breakwaters for this area is estimated to be approximately ECS\$3.0 million.

**Photo 11 Reconstruction of housing at Soubise/Marquis**

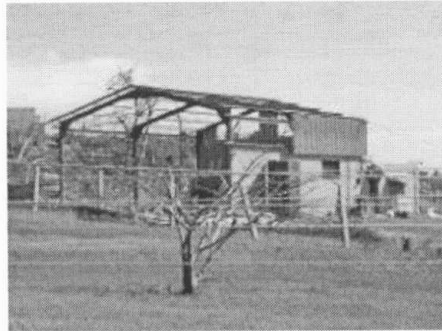
Structural damage was noted in the Tower, Terminal Building, Crash Fire and Rescue Building, Central Generating Station, Aviation Services office, Taxi Association office, Staff House. Of note was the collapse of the Store Equipment Building (Photo 12).

**Photo 12 Total Collapse of Walls of Store Equipment Building for PSIA**

The estimated cost of structural repairs is EC\$1.0 million. This does not include the cost of repairs for specialized equipment, which is presently being assessed. It should be noted that after the passage of the hurricane, all flights, with the exception of emergency and relief flights, were put on hold. Passenger service resumed after a period of approximately one week. During this period, September 6<sup>th</sup> to 13<sup>th</sup>, there was loss of revenue from: landing fees; cargo through-put; navigational Aids; Fuel through-put; aircraft overtime; ground handling; aircraft parking; concessionaires; offices; departure tax; and passenger facilitation charges. Discussions with PSIA management revealed an approximate estimate of lost revenues as a result of the hurricane, of EC\$500,000.

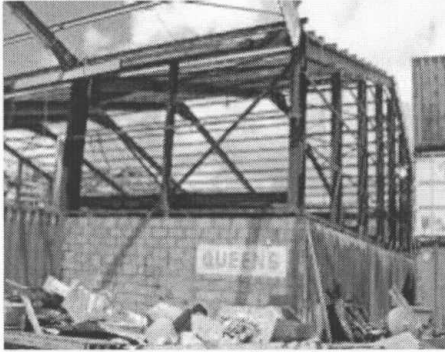
Photo 13 Queen's Warehouse

Damage to the main port terminal was confined to structural building damage (Photos 13 and 14). No damage was reported as occurring to the container stacking equipment, to the docks or to the fendering system. At the new cruise terminal location, no damage was reported as occurring to the dock, although minor damage occurred to the new Welcome Centre. In particular, a damage assessment commissioned by the Port Authority revealed that damages were recorded to the:

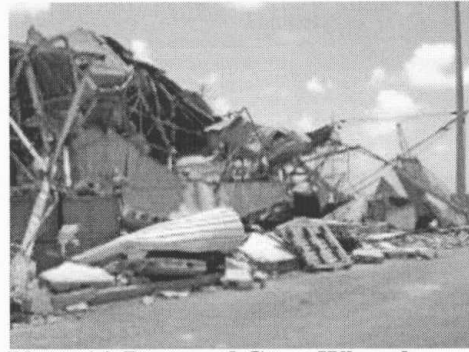
Photo 14 Damaged Geest Warehouse
