His Majesty's Government
Ministry Of Health

His Majesty's Government
Ministry of Health
Department of Health Services

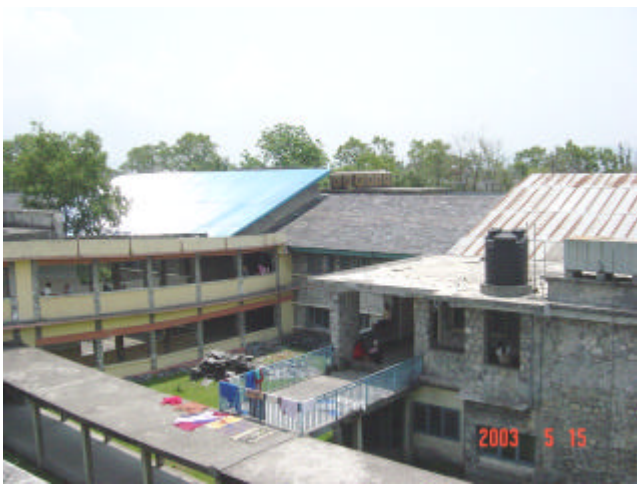
Photo 1: Buildings of different height, shape and structural properties connected with each other can cause severe pounding during earthquakes.

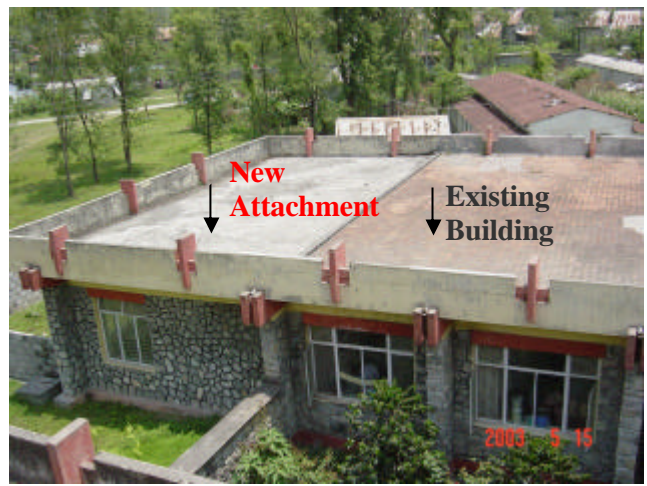
Photo 2: A new attachment to existing buildings with no seismic gap has made both the existing and the new building vulnerable.

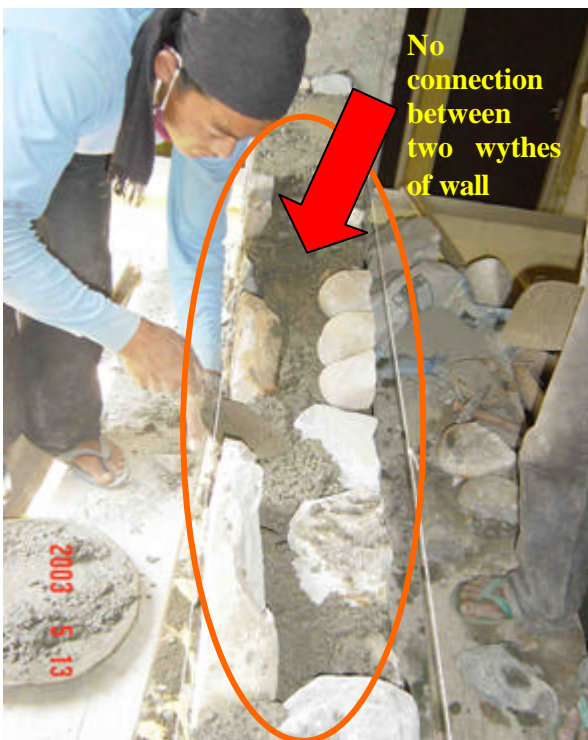
Photo 3: A stone masonry infill wall construction in the new building. There is no proper connection between the stone units making it a very vulnerable wall. The mortar used is 1:6 cement: sand mortar.

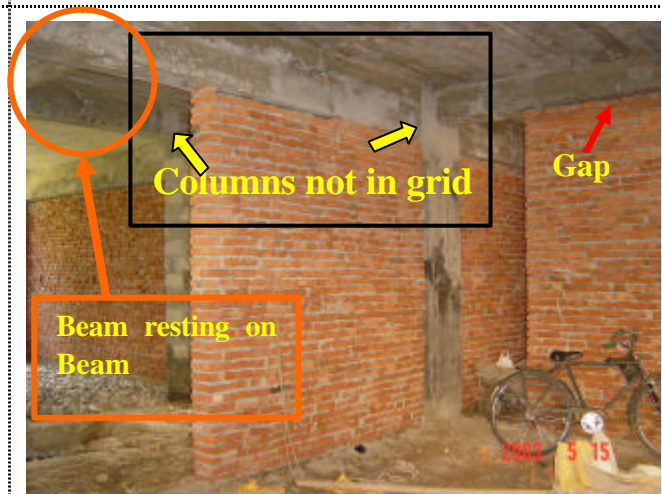
Photo 4: The structural system and load path of the new building is not proper. The columns are not in grid, beams are just connected with beams and there is a lack of columns. Improper connection of infill walls with the frame has made the infill walls more vulnerable.

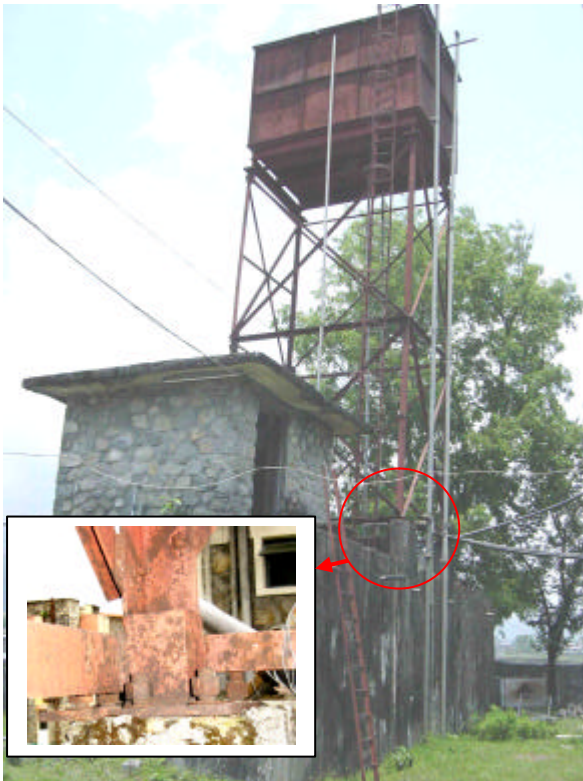
Photo 5: The base of an overhead tank; the bolts are not properly fixed and are rusted, the base is weathered.

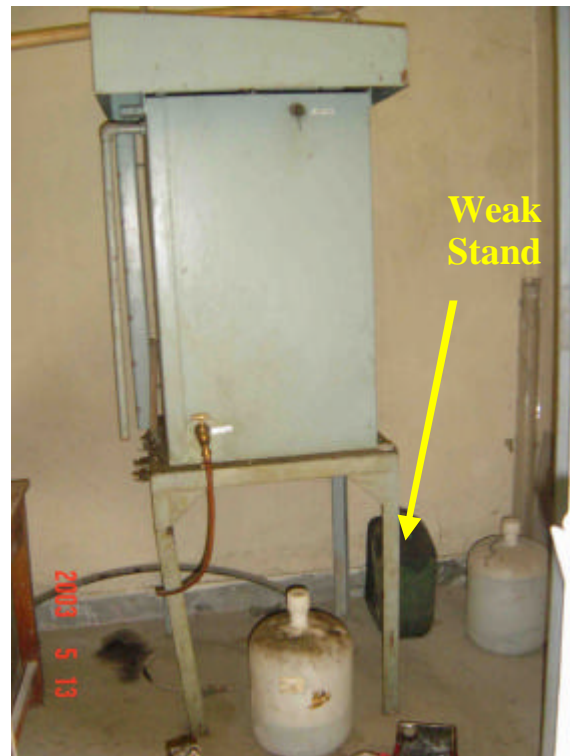
Photo 6: 300 litres fuel tank of the generator; on a weak stand without anchorage and lateral support.

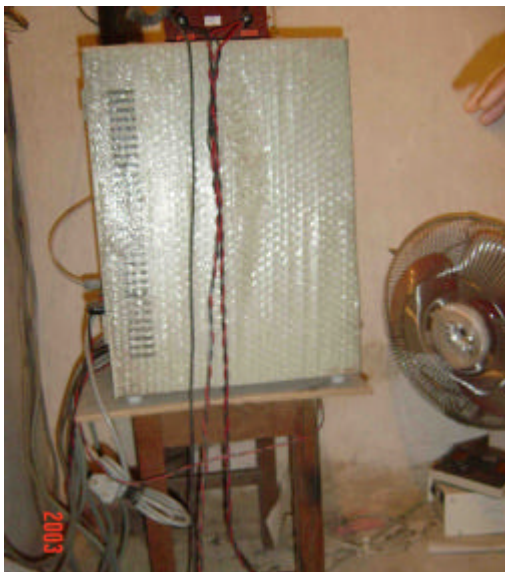
Photo 7: Communication equipment on a temporary type stand. It needs a proper stand with anchorage and fixing.

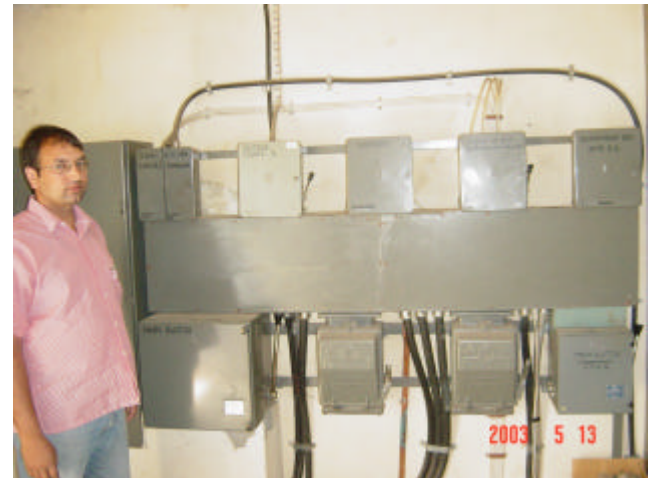
Photo 8: The main board for electricity distribution within the hospital; properly anchored on the wall and with low vulnerability.

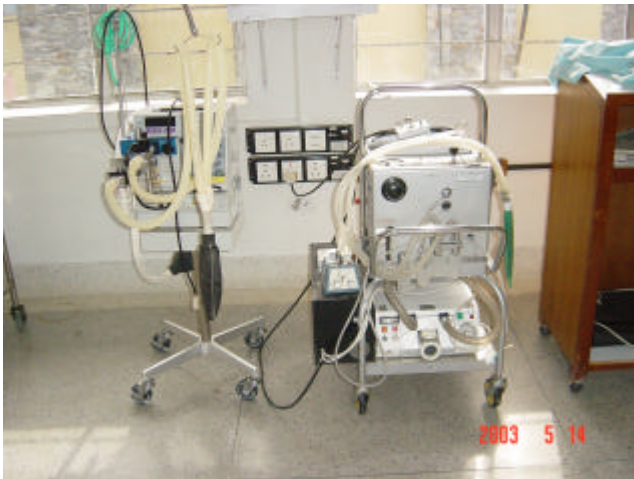
Photo 9: Equipment on rollers in the operation theatre and other places is vulnerable as it may roll and impact with other objects.

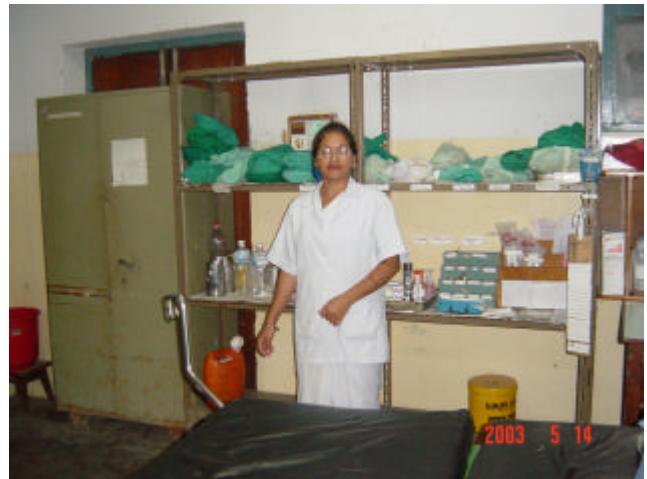
Photo 10: Cupboards and racks storing important equipment, medicines and chemicals are vulnerable because they are not fixed to the wall and strapped.

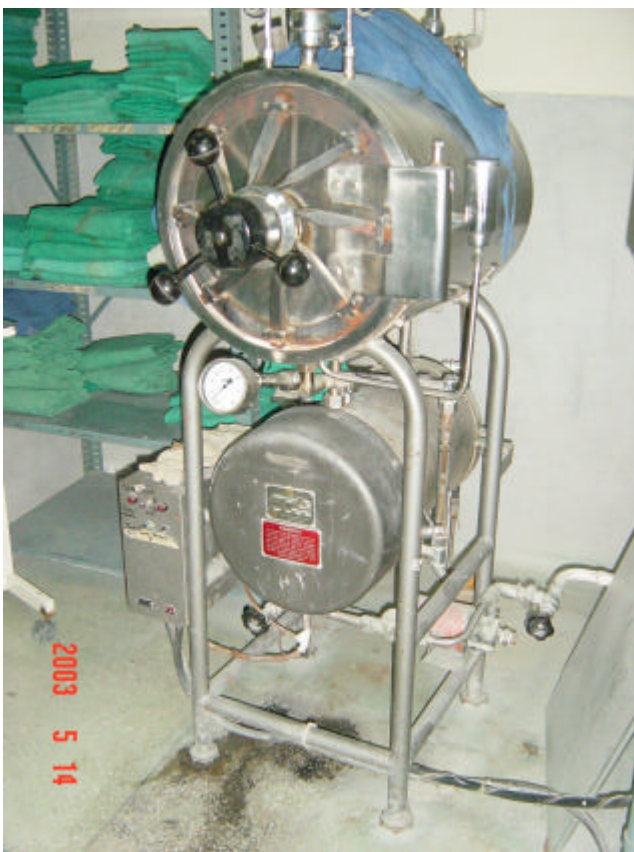
Photo 11: Autoclave machine needs anchorage at the base.

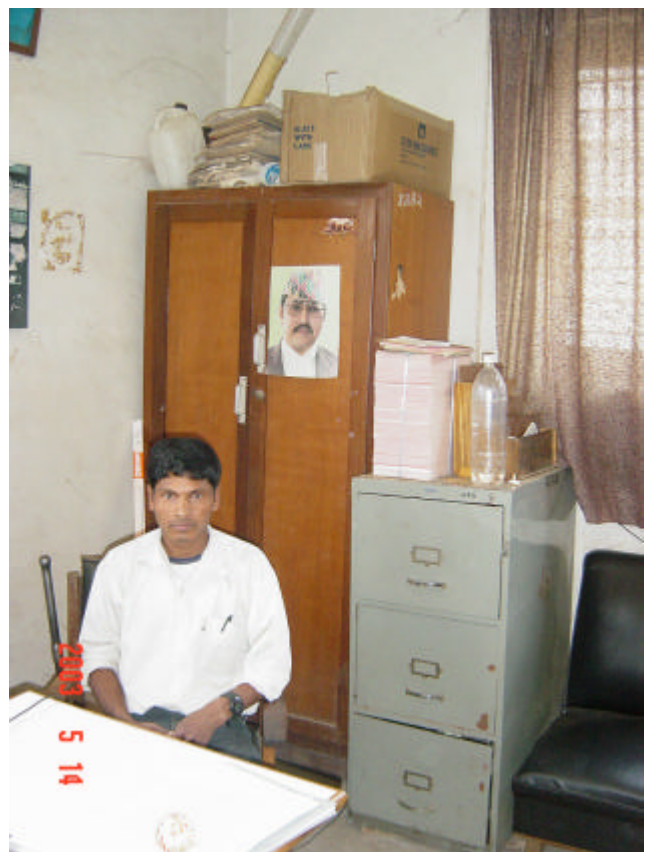
Photo 12: The cupboards and racks near working stations in the administration and other places of the hospital can be life safety hazards.

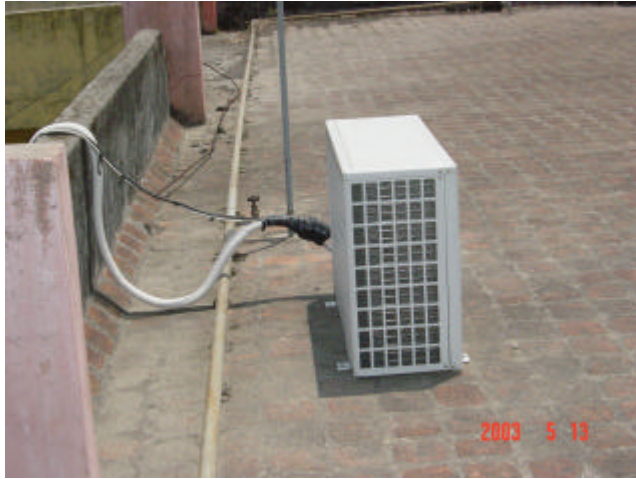
Photo 13: The air conditioning equipment for the OT is kept on the roof with no fixing.

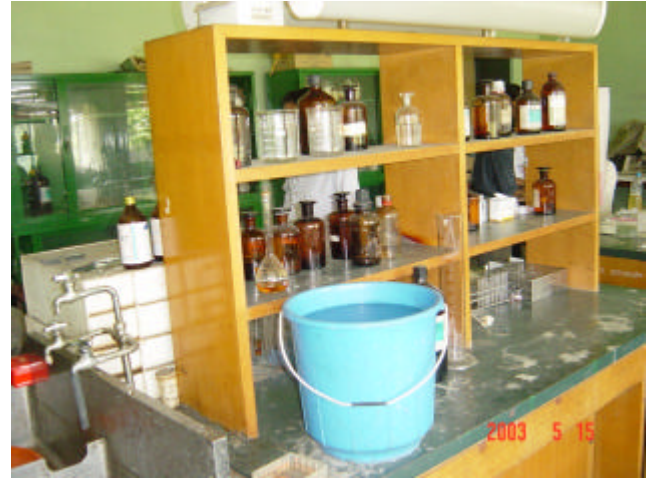
Photo 14: Racks containing chemicals in laboratories should be anchored; chemical bottles should be strapped or relocated to improve safety conditions.

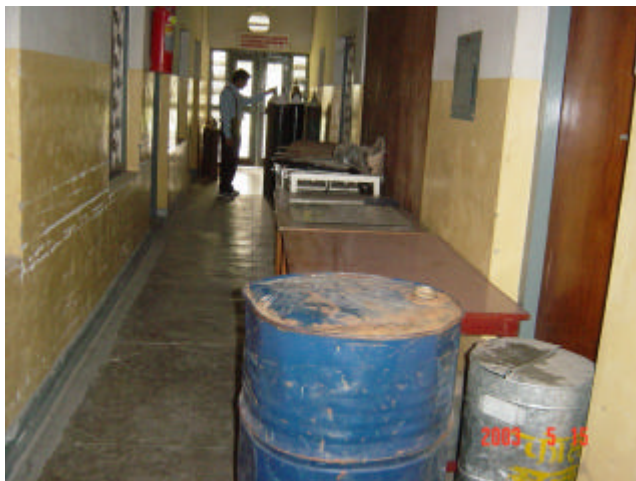
Photo 15: Cupboards and other objects in the corridors can block the exit ways during earthquakes.

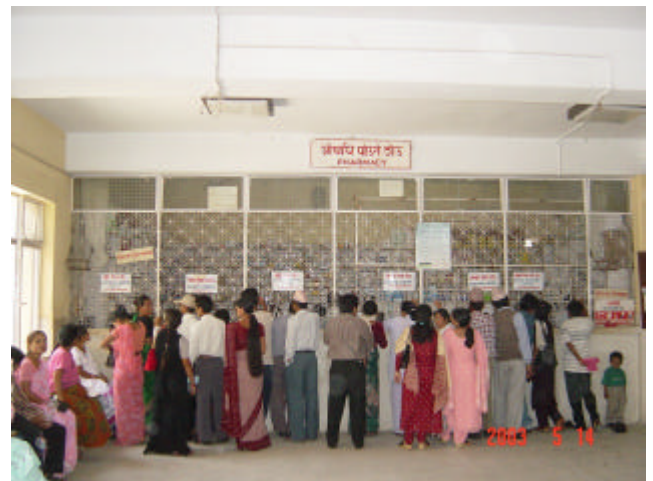
Photo 16: Window glasses or glass partitions are life safety hazards and need plastic lamination.
