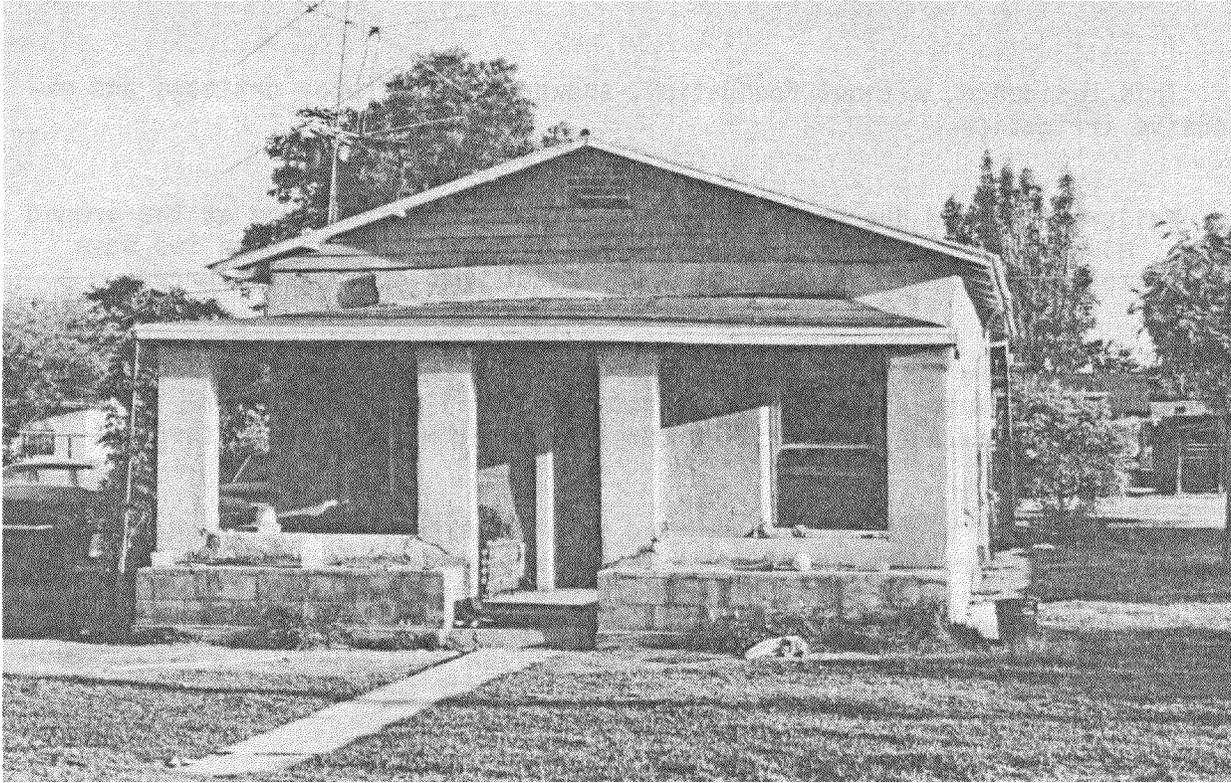
FIG. 7

Extensive damage to the Third Street residence (FIG.7) was concentrated at the ground level (FIG.8). Carefull examination revealed extremely wet adobe within the wall at the point of failure.
