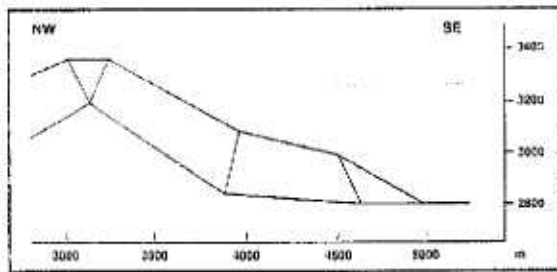
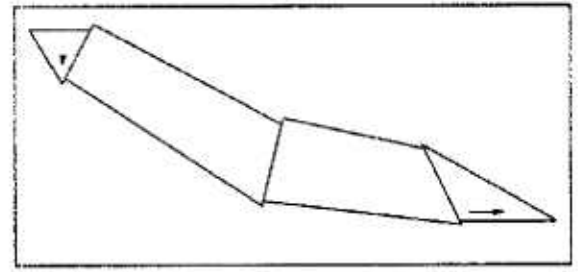
In the present analysis (fig. 13), the following parameters have been applied:

FS = 2.48 (water table at elevation 3263 m;
 no horizontal acceleration)
 FS = 1.15 (water table at elevation 3263 m;
 horizontal acceleration = $0.5 g$)
 FS = 2.53 (water table at elevation 2800 m;
 no horizontal acceleration)
 FS = 1.43 (water table at elevation 2800 m;
 horizontal acceleration = $0.5 g$)

This signifies that, even under the worst circumstances, the stability of the dam against slope failure towards the lake is fairly high, based on the knowledge that a horizontal acceleration of $0.5 g$ is an extreme value to assume in a pseudostatic earthquake analysis (Newmark 1965).

Fig. 13. Kinematics of a potential slide failure of the upstream side of the Usai landslide dam using the "Method of Kinematic Elements" of Gussmann (1982, 1992). The angle of internal friction between the elements is assumed to be 40° and the cohesion to be zero. It is further assumed that the angle of internal friction between the base of the dam and the underlying geologic material is 25° and the cohesion along this contact is 10 kN/m^2 . For further explanation, see the text.

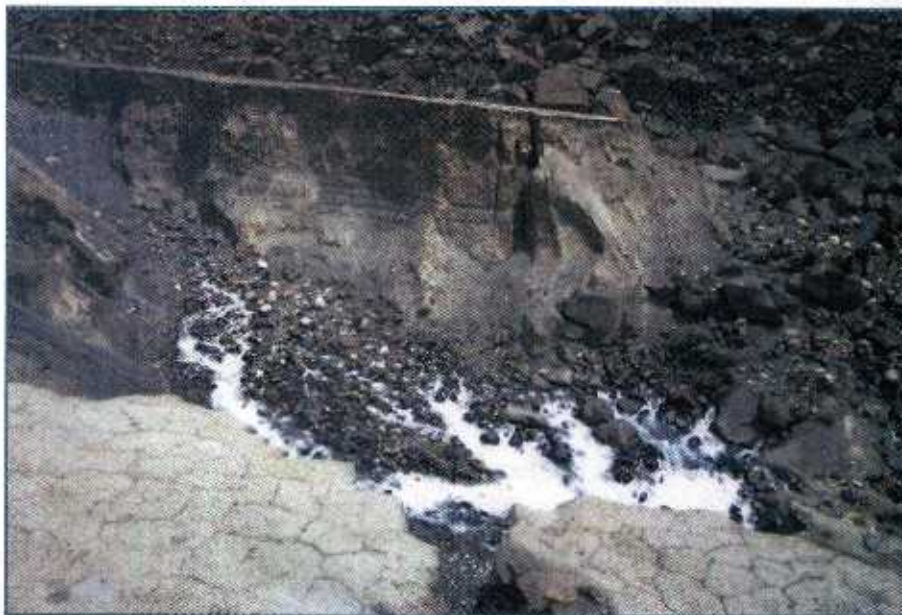
At the downstream slope, along the line of seepage springs, a small canyon has formed, with a depth of approximately 20 m (photos 14 and 15). This canyon has developed partly in the dam material at its toe but mainly in a flood plain of debris-flow deposits that are resting on the downstream slope of the dam. The amount of erosion of the dam foot is absolutely minor, so that worries about the influence of dam stability are not justified (cf. State Committee on Emergencies, 1997).

Photo 14. Seepage springs on the downstream side of the dam causing erosion of the debris-flow (i.e. flood-plain) deposits lying on the blocky dam material to the right (bottom of photo). Photo credit: Jörg Hanisch.

- Seepage through the dam should be measured on a regular basis; this measurement should include determination of the presence of suspended sediments and an inspection of the downstream slope to detect possible new springs and changes in the existing ones.

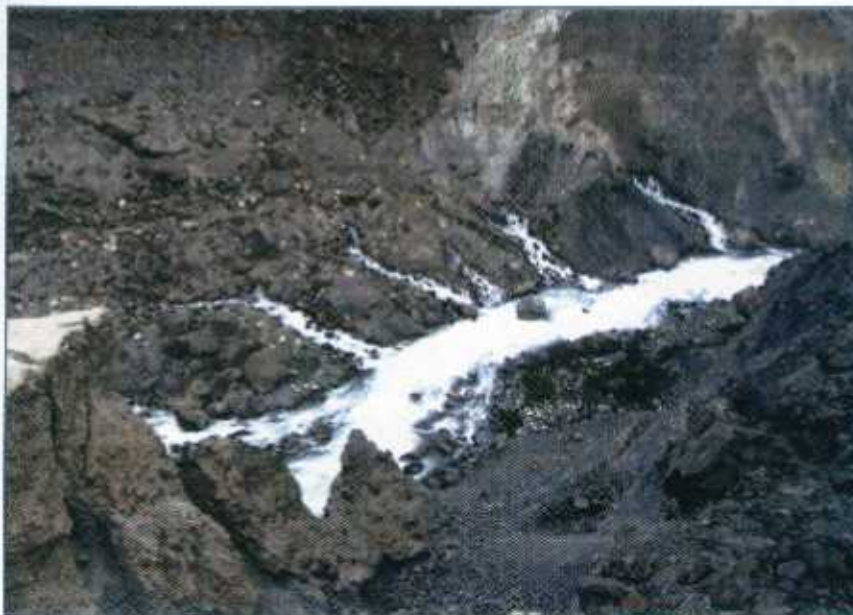
One important feature of the leakage is that the springs are all located on more or less the same topographic level, which is approximately 140 m below lake level (photo 15). This indicates that the lower part of the dam, with a height of about 350m, has a very low permeability. On the contrary, the upper part of the dam is very permeable. The blocky dam material visible in large parts of the dam surface should be responsible for this high permeability.

Photo 15. Line of seepage springs along one topographic level forming the post-dam Mungado River. Photo credit: Jorg Hansch

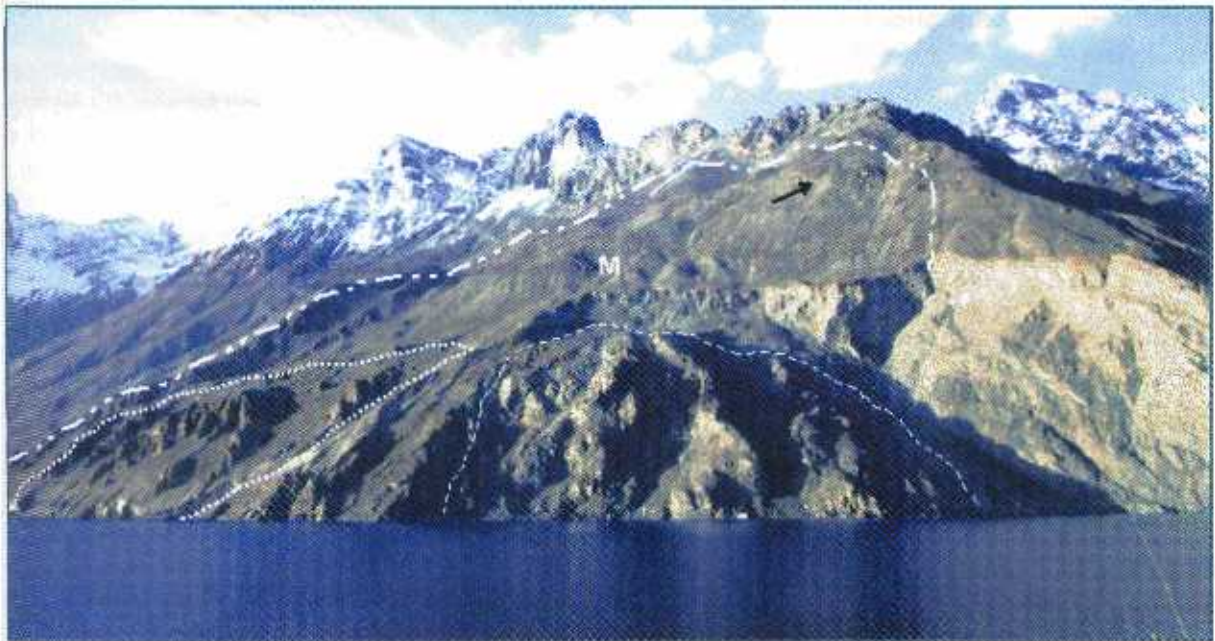
Photo 17. Unstable slope above the right bank of Lake Sarez opposite the base camp. Lower right part of photo: scarp of active rock fall, consisting of a face of solid rock covered with about 60 m of colluvial soil. Lower middle part, dashed line: landslide that moved downslope about 100 m in 1911, but for some reason stopped at its present location. Visible part immediately above water level: landslide material, volume ~ 150,000 m³. Lower left part, stippled line: probably an older landslide of the same type as in the middle, but much more deteriorated and eroded. Upper right part: smooth slope surface with thick colluvial cover intersected by numerous cracks as much as 3 m wide (arrow), most of which are monitored by extensometers. Hatch-stippled line: approximate extension of maximum possible landslide as estimated by Tajik workers (State Committee on Emergencies, 1997). Photo credit: Jörg Hanisch

- In the middle part of the slope (marked by M in photo 17), there are clear indications of a long-lasting, but slow, sliding process of the thick colluvial cover. The landslide area lies about 20 m deeper than the immediate upslope area and is separated by a pronounced lateral escarpment. According to Tajik colleagues, the seismic-reflection studies carried out during former Russian investigations revealed a thickness of the colluvial debris of up to 60 m;

- To determine the depth(s) of the surface(s) of rupture in the middle part (cf. photo 17) of the slope, two to three drill holes are required, followed by installation of inclinometers.
