# Maps, Satellite Imagery, Photos

# Indonesia - Banda Aceh Subset 2 IKONOS - January 10, 2003 - PRE-DISASTER IMAGE

# Estimated Collapsed Structures-Banda Aceh

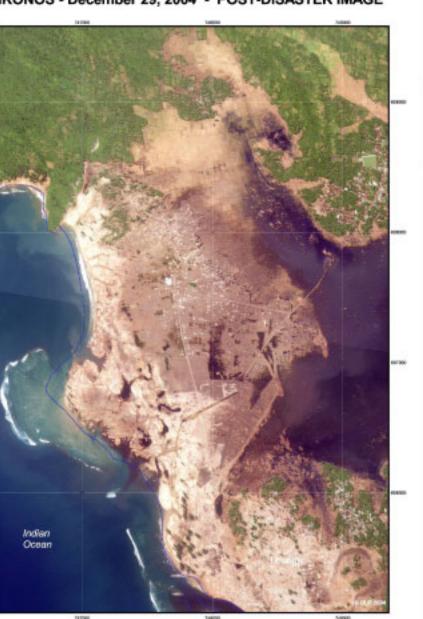
IKONOS - December 29, 2004 - POST-DISASTER IMAGE

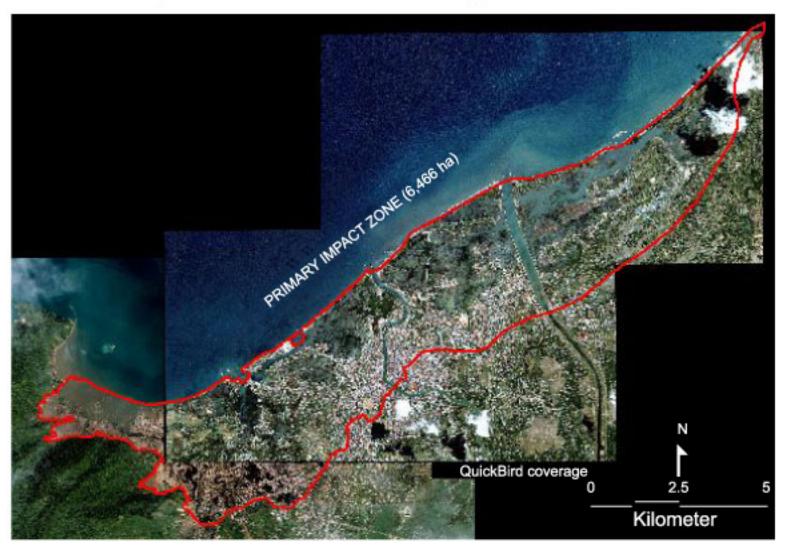
29,545 structures collapsed

82% structures collapsed in PIZ

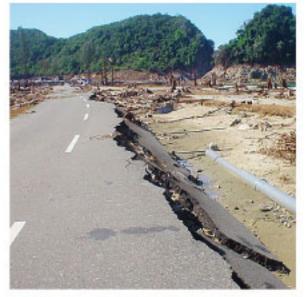
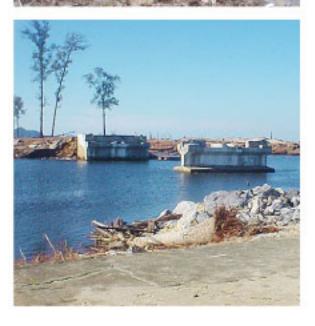
## Critical Infrastructure Destroyed

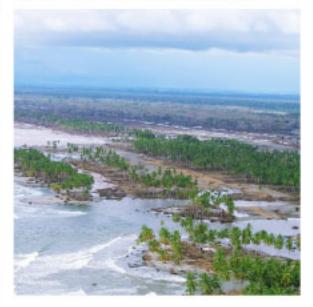
### **Coastal Communities Devistated**

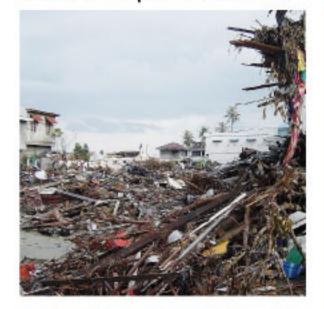
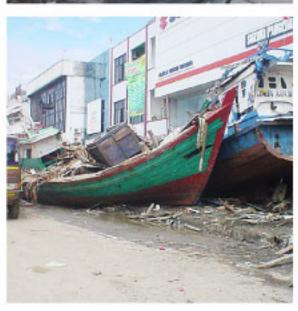
## Homes and Shops Turned to Rubble

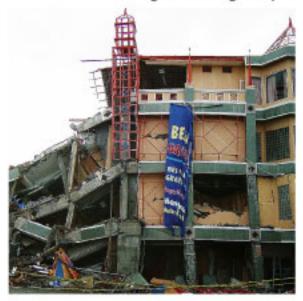
## Earth Quake Damage, Leveling Shops
