LEARNING FROM EARTHQUAKES

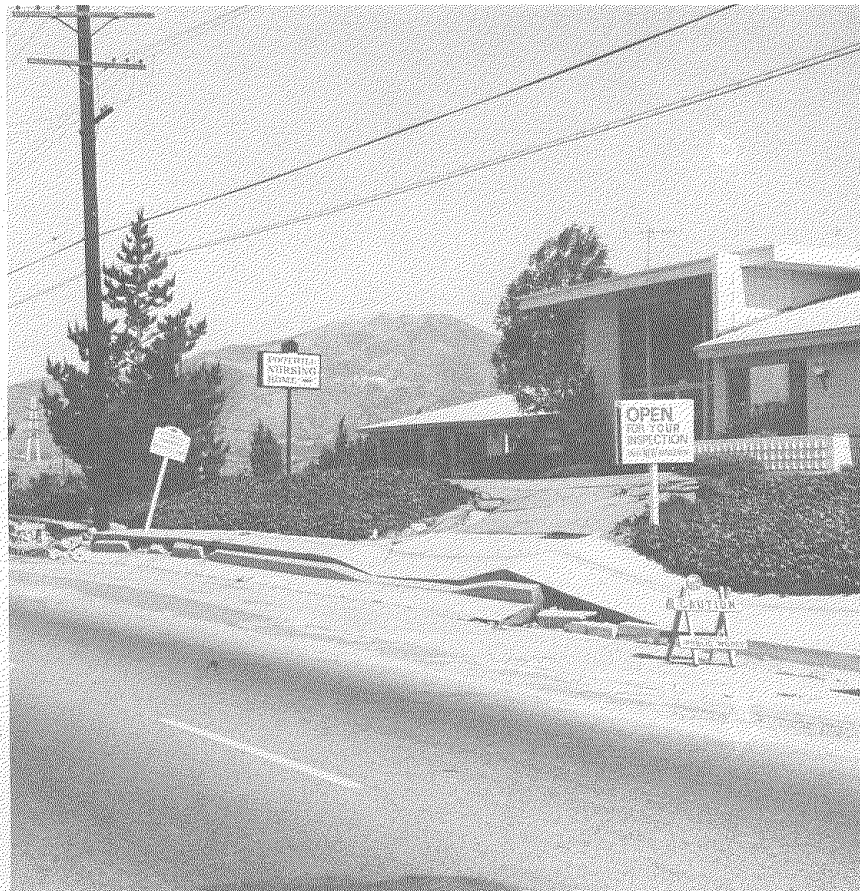
Figure I-5: Surface Fault Break. Area beyond curb was raised about 3 feet relative to the street. Unoccupied nursing home was damaged but did not collapse. (Los Angeles City Department of Building and Safety photo)

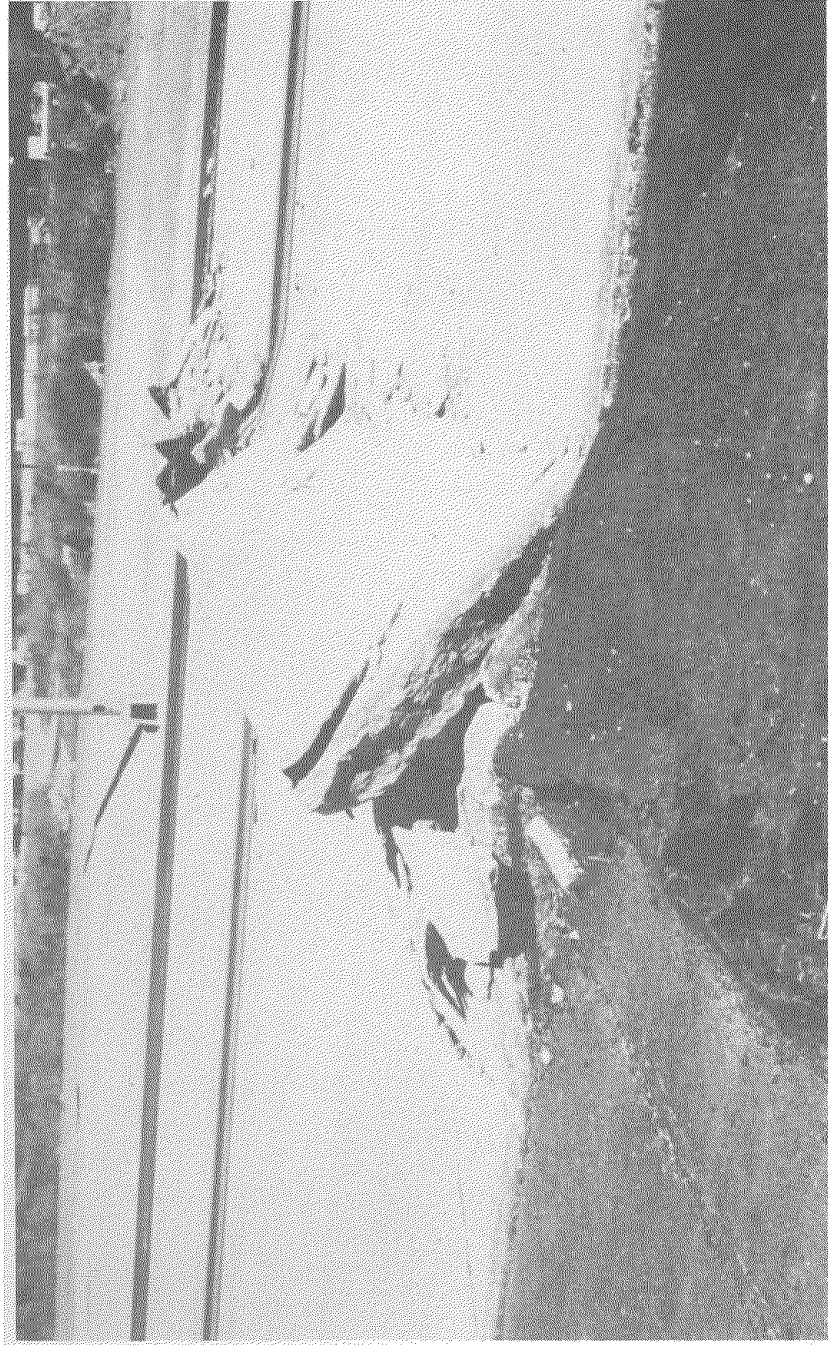
Figure I-6: Buckling of Freeway Pavement Due to Ground Surface Displacements. (C.M. Duke photo)
