LEARNING FROM EARTHQUAKES

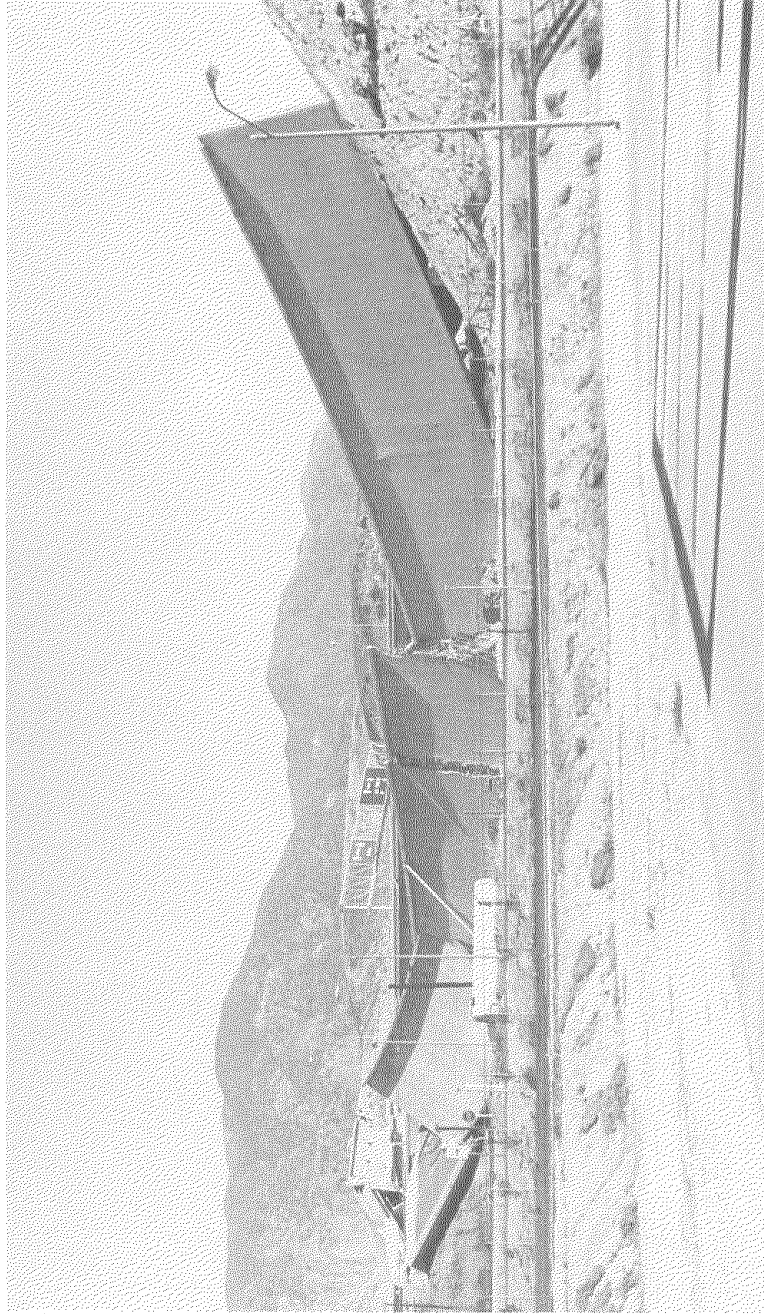
Figure I-10: Collapsed Freeway Overpass. Two motorists were killed by a freeway bridge collapse in this area. (Los Angeles Department of Water and Power photo)

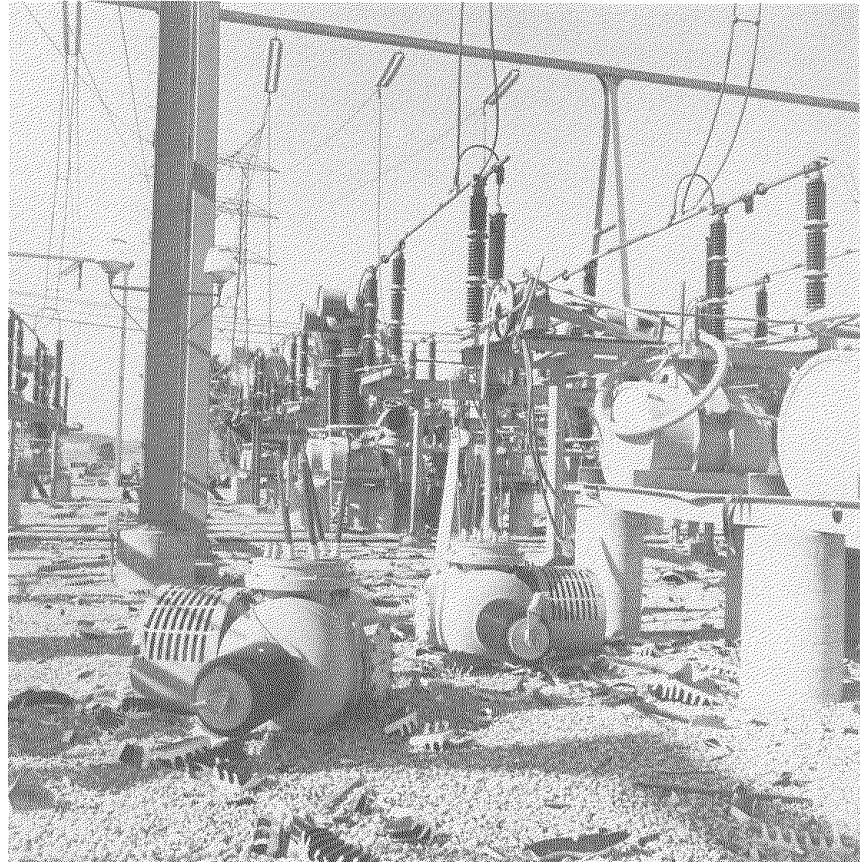
Figure I-12: Damaged Electrical Circuit Breakers at the Sylmar Converter Station. Total damage at this station was about \$25 million and required about one year to repair. (Los Angeles Department of Water and Power photo)
