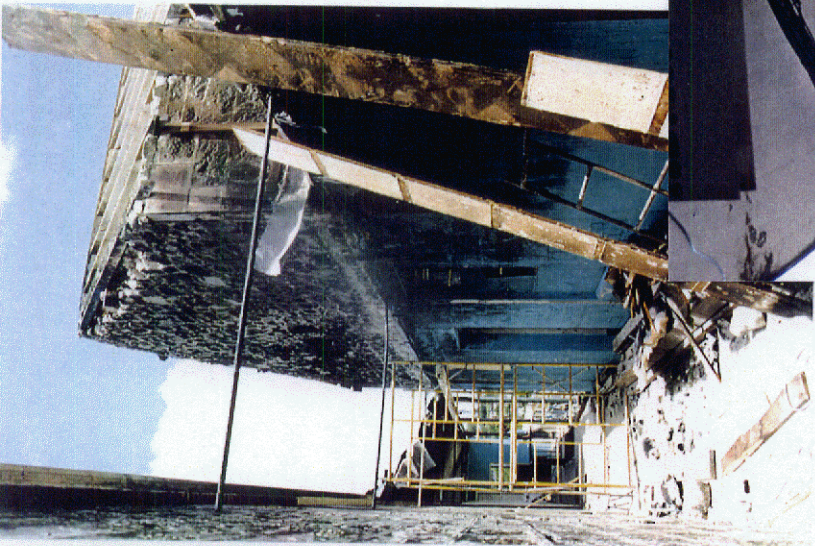
Photo 5: Gable-end wall to right formed part of the old operating theatre in the L-Block. It is to be partially demolished.

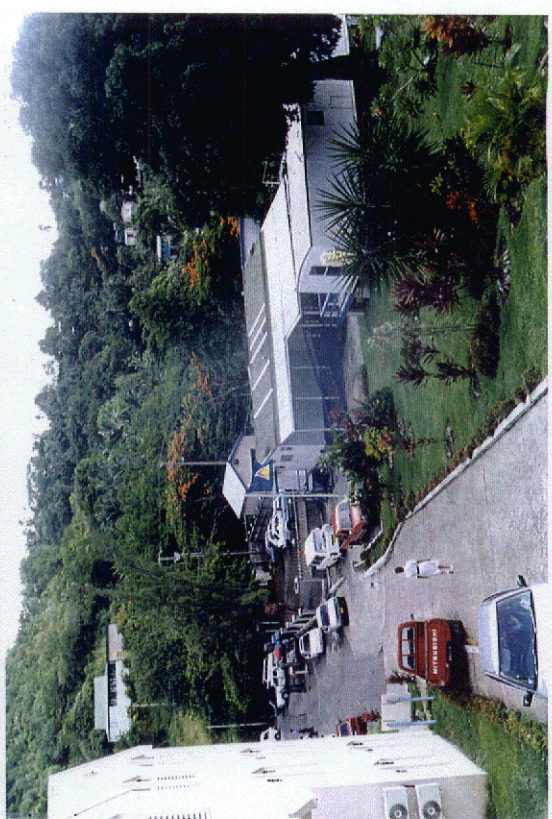
Photo 8: The two closer buildings on the right (near the entrance to the hospital) are temporary structures erected to accommodate facilities (including a ward) lost during the fire.
