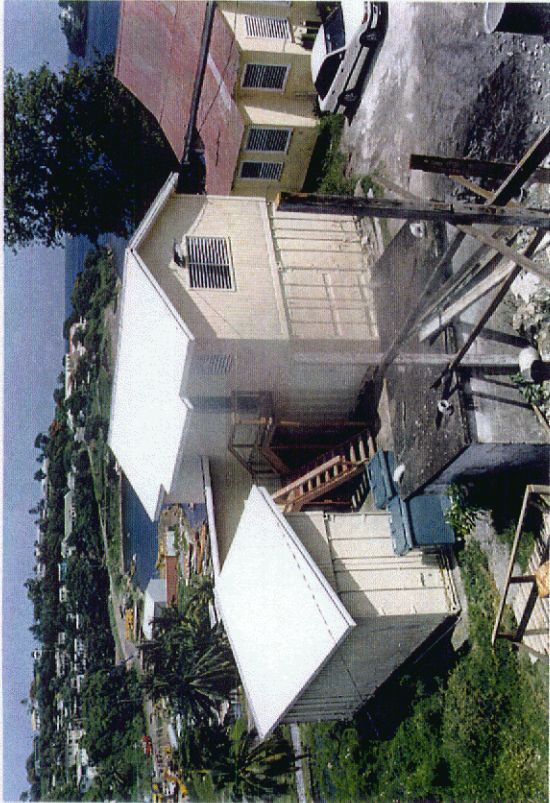
Photo 13: New structure erected adjacent the geriatric ward. Used to house non-perishable stores.

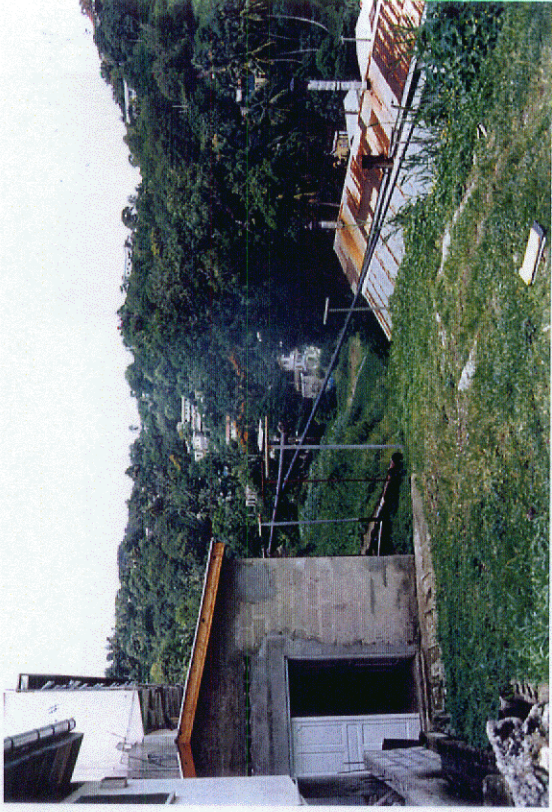
Photo 15: New small structure on the left contains hospital autoclave (used to sterilise equipment). Pipes from the boiler feed the autoclave and hospital laundry. The autoclave was located inside the L-Block until the fire.

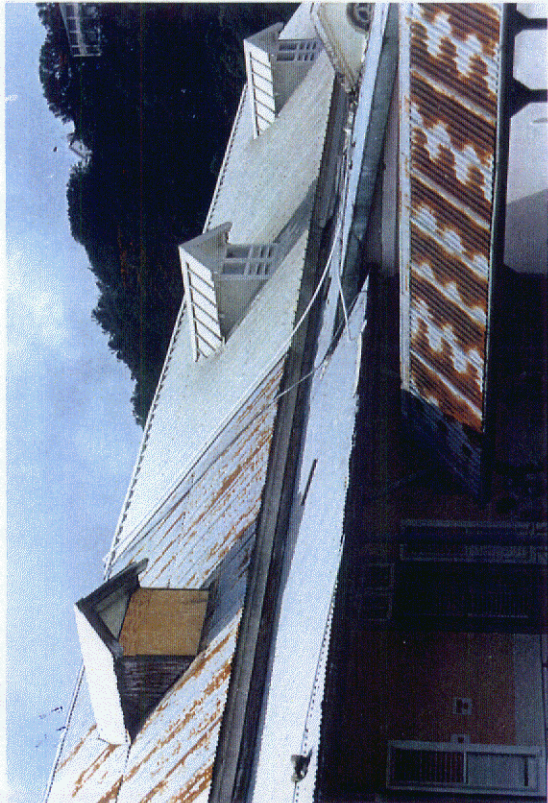
Photo 14: View of renovated and to-be-renovated sections of the L-Block. Cyclone washers have been used on the newer sheeting. Note roof of the "link" in the foreground.

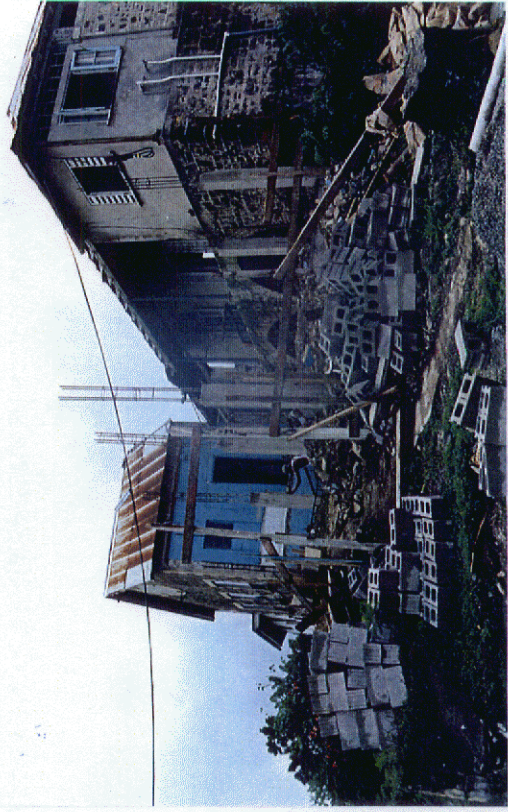
Photo 16: New extension at NW end of L-Block under construction.
