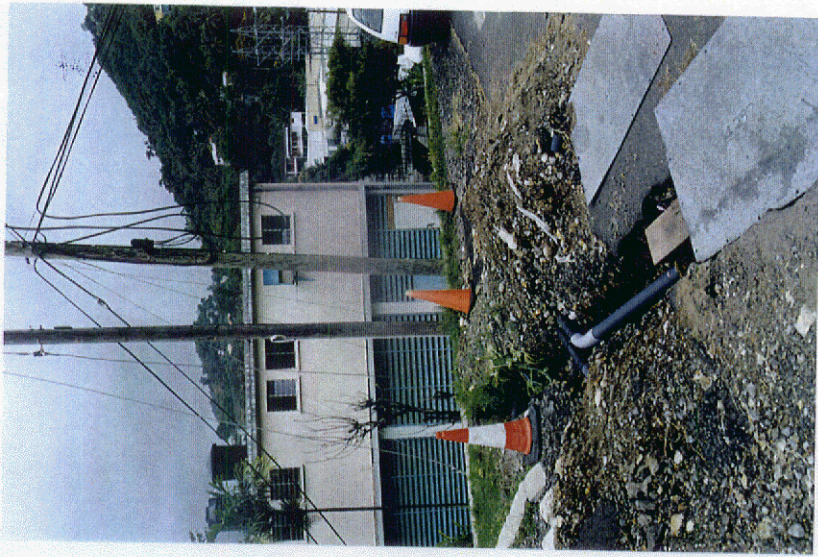
Photo 25:
Electrical cabling
being placed
underground for new
L-Block.

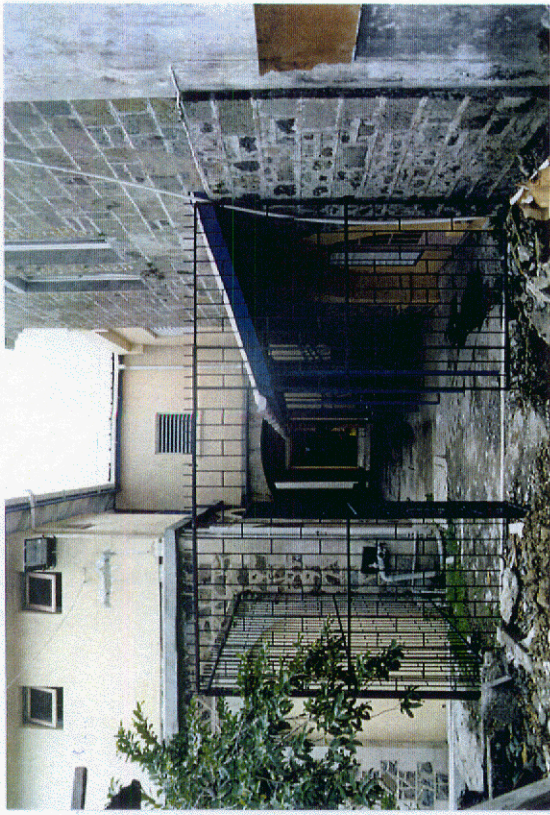
Photo 27:
New lean-to shelter roof between Baron Wing and L-Block. The bridge connecting the two buildings is in the background.

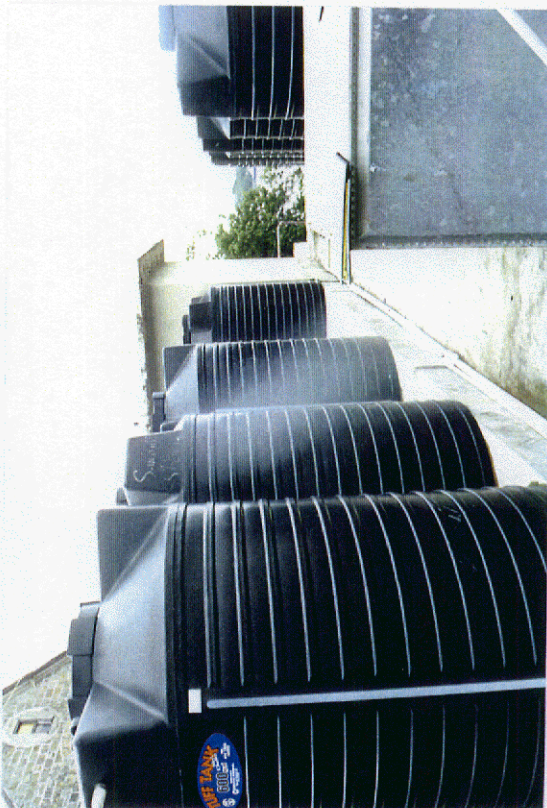
Photo 26:
Additional free-standing storage tanks atop roof of existing concrete water tank. They are not fixed to the concrete.

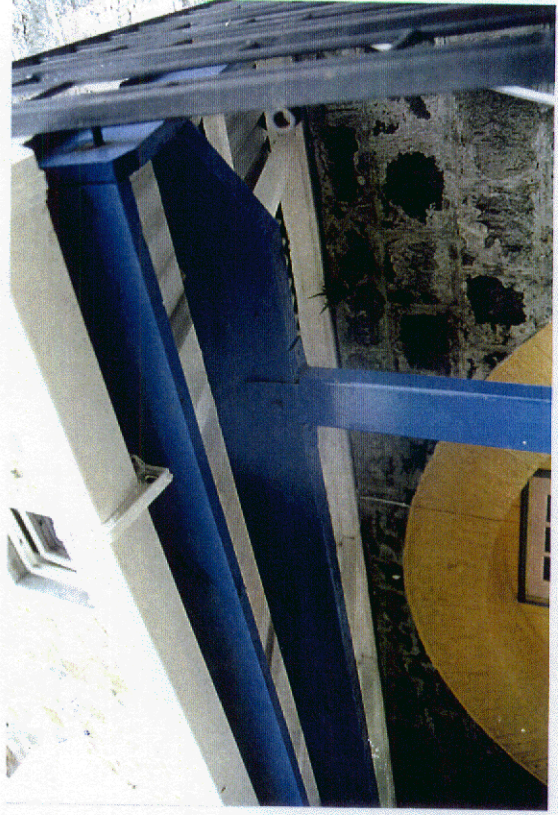
Photo 28:
Inadequate details on shelter roof (previous photo). Steel column has actually been split at the topmost four corners. It is nailed to timber beam on the underside and bolted on the sides. Some bolts were missing.
