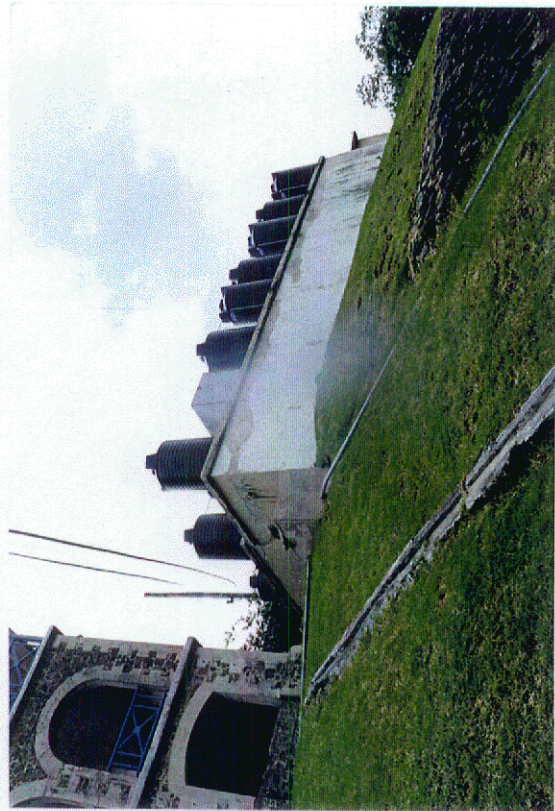
Photo 31: View of repaired water tank with additional storage drums.

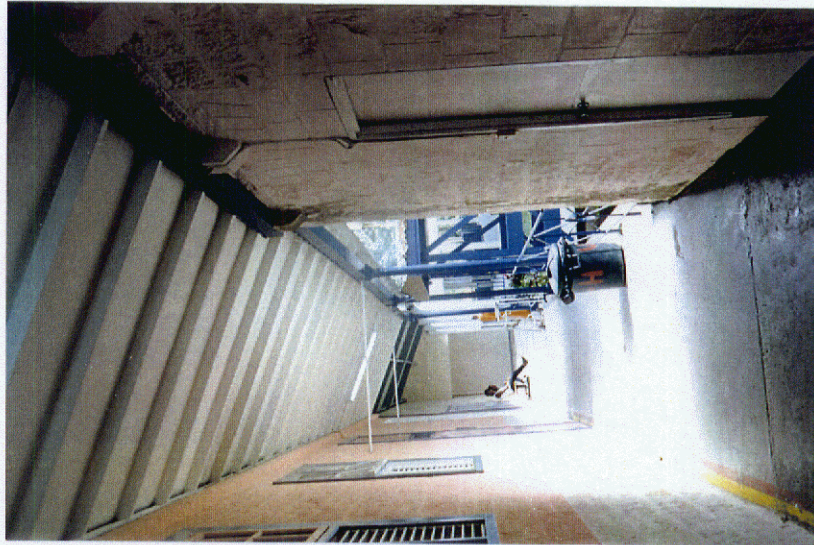
Photo 32: View along verandah of renovated L-Block. The timber beam on the outside edge of the balcony sits on cast iron columns. There is no obvious connection between the two members.

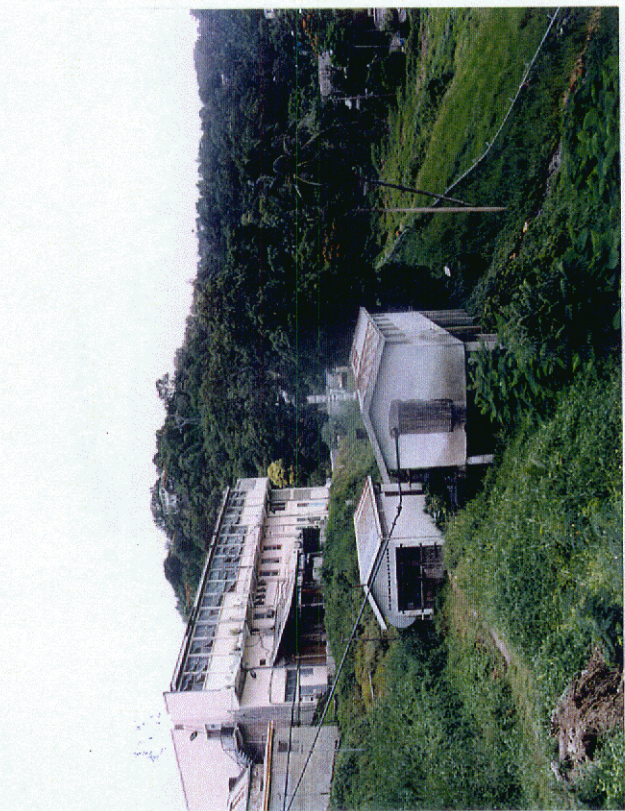
Photo 29: View of western side of compound. The hospital boundary (note fence on right of picture) has been moved inward to accommodate a new highway to be constructed close to the line of the existing road. The boiler and standby generator rooms remain in the same state as in 1993.
