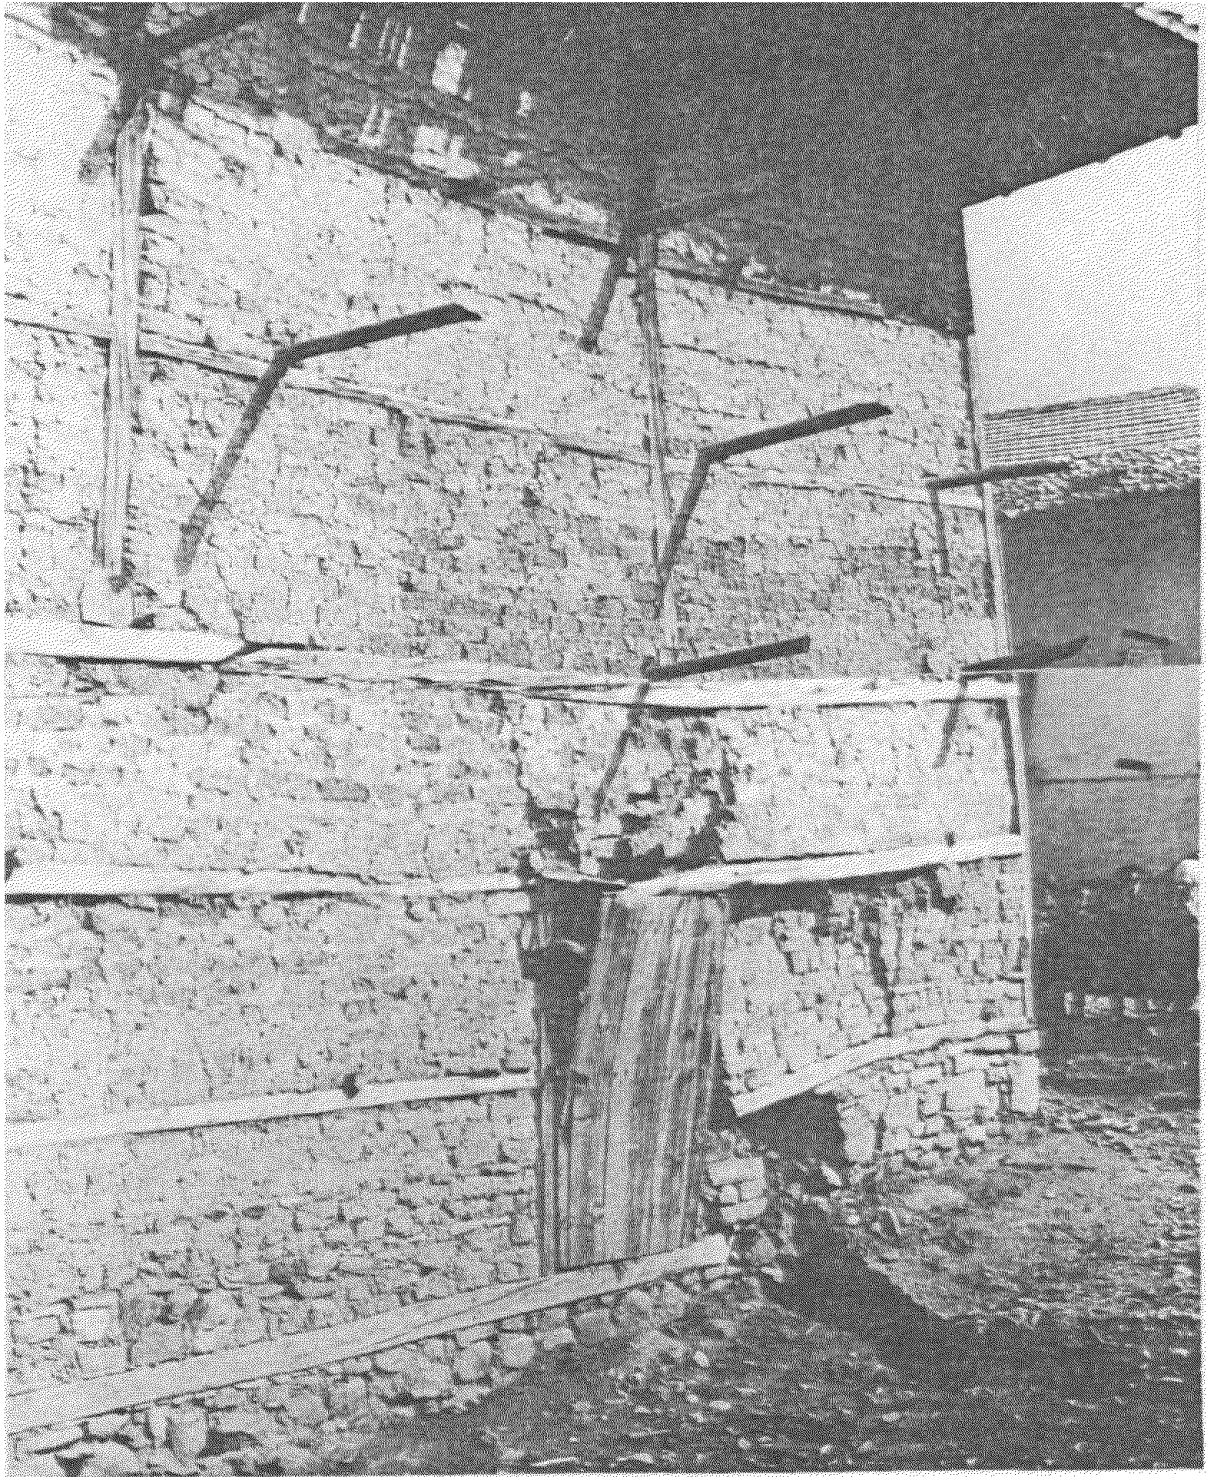
FIG. 9

A two storied brick building right on the ground rupture, after Gediz (Western Turkey, 1970) earthquake. The wall at ground floor absorbed considerable amounts of deformation, leaving the upper story practically intact, thanks to the horizontal timber bond beams provided at various levels. Although the material of the wall is not adobe, it gives an idea as to the effectivity of bond beams in such buildings.
