4. The Need for Training the Local Builders

5. Conclusion and Areas where Research is Needed

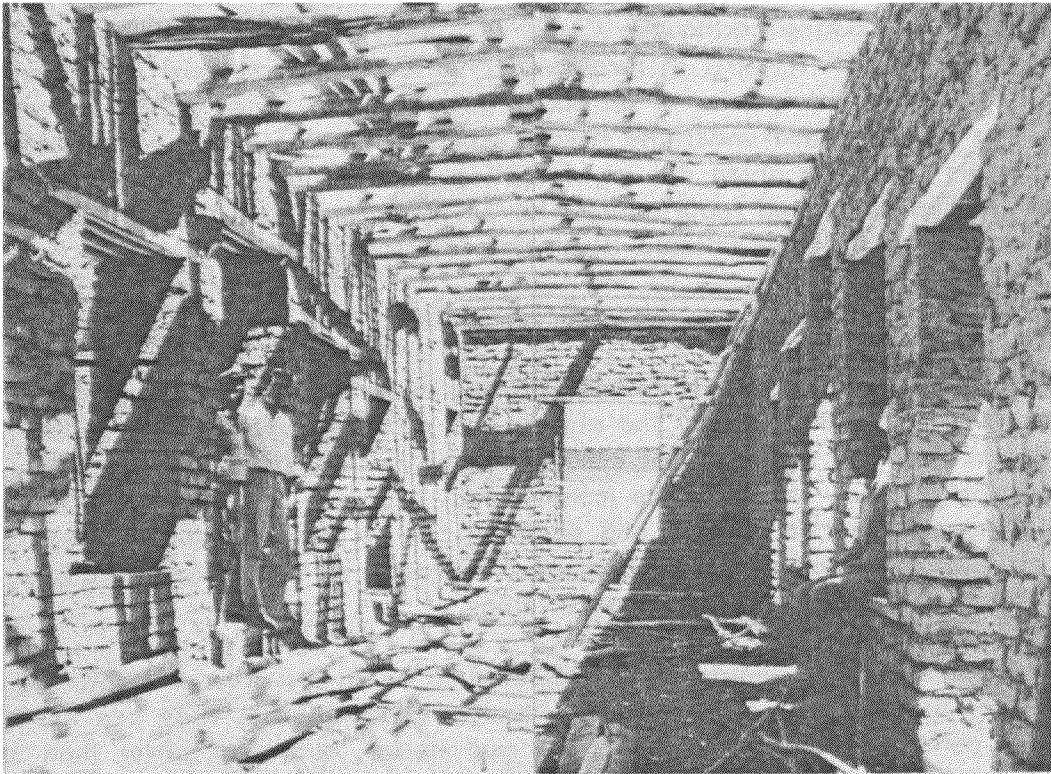
Interior of an adobe building, during construction (Özalp, Eastern Turkey) . The window and door openings have timber lintels on the top, and sills in the bottom. However, no continuous timber bond beams exist in the walls, at proper levels. Also note the lack of collar beams, along the supports of the ceiling beams ; the latter rest on the adobe walls, directly. The solid wall portions between openings , are not adequate. Finally : this is not a good example for an earthquake resistant adobe building.

Although the existing Earthquake Code of Turkey (1) has a section on adobe buildings (APPENDIX I), still in rural areas various problems exist in implementation (4). FIG. 17 shows the interior of an adobe building in a major earthquake zone. The deficiencies are described under the figure. Considering this reality, education of the local builders should be given due consideration. The Ministry of Reconstruction and Resettlement has conducted local courses for builders, and also prepared and distributed colored posters, carrying practical, illustrated instructions.
