Observations of the Westmorland Earthquake

By: Robert E. Barnes

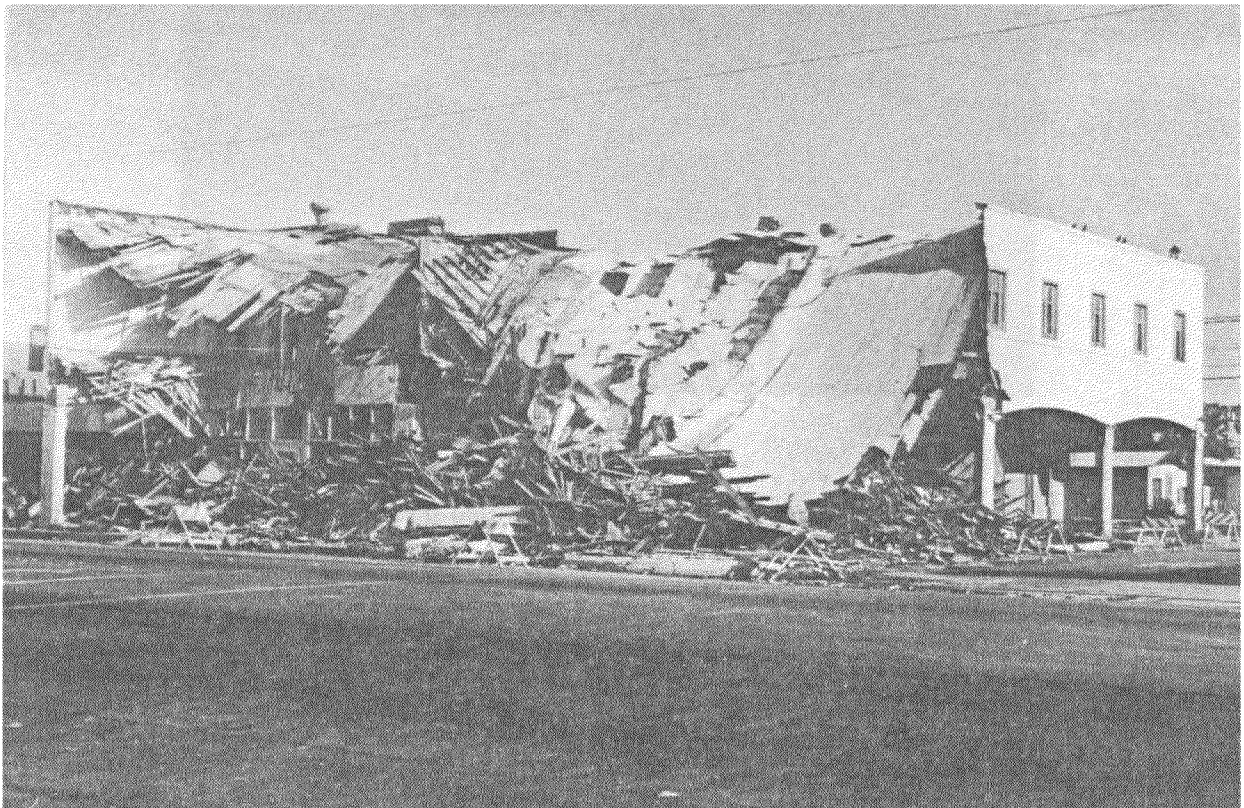
FIG. 1

Upon arriving at approximately 4:00 p.m. we noticed two severely damaged structures along the main street. One structure was of frame construction (FIG.1) and the other was an abandoned adobe (FIG.2).

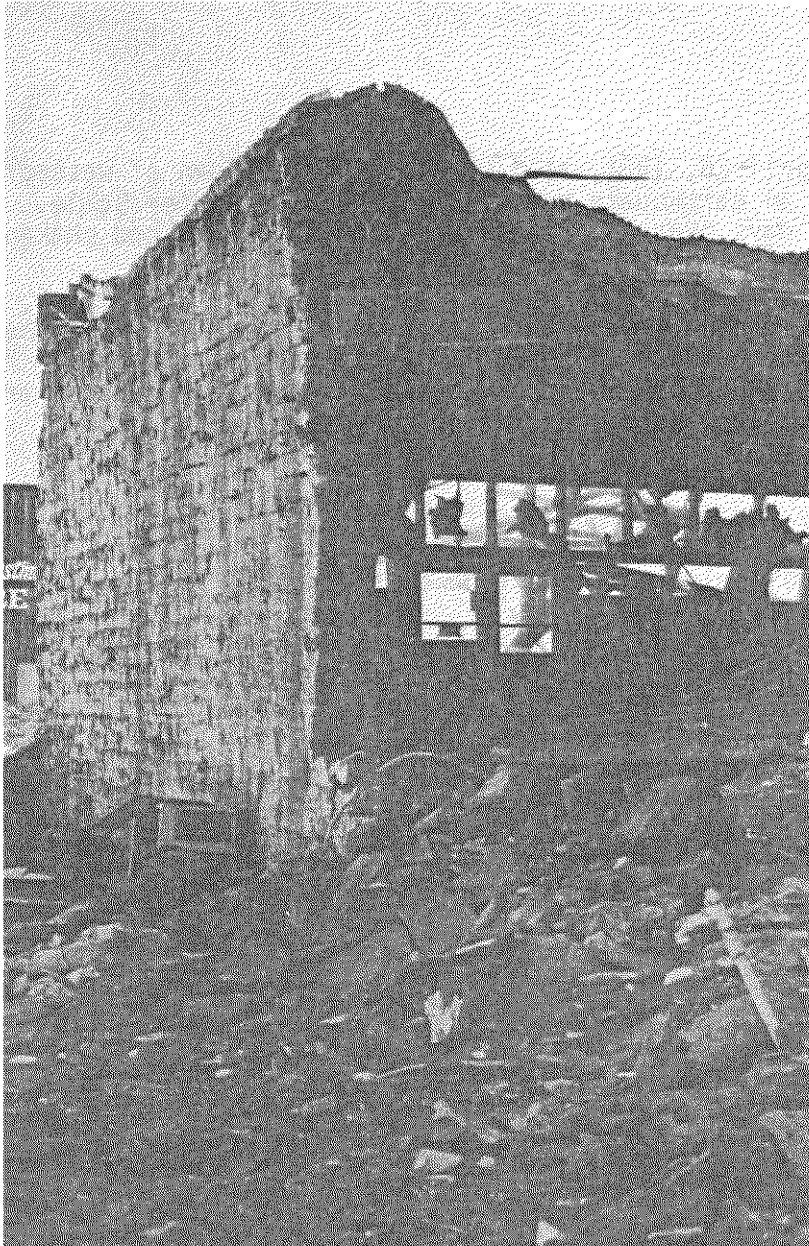
FIG. 2

Conversations with neighbors and later the police department told us the adobe structure had been abandoned for several years and was in structurally poor condition before the quake.

Detailed photographs (FIG.3) show the wall/roof connection, no bond beam or anchors were used and all materials showed signs of rot and deterioration. The wall immediately south of the wall failure was severely under cut from rising damp. There was no indication of a foundation.
