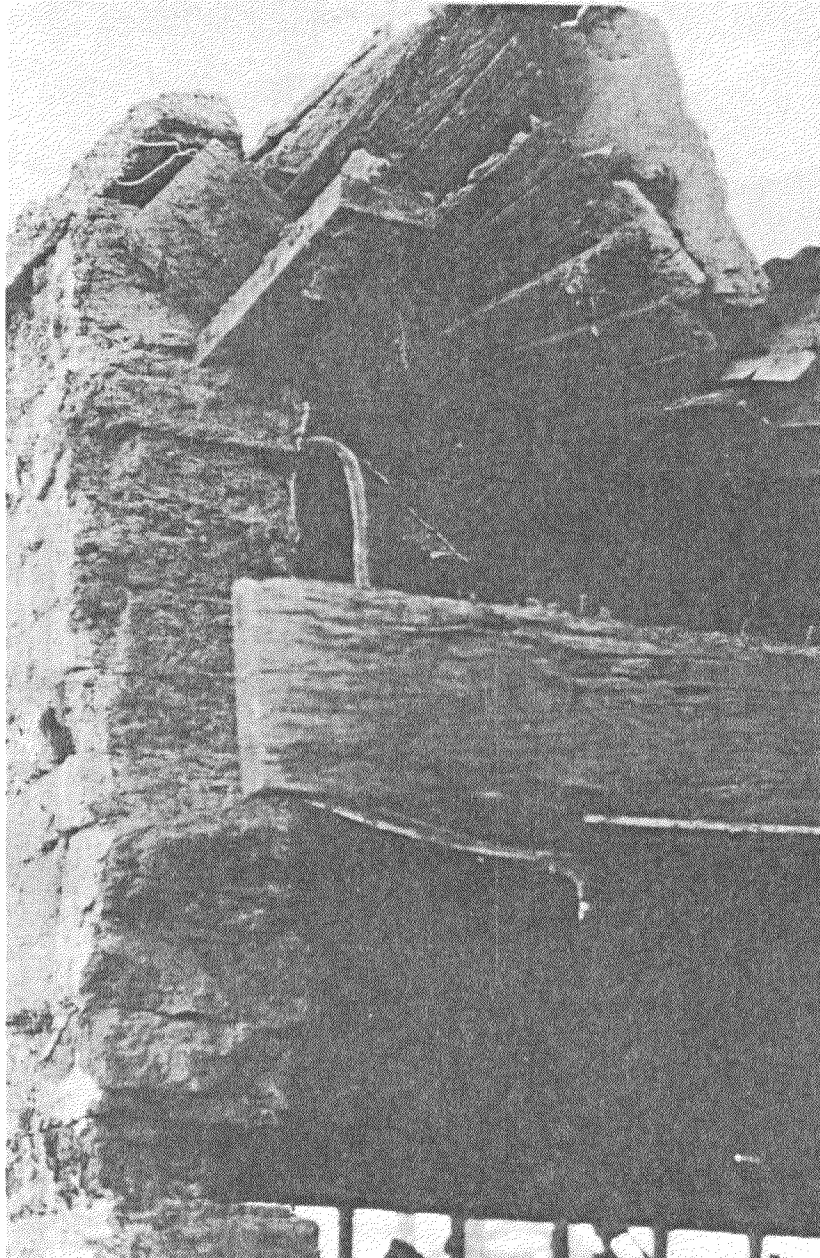
FIG. 3

The wall that failed was only minimally supported at the ends by poorly constructed frame walls, the roof was not constructed as a diaphragm.
