## Description of the Problem

## El Progreso

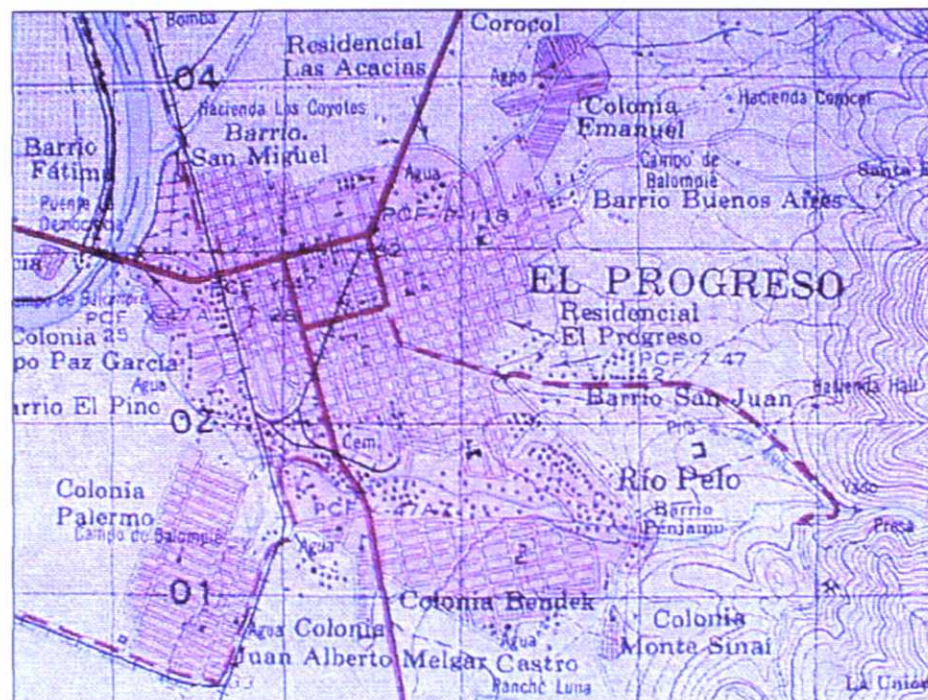
The Rio Pello, and the much smaller Rio Corocol produced flooding in the municipality. The Rio Corocol caused shallow flooding (<0.30 meters) but did not cause extensive damage. On the

other hand, the Rio Pello widened its channel by as much as 200 meters, and it produced up to 3.5 meters of bed aggradation. Sedimentation and the fate of sediment are the immediate issues that need to be addressed here. Local engineers estimate the sediment accumulated in the river basin at 250,000 m<sup>3</sup>.
