8.8 Damage assessment

8.8.1 General

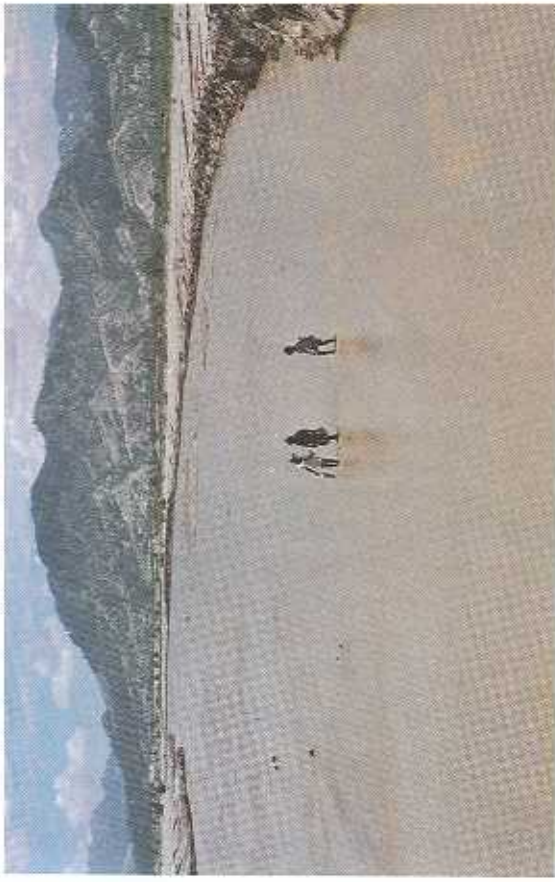
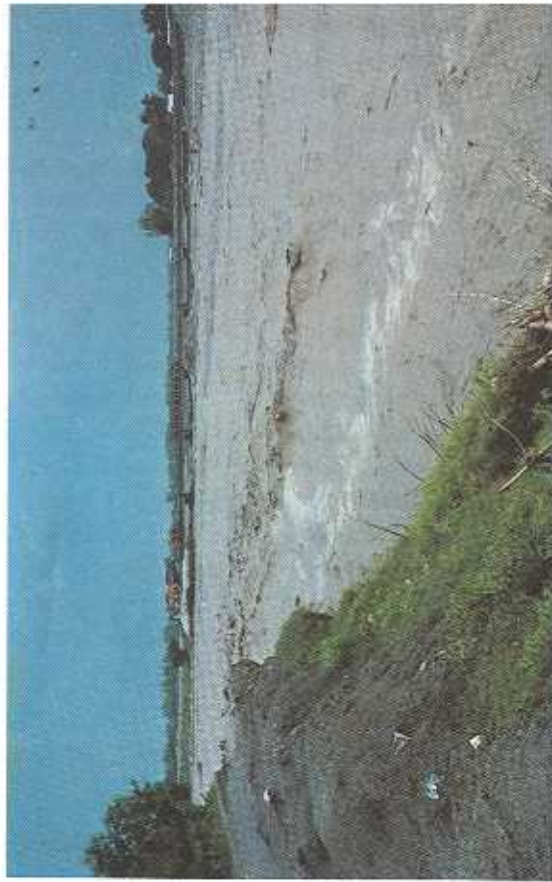
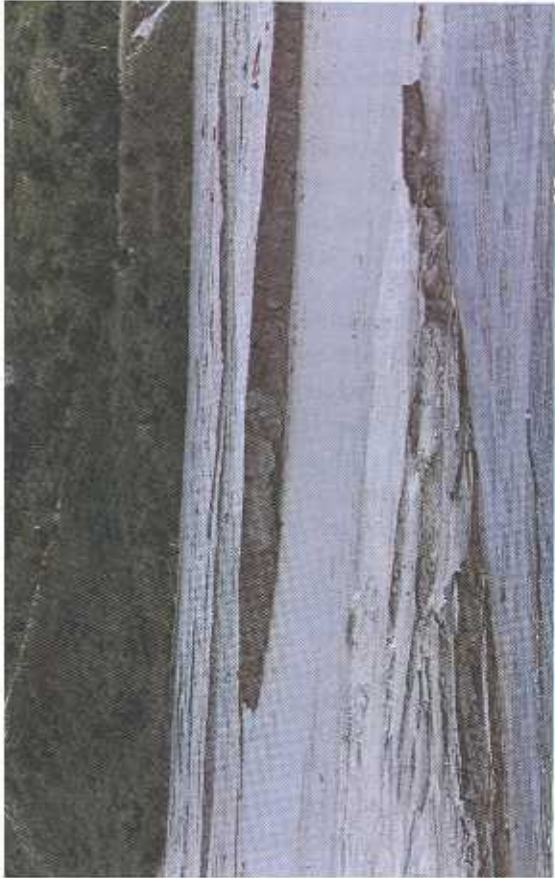
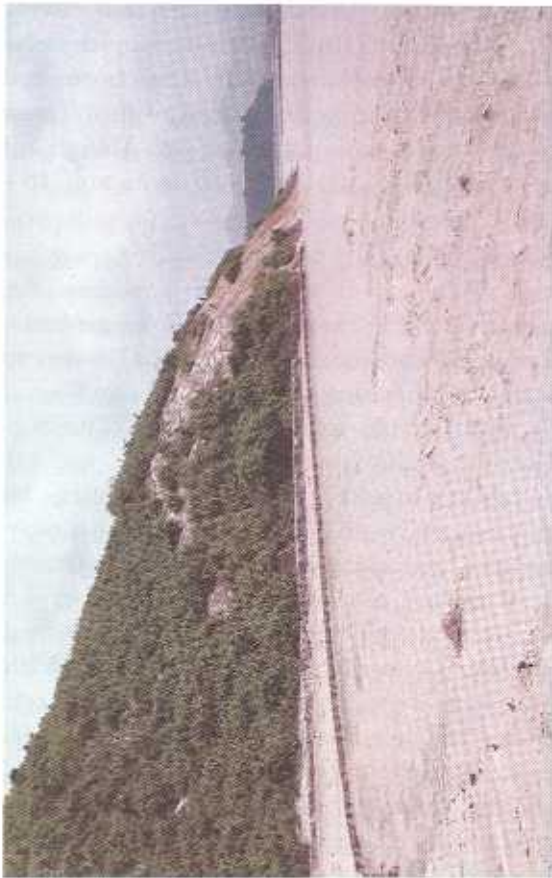
Fig. 8.9 – Sheet-like lahar deposits upstream of the O'Donnel River a few km from the crater (top left). The deposits are entirely composed of fine sediments; neither blocks nor debris are present. Calm lahar near Angeles City (Abacan River), with the surrounding landscape blanketed by volcanic ash (top right). Cold roaring lahar about 12-km from the crater along the O'Donnel River, near Santa Lucia (bottom left). Turbulent cold lahar at Pabanlag Bridge, near Floridablanca (bottom right). The pictures were taken in July-September 1991.

The major rivers originating from the volcano, whose beds were clogged by lahars, from northwest clockwise (Fig. 8.7) are Marella-Sto. Thomas, Balin Baquero-Bucaco, O'Donnel (Bangut)-Tarlac, Sacobia-Bamban (Abacan), Pasig-Potrero and Porac-Guman. Figure 8.9 illustrates examples of major lahars at distances ranging from a few km to about 30 km from the crater and Table 8.1 shows sediment delivery rates from 1991 to 1993.

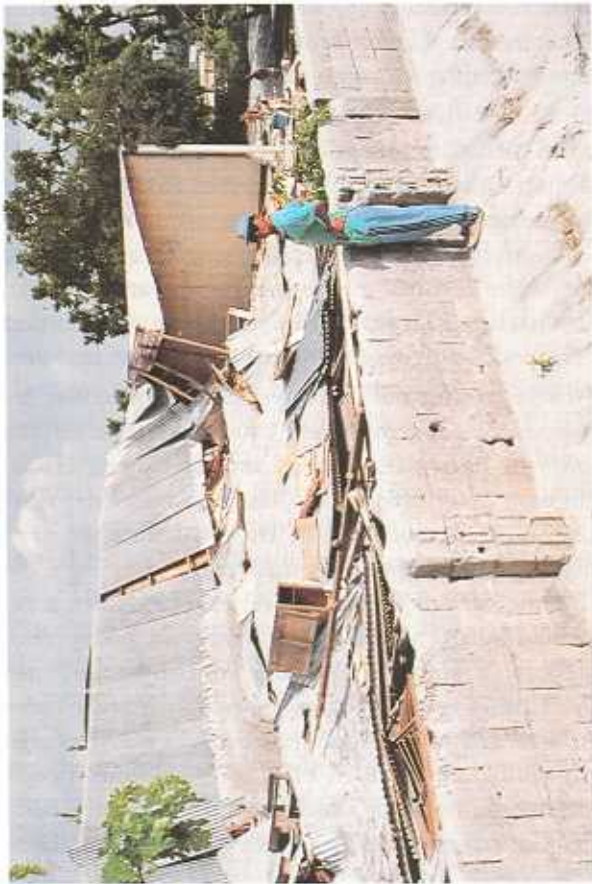
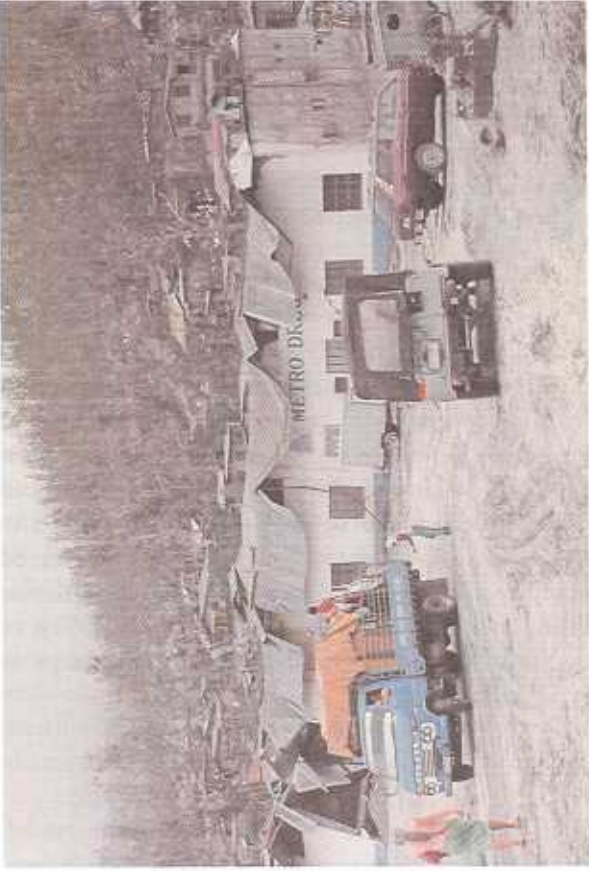
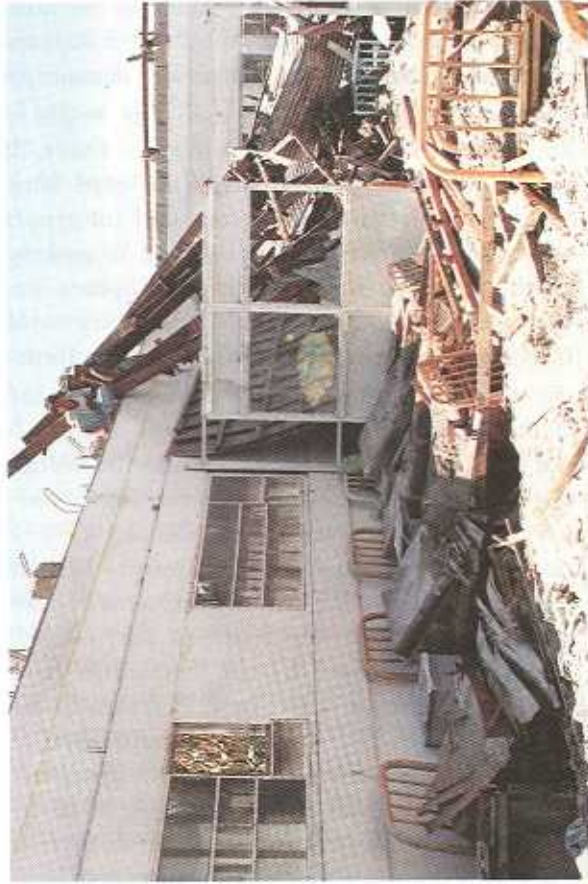
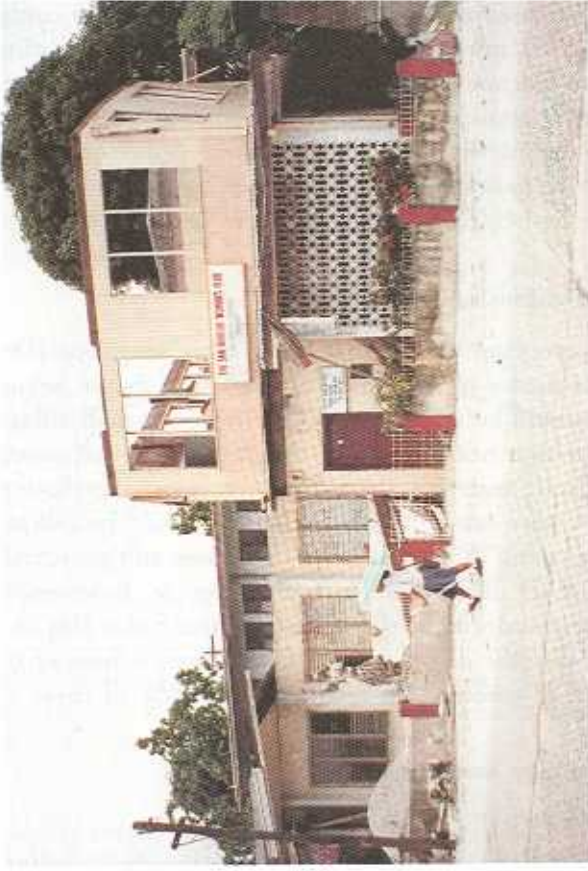
Fig. 8.11 - Collapsed school in Panau (top left), damaged roofs (top right) and destroyed hospital (bottom left) in Olongapo City, and collapsed roof in San Narciso, Zambales, (bottom right). Light roofs in general could not withstand the weight of the ash cover.

It was fortunate that the ash blanket accumulated more thickly on the western side of the volcano where cities are fewer and hence the population is comparatively smaller. Because of the tropical climate in the Philippines, roofs are merely designed to support their own weight and the loads that occur during typhoons and repair works. However, an ash blanket 10 cm thick resulted in an additional load of about 150 kg/sq.m, excessive for many light structures.

Many buildings collapsed: houses, schools, hospitals and numerous markets where roofs were merely designed to offer a protection from rain and sun. Figure 8.11 shows typical damage due to roof collapse. Water supply and sewerage systems also suffered sizable damage both from the direct impact of ashfall and for the collapse of buildings in major cities around the volcano. Telephone and power lines were also interrupted during the critical eruption phase, because dust, high temperatures and ash-covered roads prevented repair works for days.

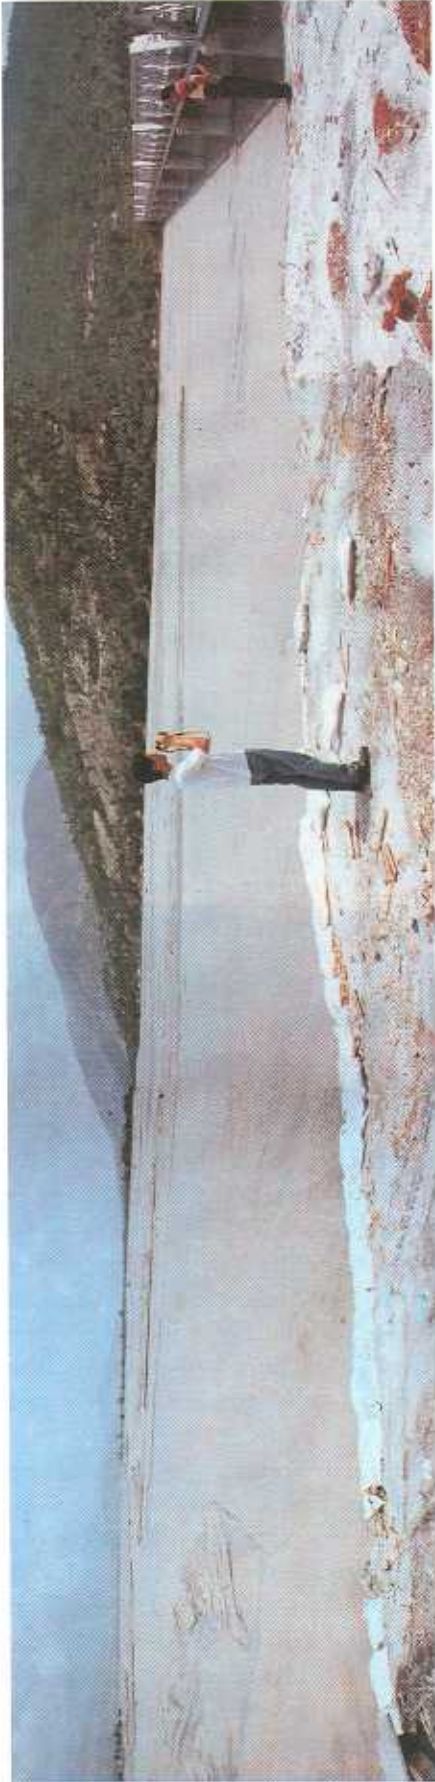
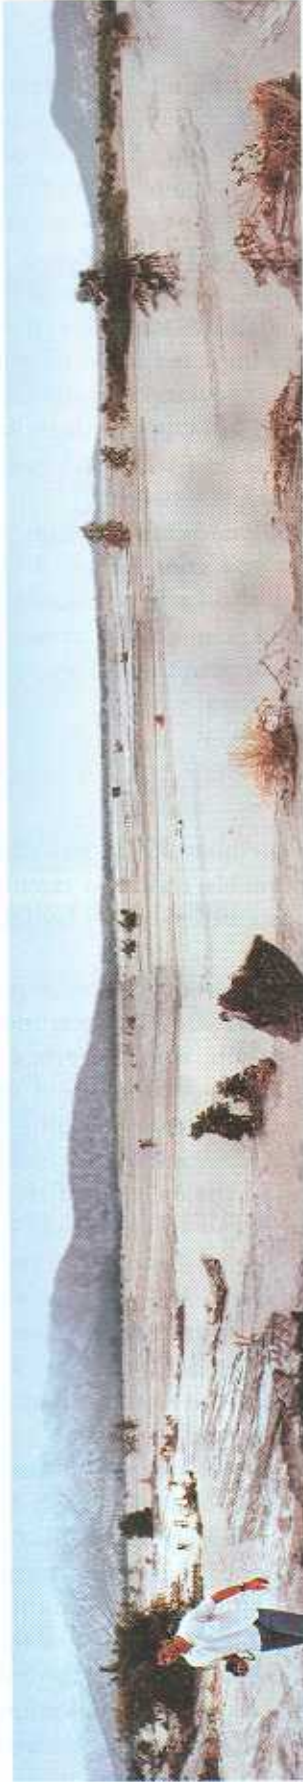
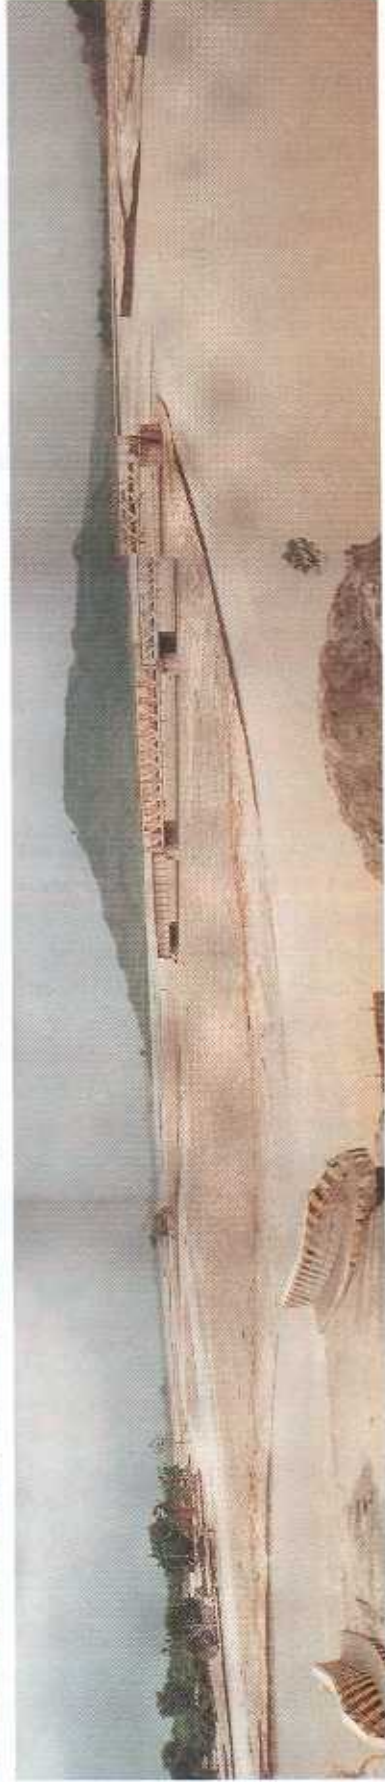
Fig. 8.12 - Enormous lahars in Zambales at the Bucao River (top) where the road along the right bank was buried by sediments, and Santo Thomas River (middle) where a long concrete bridge was destroyed. Catastrophic lahars at the Bamban Bridge (Pampanga), about 10 km N of Angeles City (bottom). Both the railway and the highway bridges were washed out by the destructive power of lahars, the riverbed being clogged by about 2 m of sediments.

Lahars are powerful landform-molding agents because of the huge quantities of sediments they carry. In the case of Bamban Bridge (Fig. 8.12) the existing structure was destroyed, the channel clogged with fine sediments and the drainage pattern of the site markedly modified. Soon after the collapse of the road and railway bridges, it was evident that new bridges would have to be longer. The geomorphological changes in other cases altered the drainage pattern by laterally moving the riverbed and hence imposing a different location for the new bridge.

Damage to roads and bridges is evident from Figures 8.12-8.14, which illustrate the different types of problems caused by lahars. The sequence of figures concerns bridges located counterclockwise around the periphery of the volcanic edifice. Figure 8.12 shows the huge lahars along Bucao and Sto. Thomas rivers in Zambales (top and middle), and the damage to the road and railway bridges along the Bamban River (bottom). Figure 8.13 shows the condition of the Santa Rosa bridge (top left) in Cabangan (Zambales), about 34 km west of the Crater, where siltation clogged the river almost entirely, leaving a mere 40 cm clearance beneath the deck-beams. Maculcul bridge (top right) north of San Narciso (Zambales) suffered a similar problem. The bottom figures show the partly and totally collapsed

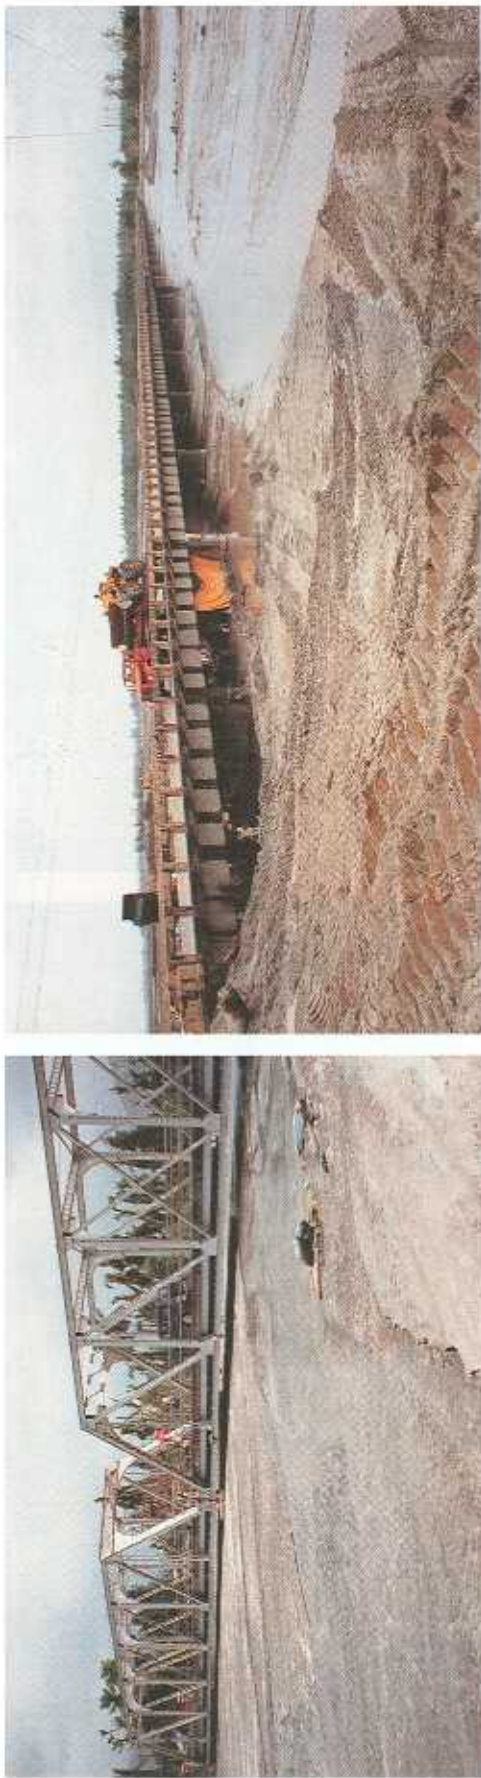
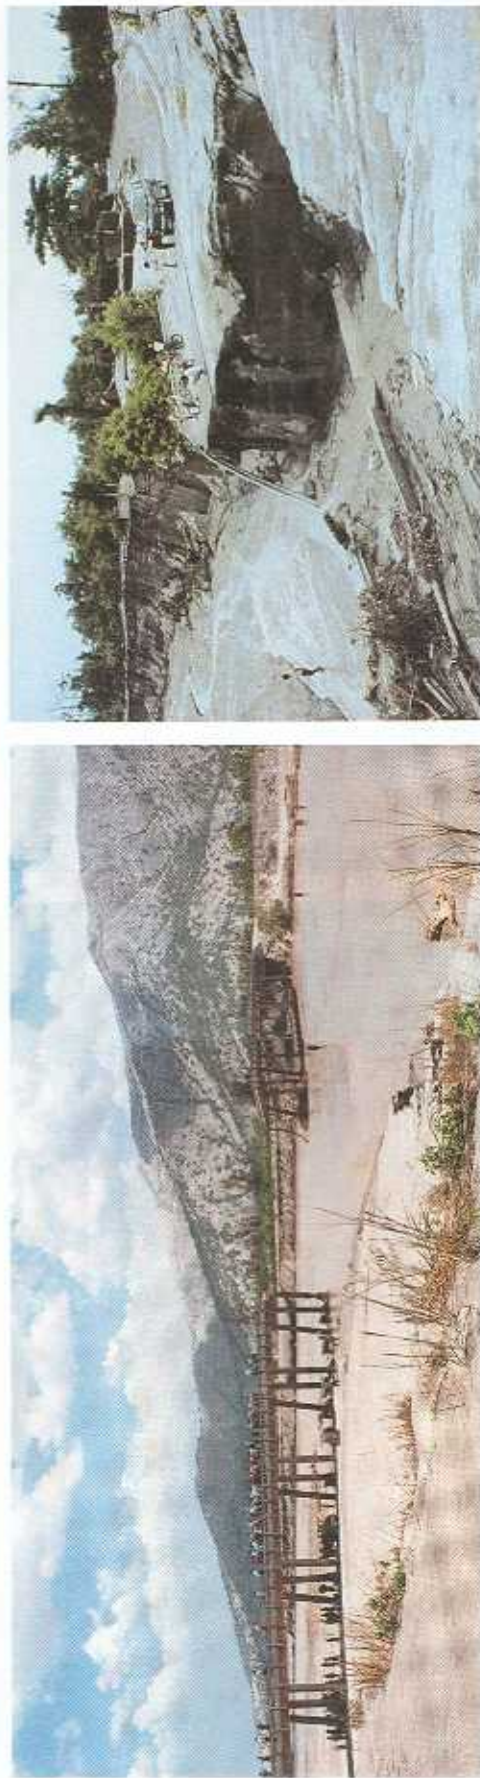
Fig. 8.13 - Damage to bridges in Zambales, between San Narciso and Botolan (see also Fig. 8.2). Clogged riverbeds by lahars in Santa Rosa (top left) and Maculcul Bridge top right), where the clearance was reduced to 40 cm and 2 m, respectively. Partly (bottom left) and totally destroyed (bottom right) Sto. Thomas bridge near San Marcelino.

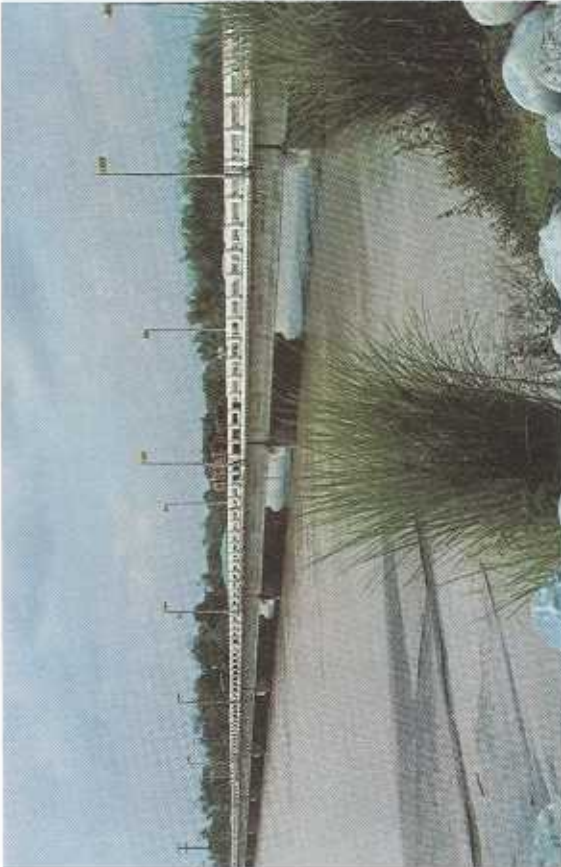
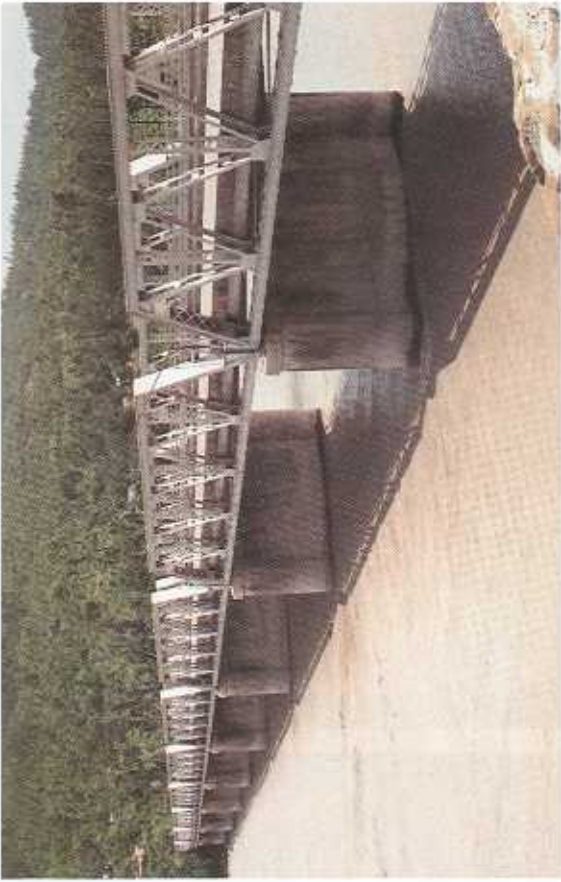
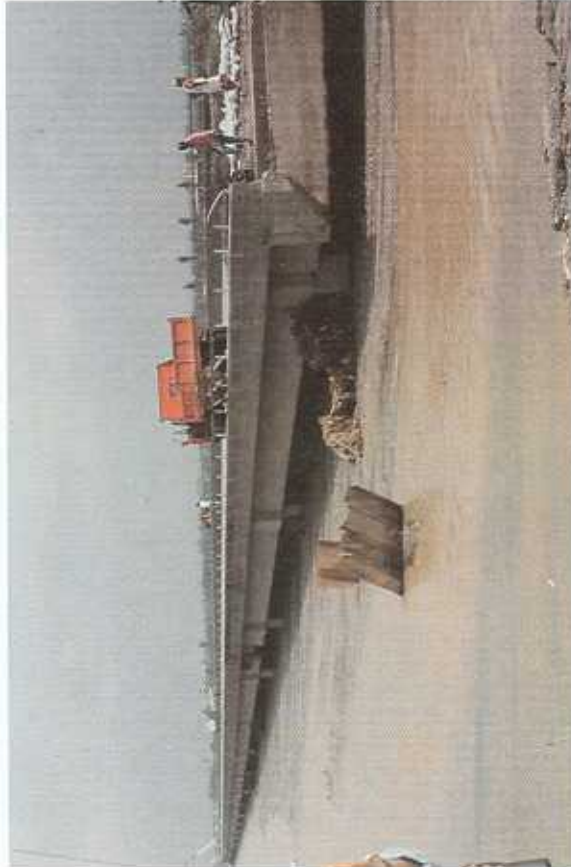
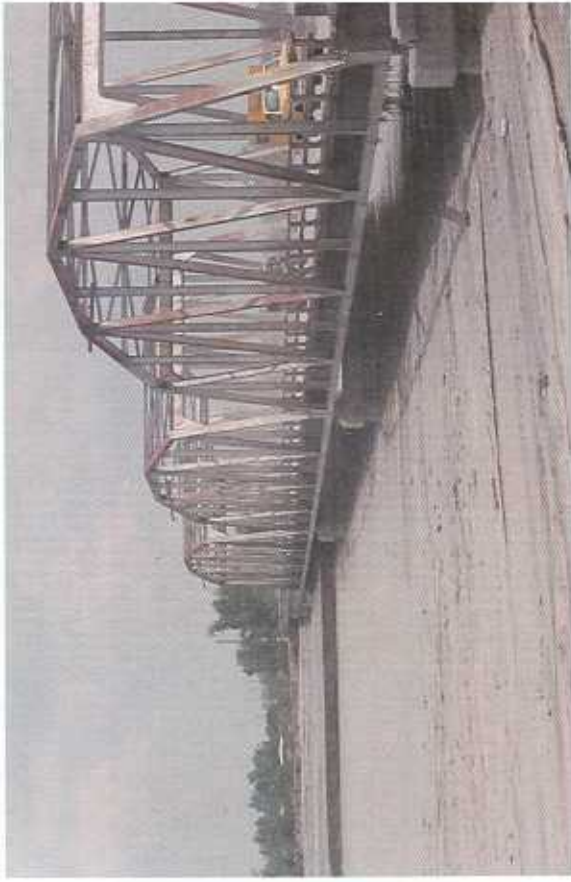
Fig. 8.14 Clogged riverbed in Tarlac (top left), and partially filled riverbed of the Bacun River (top right), on the Zambales side. Collapsed bridge span and clogged riverbed along the Superhighway around 30 km N of Manila (bottom left), and clogged floor of the Apaya River with only 1 m clearance (bottom right), north of Manila.

bridge in San Marcelino. Figure 8.14 illustrates the condition of bridges with a significant reduction in clearance (top); two bridges North of Manila (bottom) underwent a severe reduction of the clearances, and the one on the left also suffered with the collapse of a span.

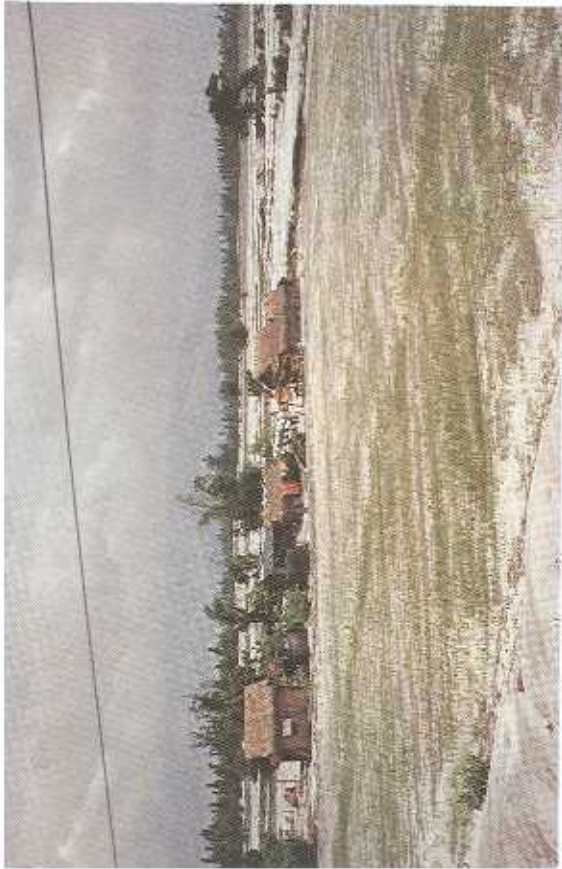
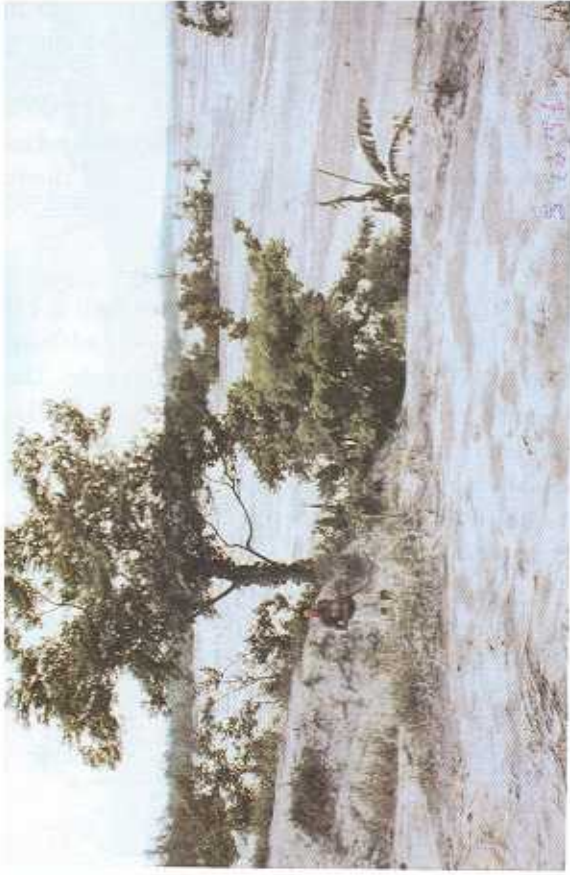
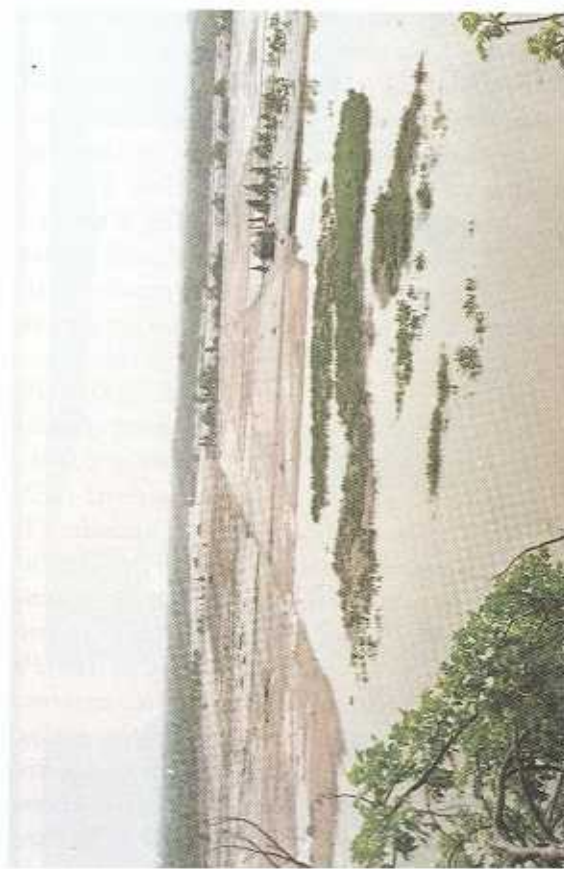
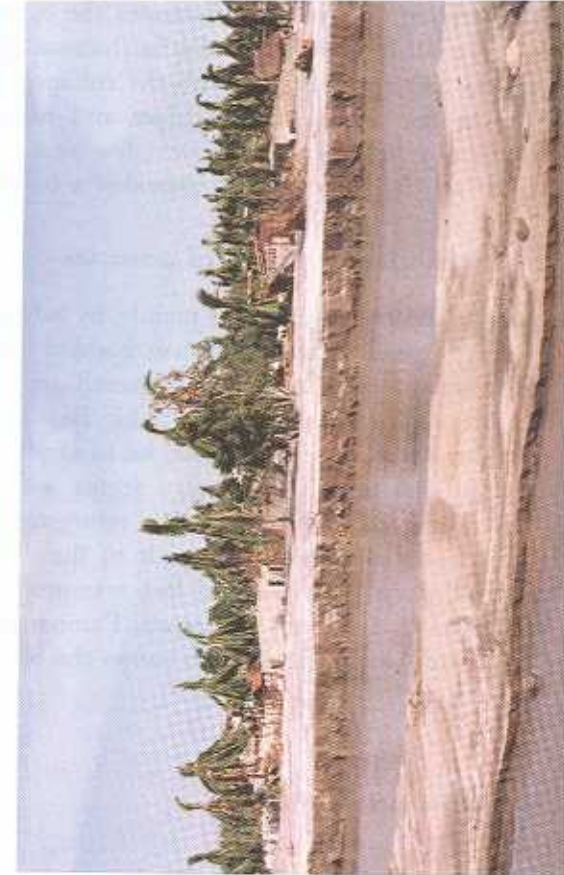
Fig. 8.15 – Farmland blanketed by the volcanic ash between San Narciso and Botolan (top left), and near San Marcelino (top right), and Zamboales side. Partly submerged ricefield (bottom left) by grayish ash-rich waters (Zamboales side), and village in Porac affected by ashfall and later on by lahars (bottom right) Due to the ash deposited during the eruption, trees look like closed umbrellas.

About 16,000 ha of fishponds in Bataan, Pampanga, Tarlac and Bulacan were affected by siltation due to the ashfall and lahars. Figure 8.15 shows the effect of the ash blanket and flooding of croplands around the volcano.

Figures 8.15 and 8.16 (top) give an overview of impacts resulting from lahars on flat lands.

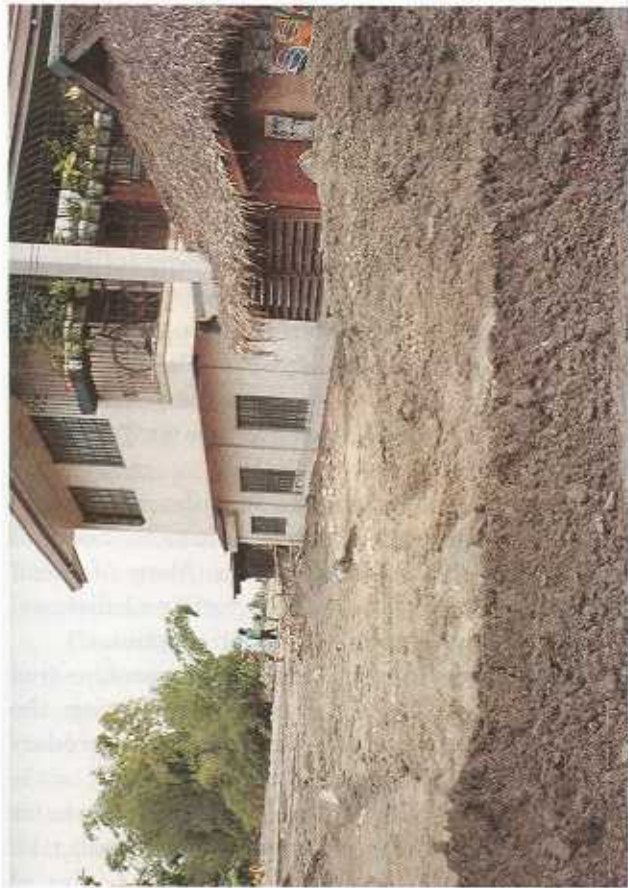
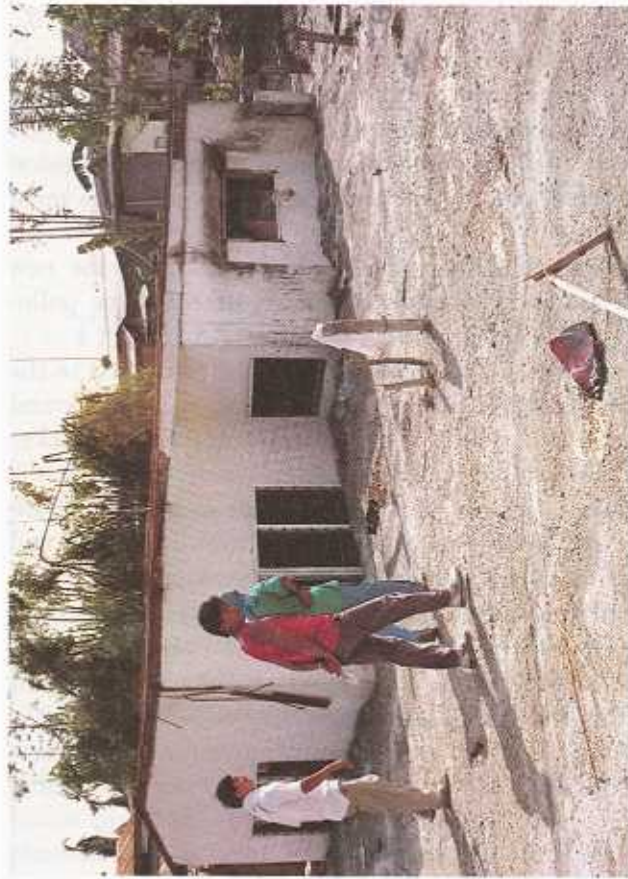
Fig. 8.16 – Houses surrounded by sediments in San Fernando, Pampanga (top left), and Porac (top right). Aetas people at the Evacuation Center in Porac in July 1991 (bottom).
