1. PRITHVI HIGHWAY

Naubise

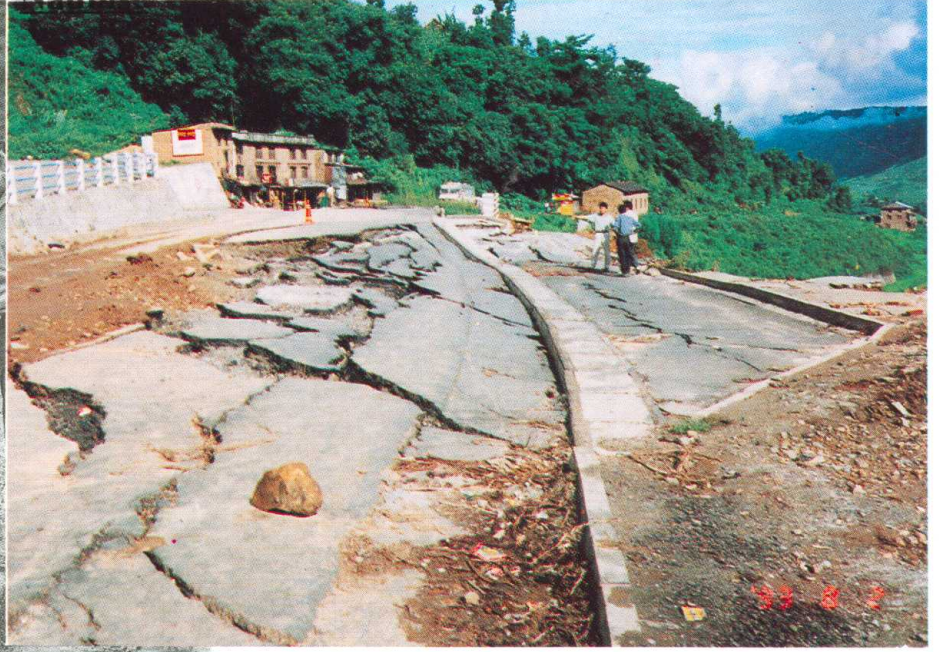
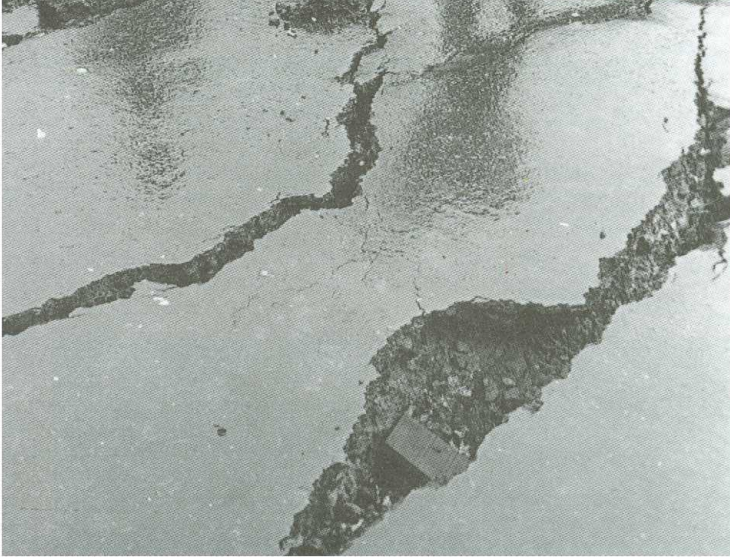
Rains wreak havoc: The road head at Naubise of the Prithvi Highway gives way to Chasms Falling victim to the torrential rains recently, while the bridge seen in the picture stands as vulnerable.

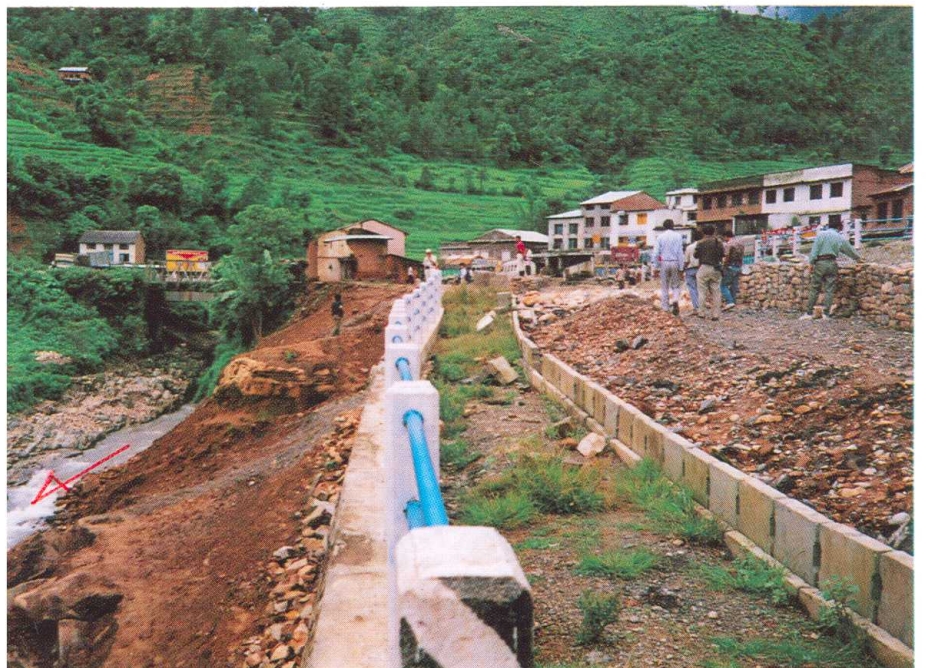
Mahadevbesi Bridge

Three out of four spans were washed away. Erosion on the other side of Mahesh Khola implies the severity of debris flow of Agra River.

Prithivi Highway was seriously damaged between Naubise and Mugling (L = 84 km): Three major bridges of Mahadevbesi, Belkhu and Malekhu were destroyed; Road was heavily eroded by flood of Trishuli river at many locations; Major landslides took place to block the traffic in Jogimara.

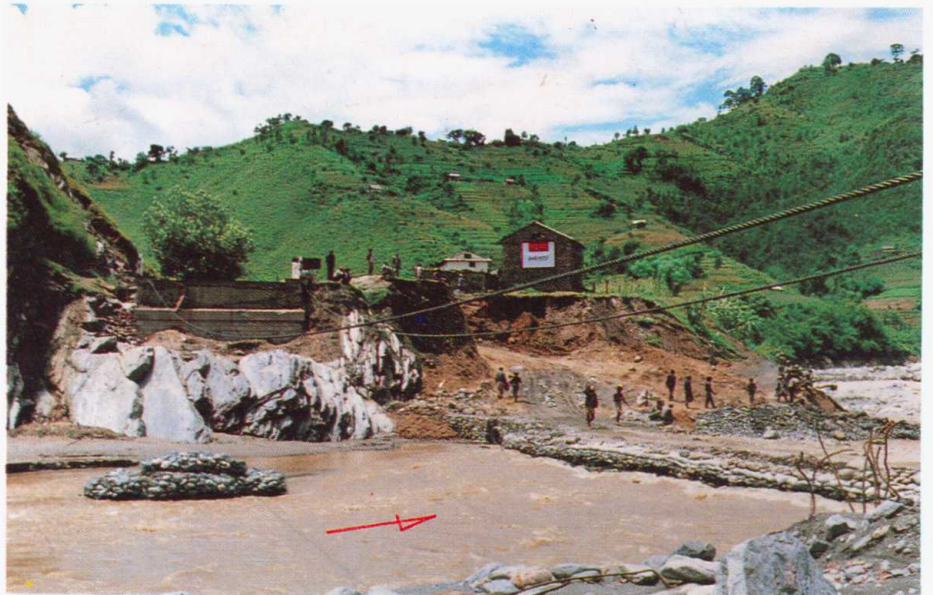
Temporary cable crossing at Mahadevbesi
