Bhimphedi

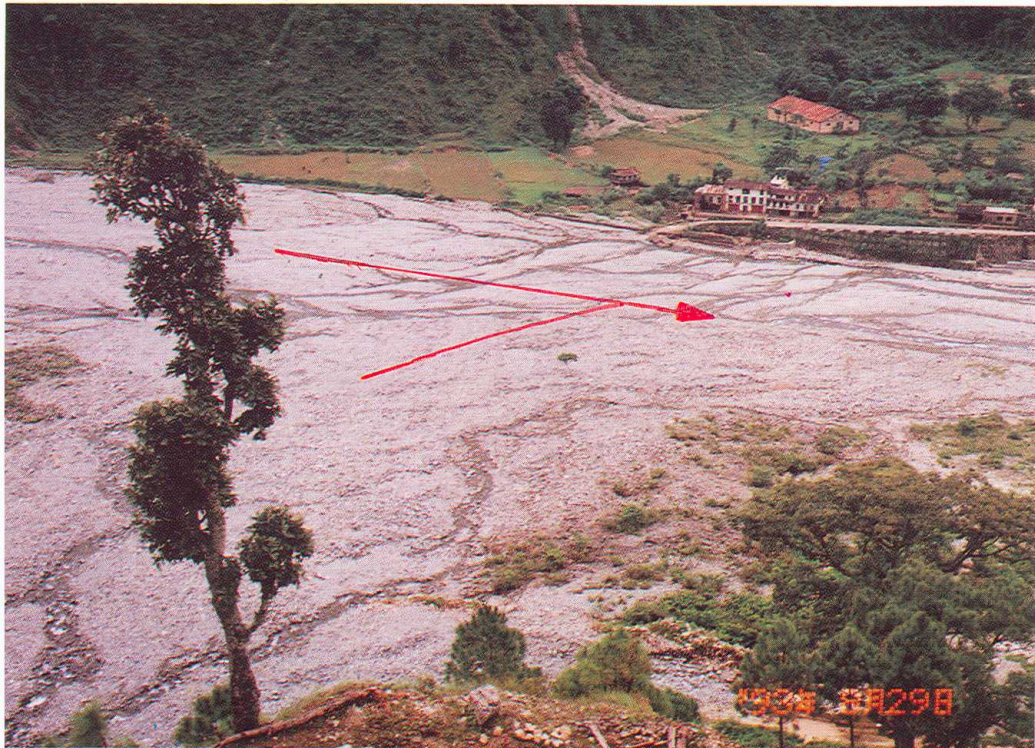
The above photos show River terrace eroded by Bhimphedi Khola near Bhimphedi town. Bhimphedi Khola is one of the tributary of East Rapti River.

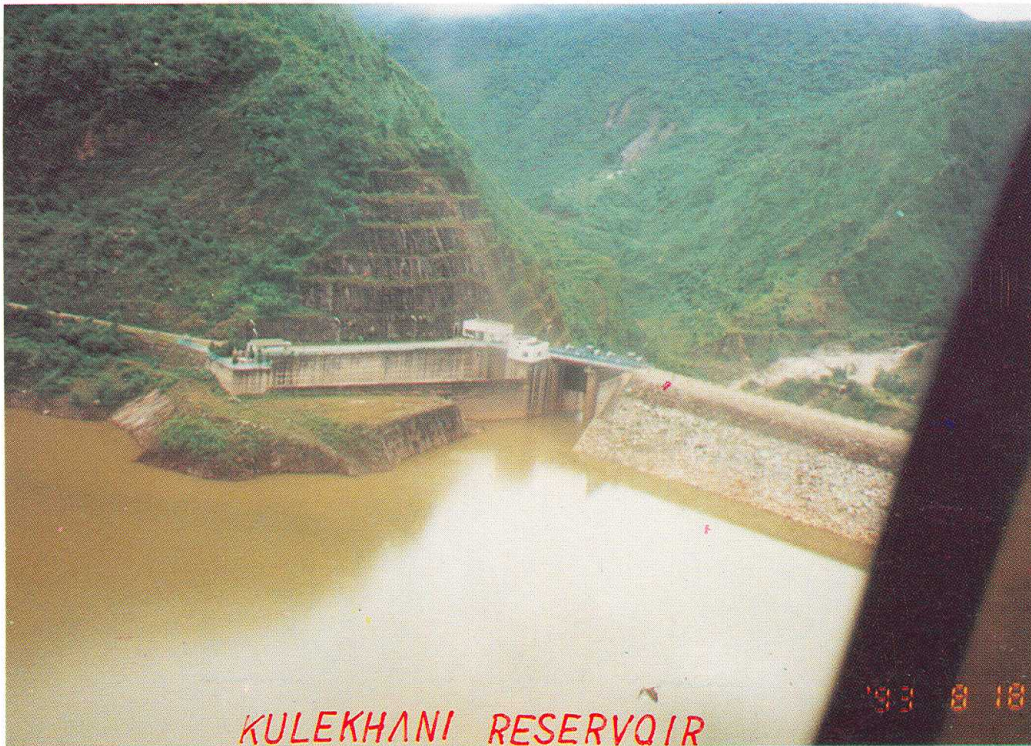
Kulekhani Reservoir

Water level rose by about 26 meters during a half day from late in the afternoon of 19 July to early in the morning of 20 July.
