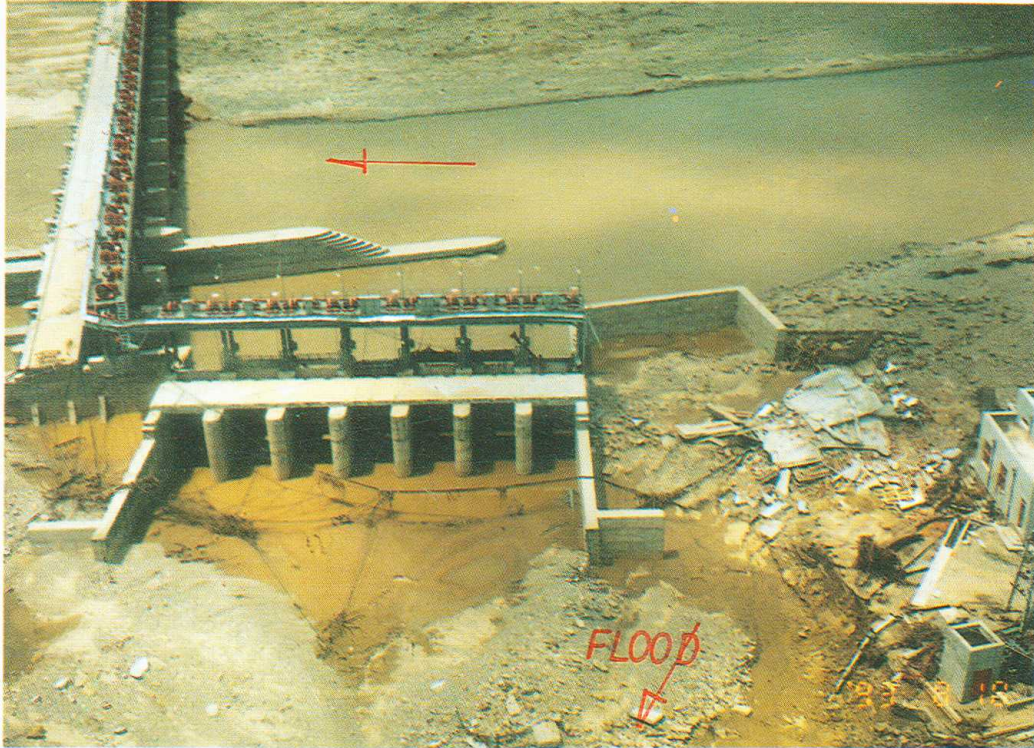
Damages near the eastern head works. The control house was completely collapsed and the generator house was inundated and partially damaged. River banks and main canal were washed away.

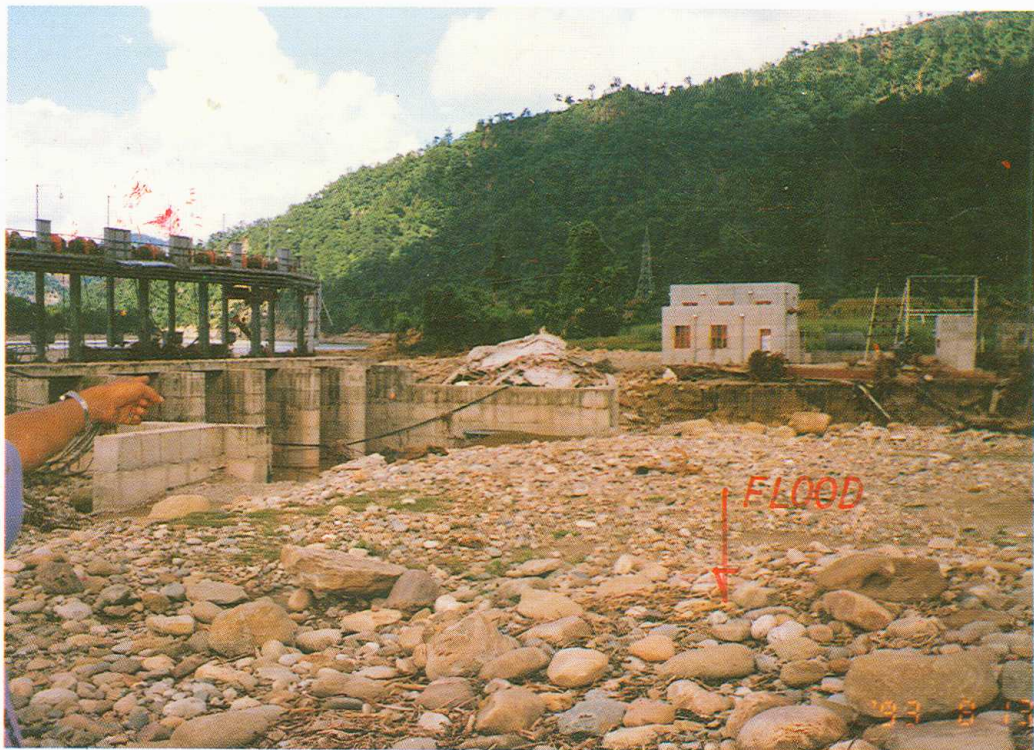
East Main Canal immediately downstream of head works.

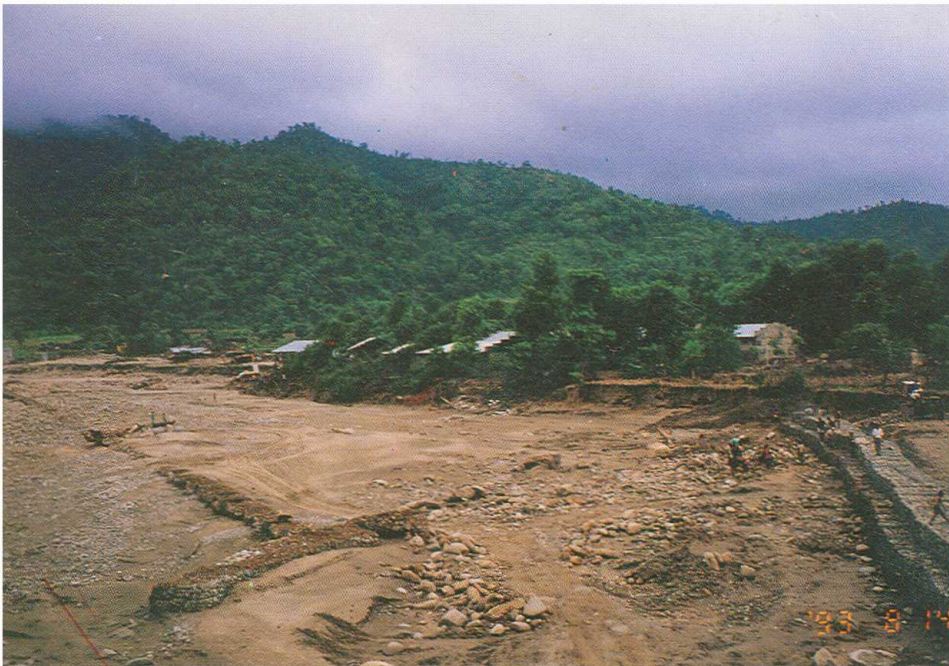
Damaged left bank between Barrage and East-West Highway

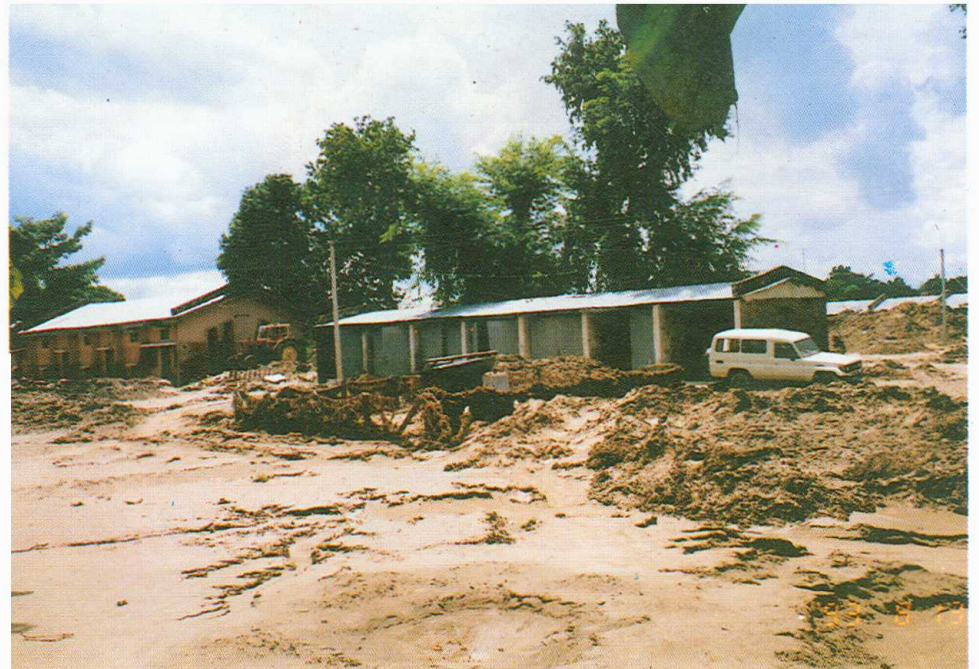
Inundation and siltation at the camp of Bagmati Irrigation Project

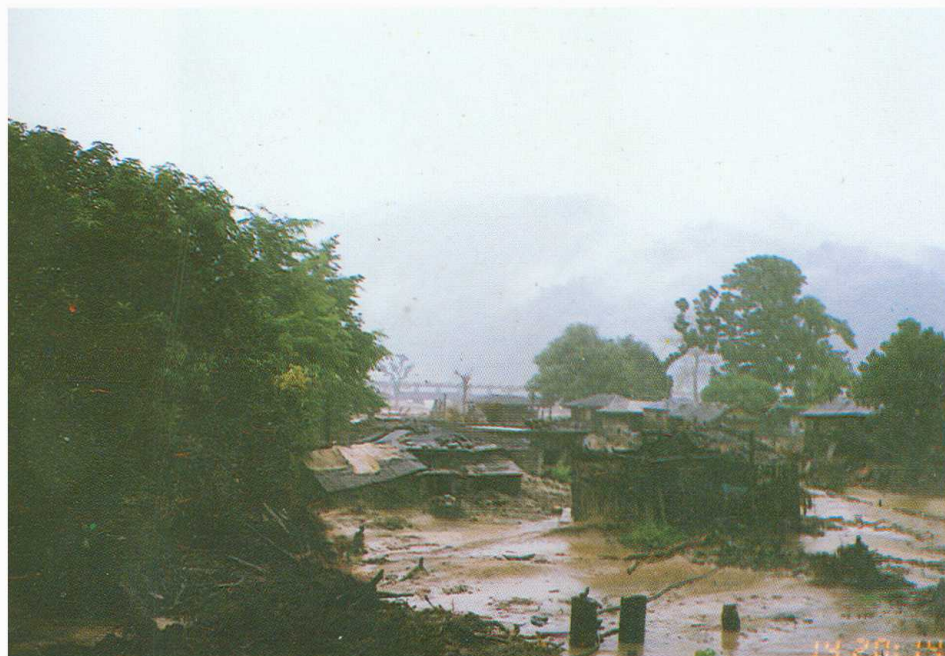
Damage to houses on the right bank of Bagmati River
