4.6. The analysis of the earthquake

4.9 Casualties, damage and environmental impact

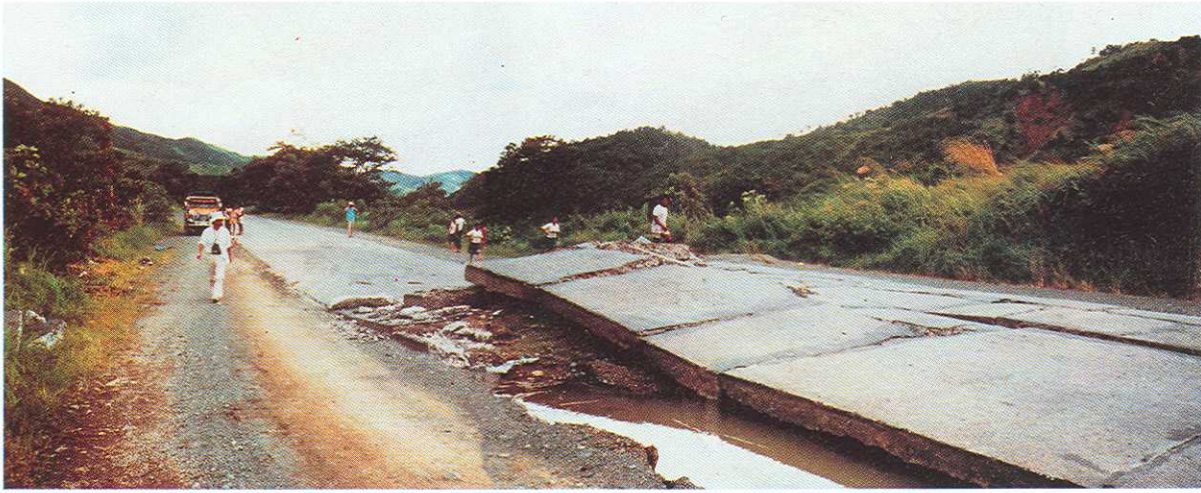
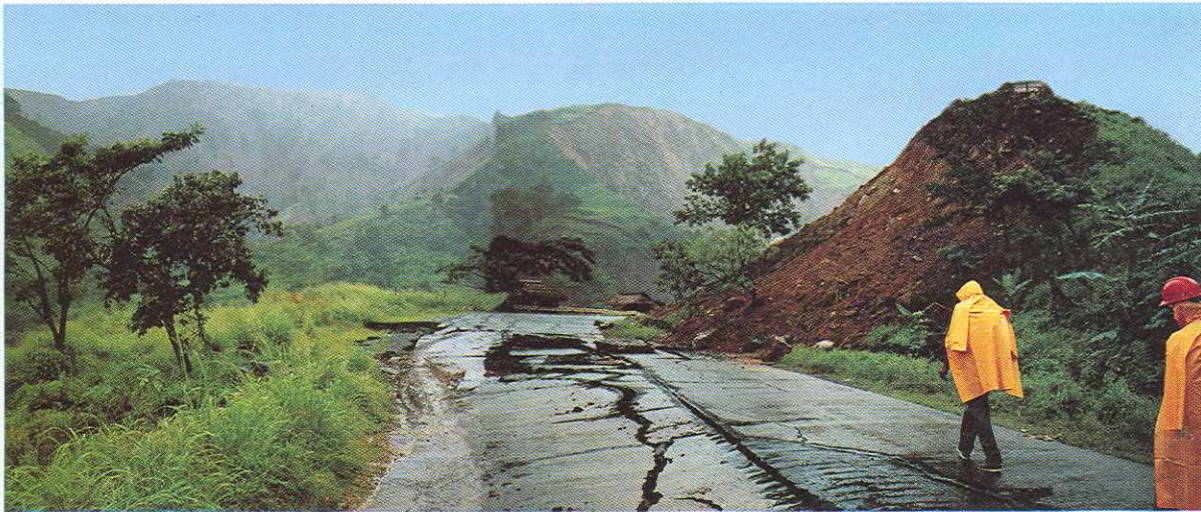
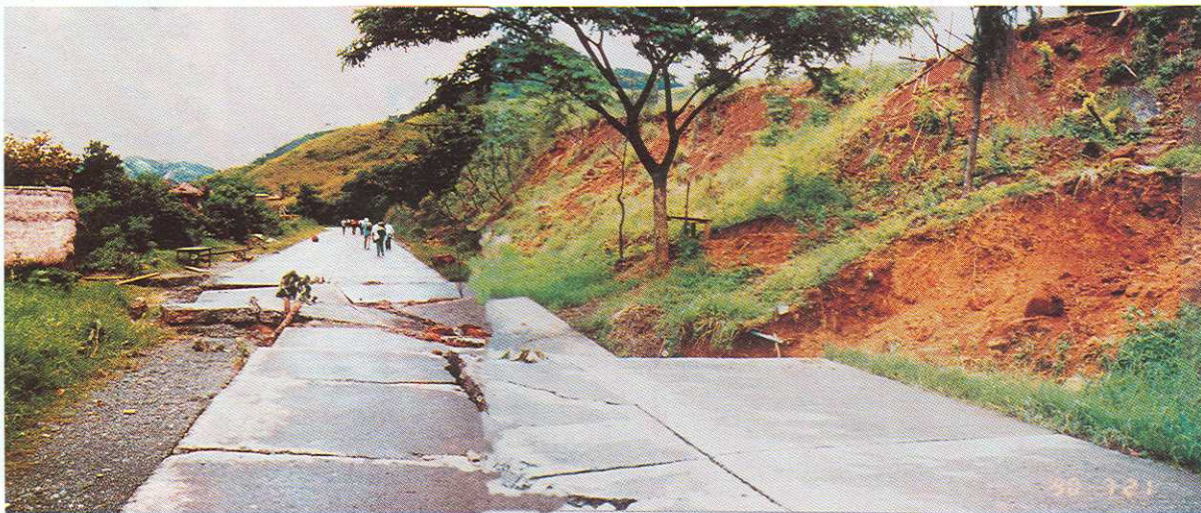
Fig. 4.15 – Fault crossing the Dalton Pass road at km 199+300 (top), at km 201+300 (center) and at km 201+400 (bottom). Courtesy of DPWH and Katahira.

The road network of Central Luzon (Fig. 4.11) and the Baguio region (JICA Report, 1990) was significantly damaged by the quake. Roads in mountainous areas (Figs. 4.21 top and 6.5) suffered damage due to cut-slope and embankment failures, longitudinal cracks, pavement deformation, differential settlement of fills. Marcos Highway in particular and Kennon Road (along the Agno River), both leading to Baguio City (Fig. 4.11) were largely destroyed by landslides. A segment of Marcos Highway near Baguio, along a very steep hillside, slid down the slope. The situation was made even worse by the onset of the rainy season (Chapter 6). Naguillian and Halsema Roads near Baguio were seriously affected by huge joint-controlled rock slides, mainly through plane failures of sandstone formations. A section of the Maharlika Highway through the Caraballo Mountains (Figs. 4.13 - 4.15) suffered enormous damage.

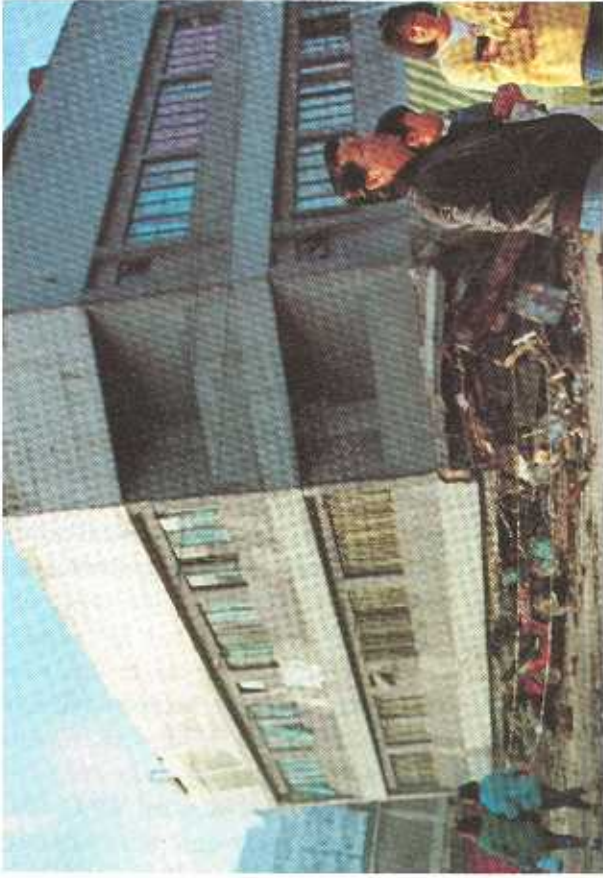
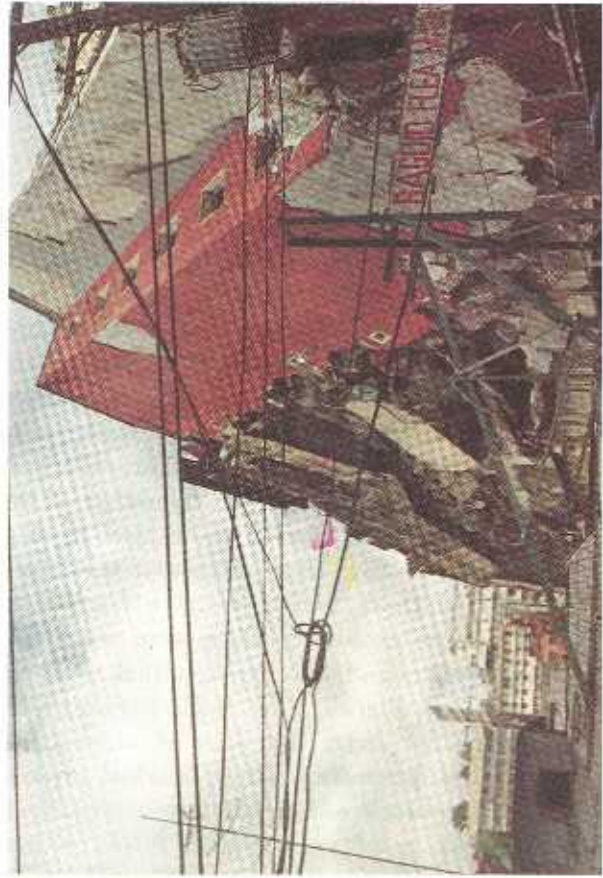
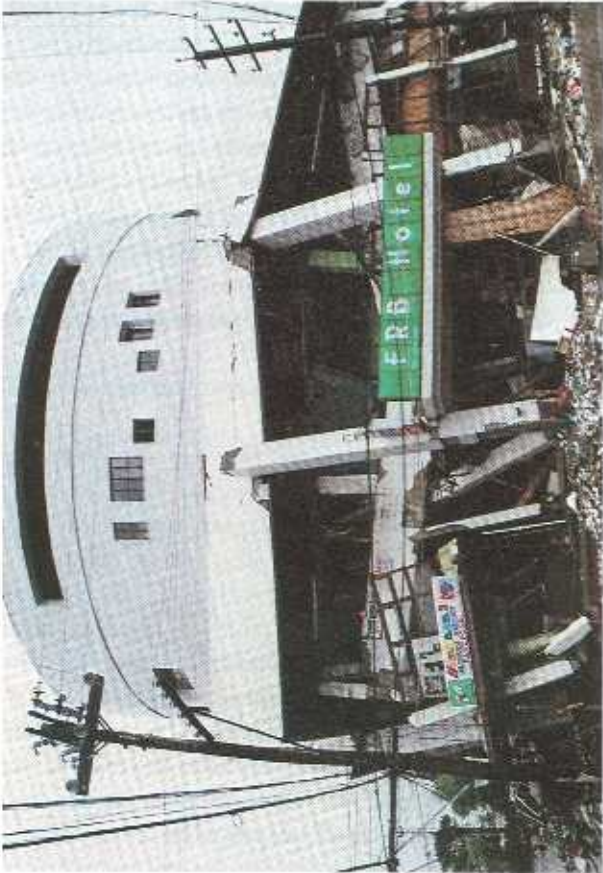
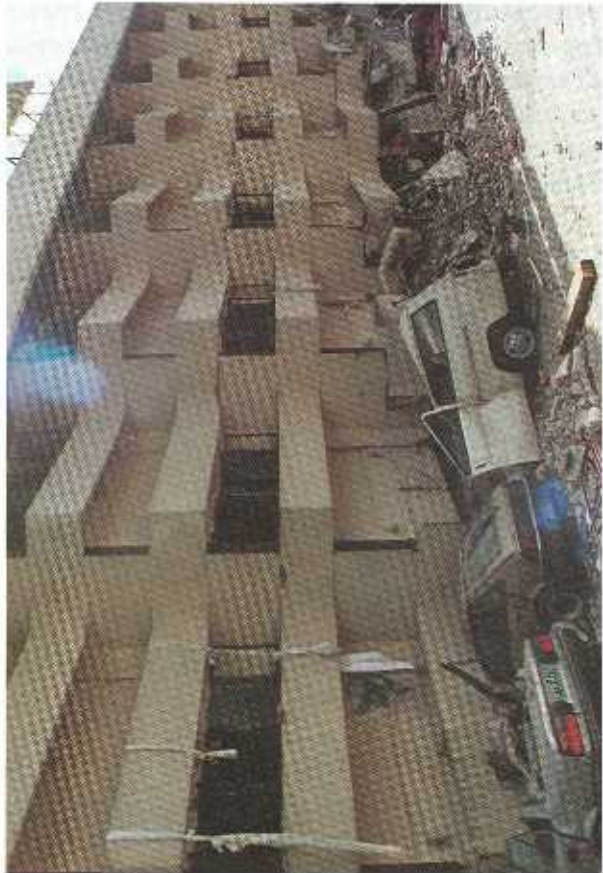
Fig. 4.20 – Badly damaged buildings in Baguio City (top, FRB Hotel and Royal Inn, bottom, Hilltop and Nevada Hotels).

Nearly 100,000 houses suffered damage and 40% of them were virtually destroyed. Figure 4.11 is a location map of the area most severely affected by the quake and Figure 4.20 illustrates some striking examples of structural damage in Baguio where a number of hotels and buildings collapsed. Towns in the coastal area south of San Fernando in La Union, along the Lingayen Gulf and in the area between Dagupan and Tarlac (Chapter 5), were damaged by extensive liquefaction. A six storey school collapsed in Cabanatuan, near the epicenter

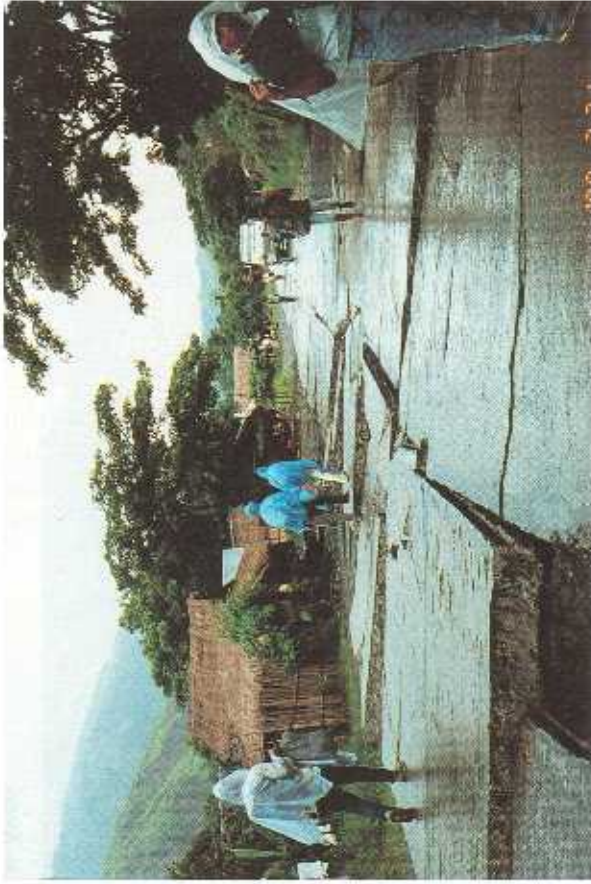
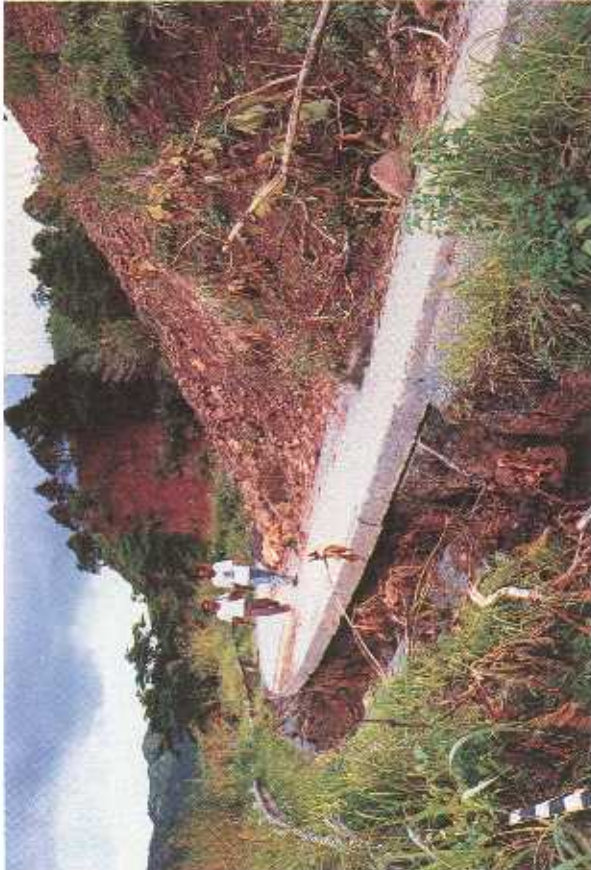
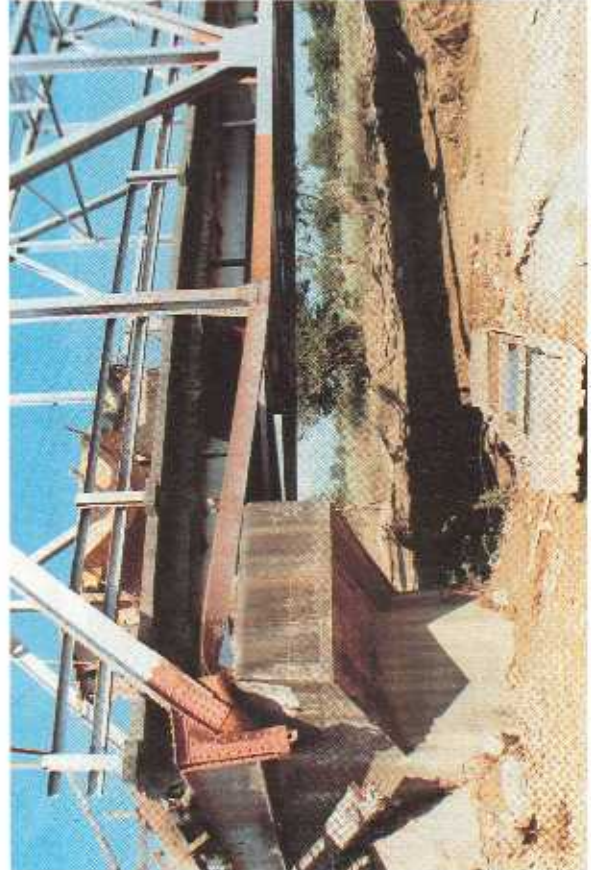
Fig. 4.21 – Damaged sections of the Dalton Pass Road at km 203 + 250 (top left) and at km 200 + 750 (top right), Courtesy of DPWH and Katahira. The collapsed Platidel Truss Bridge, over the Agno River, in Carmen (Rosales), about 60 km North of Tarlac (bottom).

Seven bridges collapsed, eight were seriously damaged and about 20 were affected by various types of lesser damage. Major bridges that were destroyed included the 600-m long truss bridge over the Agno River in Plaridel (Fig. 4.21, bottom) and the five-span Magsaysay concrete bridge in Dagupan City (Figs. 5.2 and 5.10), both of which collapsed due to liquefaction. Many bridge abutments were damaged, approaches suffered marked settlement and piers suffered tilting or settlement.

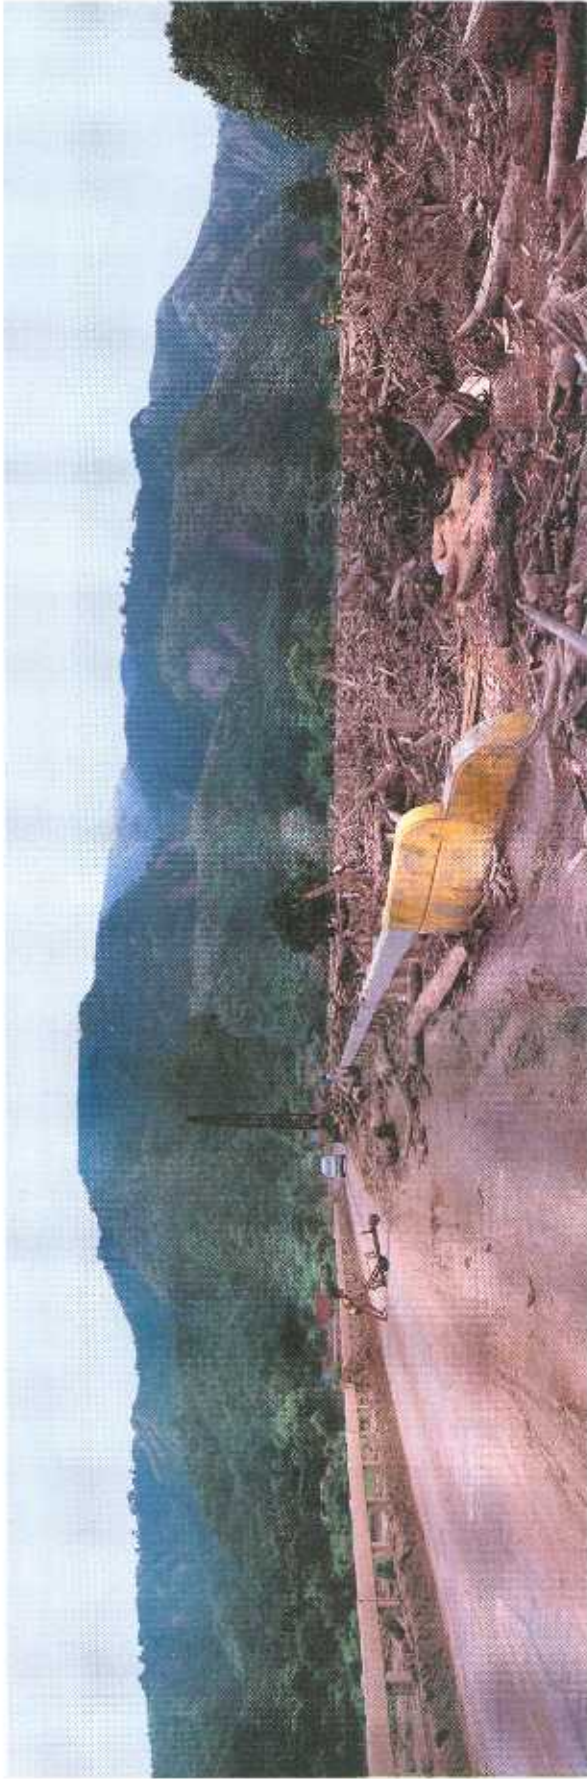
Fig. 4.22 – The overtopped Puncan Bridge along the Dalton Pass Road at km 177.

Figure 4.22 illustrates the extent of the damage through the huge quantity of trees which accumulated by August 1990 at Puncan Bridge along the Dalton Pass Road. The numerous slides in mountainous provinces contributed to the uprooting of vegetation on steep slopes where human-induced deforestation had proved impractical. Extensive alluvial fans (Fig. 4.23), produced by accelerated erosion, formed along major rivers and near the periphery of mountains.
