THE EFFECTS OF THE 1976 EARTHQUAKE IN THE SOČA RIVER BASIN

Milan Orožen Adamič

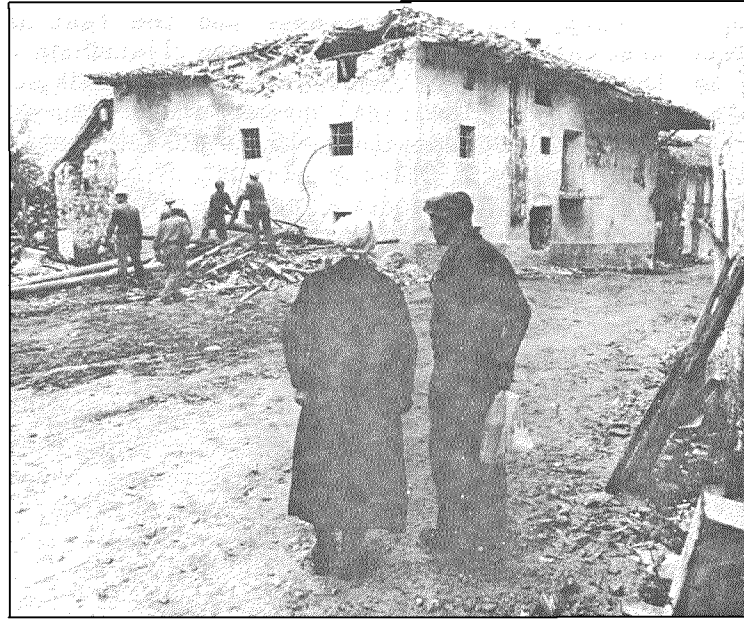
Figure 1

Earthquake Damage in Breginj, Yugoslavia, 1976

Demolition of an old house badly damaged by the earthquake at Breginj. It was particularly difficult for aged people who lost their homes to accustom themselves to new living conditions.

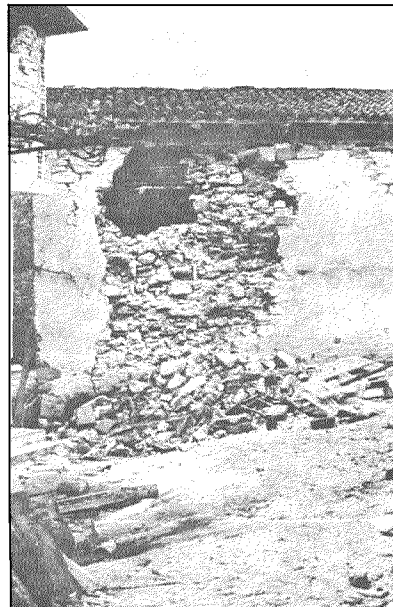
Figure 2

Earthquake Damage at Podbela, Yugoslavia, 1976

A demolished wall of an old house at Podbela constructed in the traditional manner. It was built without use of concrete or other more up-to-date construction materials.
