Roads and Drainage

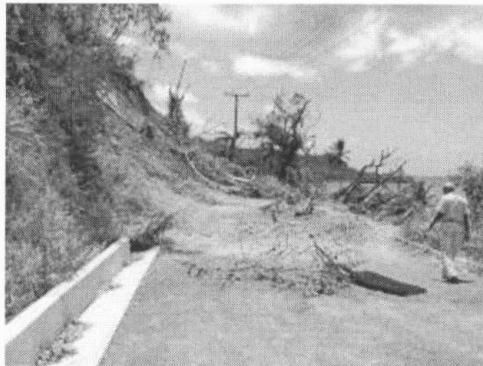
Photo 8 Land Slippage at Gouyave Blocking Western Main Road

Land slippage was observed at St. Paul's, where clean-up efforts took approximately three days. Other sites of slippage included River Road and Brizan. In addition, the effects of the storm worsened the effects of a major landslide that had occurred previously on the Western Main Road on the approach to Gouyave (Photo 8). This landslide occurred before the hurricane and urgently needs to be cleared and some slope stabilization works carried out.

Mitigation strategies for this slide could include either some form of slope stabilization, or relocation of the roadway to a lower level with sea defence works to protect it. It is

estimated that the cost of repairs to this location is approximately EC\$12 million. No indirect costs have been assigned to this project, as the length of the diversion roadway is sufficiently short that it does not present a significant difference from the main route.

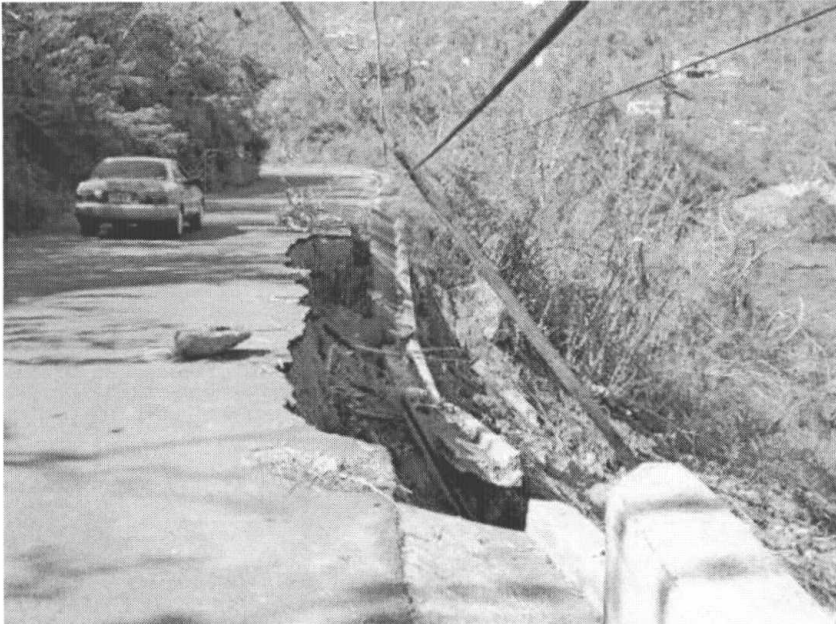
Photo 9 **Erosion of Roadway at Westerhaul**

Erosion of road edge was noted particularly at Grand Etang and Westerhaul (Photo 9). This type of road failure is characterised by removal of a section of the road, through the action of a slope failure. Remedial works should include a retaining wall, which would have to be designed on a site specific basis. Estimated costs to repair these two locations will be EC\$500,000.
