Chapter 3

Geotechnical assessment of the Usoi landslide dam and the right bank of Lake Sarez

3.1 Introduction

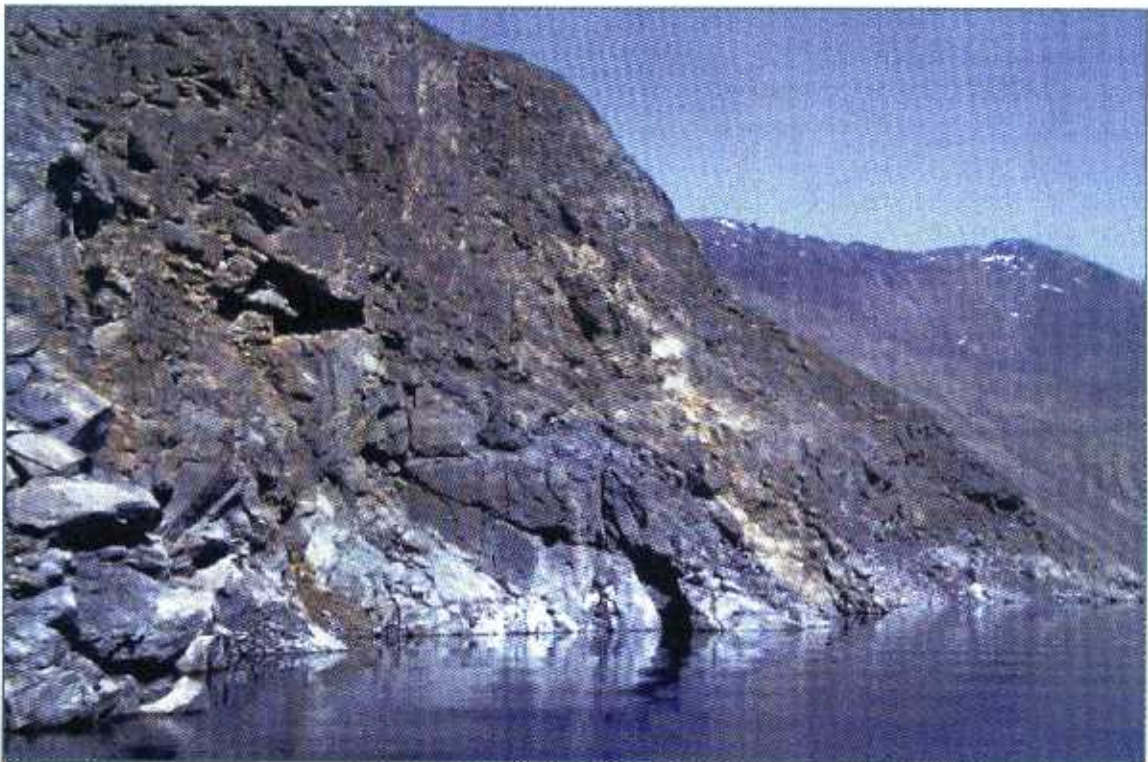
Photo 4. Example of intensely fractured rock (within the "Rushan-Pshart Thrust Fault Zone"). Photo credit: Jörg Hanisch

The highly active tectonic regime causes intense stress in the rock mass, resulting in excessive fracturing and the formation of abundant shear zones, mega-joints, and cleavage (photo 4).

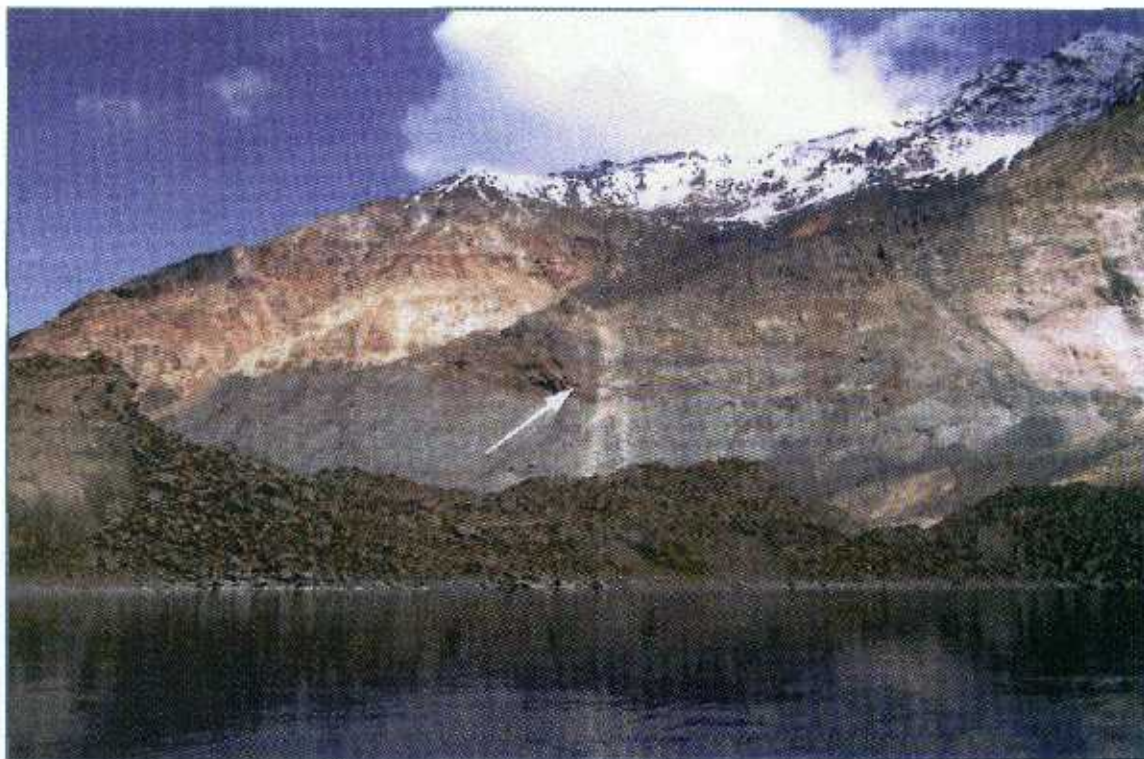
Photo 6. Westernmost part of the Usoi landslide scarp with a regional thrust fault (arrow) between Carboniferous schists and quartzites (below) and Permian-Triassic shales (above). Blocky material of the northern part of the dam in the foreground abuts against finer material of the middle part (left). Photo credit: Jörg Harisch

- (1) The generally high degree of rock fracturing from former tectonic movements,
- (2) The presence of a major thrust fault (photo 6),
- (3) The presence of a series of intensive shear zones forming the necessary geometric setting for a typical wedge failure (fig.7 and photo 8), and
- (4) The presence of a SW-NE-trending active wrench fault in the innermost corner of the wedge (photo 8)

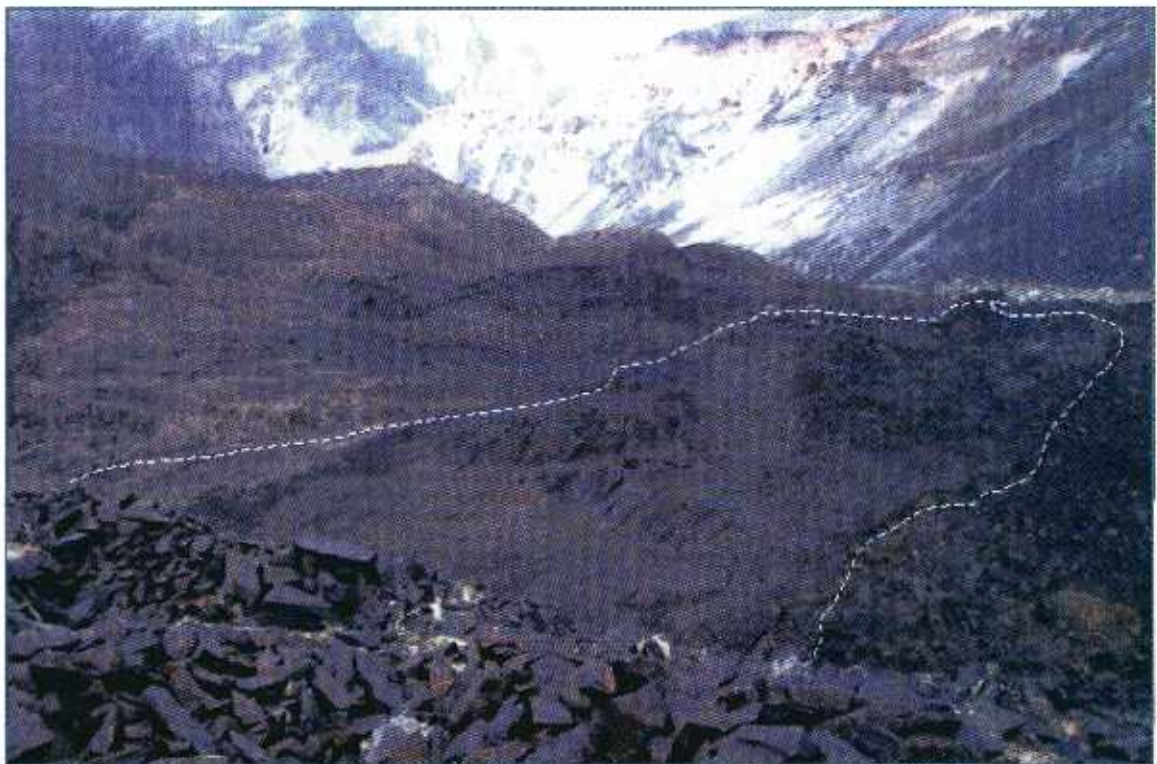
Photo 9. Huge, rather undisturbed rock block (dashed line) within the central part of the dam. This block was displaced by a secondary landslide (scarp is immediately behind the blocky material near the crest line of the dam). Photo credit: Jörg Hantsch

- *Central sector:* This part rises on the average approximately 100 m above lake level and has a distinct border towards the right part, where the surface is lower. The surface in this central part differs from that of the rest of the dam in that there are no large blocks, and the surface includes a large amount of fines (silt). There are clear indications that this material originated from surficial colluvial deposits on the slopes before the landslide occurred. The surface is extremely irregular and several cracks or openings in the ground exist. The downstream part includes large fragments of more-or-less undisturbed rock (photo 9).

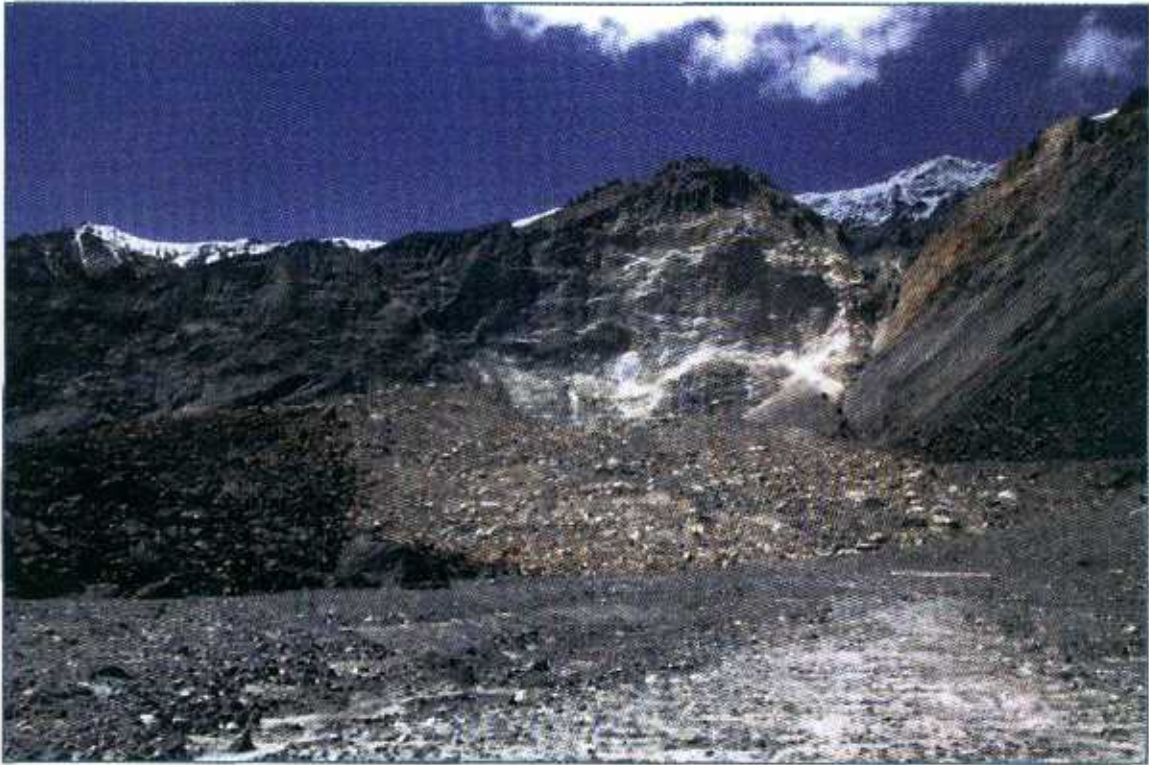
Photo 10. Rock avalanche deposit lying upon a debris-flow cone (in the foreground) and abutting against blocky, dark grey dam material to the left. The scarp of the 1911 landslide is in the background. Photo credit: Jörg Hanisch

- *Northern sector:* This is the lowest part of the dam, with a minimum freeboard of approximately 50 m. A continuous surface from the lake to the downstream side is covered by large blocks; the largest diameter of these blocks is approximately 20 m and the average diameter is estimated at 2-5 m (photo 10). Practically no fines are visible. In the area closest to the source of the old landslide there are active rock avalanches, debris flows, and mudflows (photo 10). Today, these flows are directed towards the lake. One of the rock avalanches apparently has diverted sediment transport from the slope above the downstream side towards the lake.

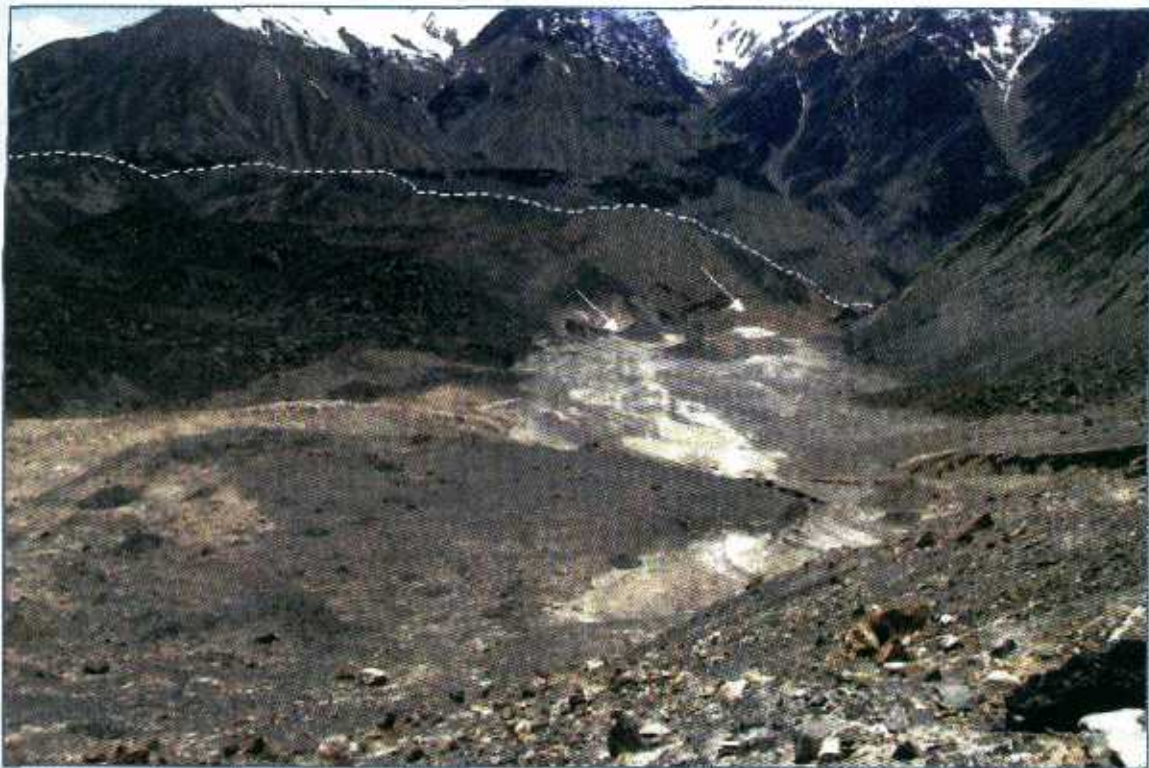
Photo 11. View to the downstream side of the dam (dashed line) with the debris-flow "flood plain" in the centre. The erosional channel ("canyon") at the terminus of this flood plain cuts partly into these recent fluvial deposits (left arrow) and slightly into the dam material itself (right arrow). Photo credit: Jörg Hanisch.

Along the downstream face of the dam, a large flood plain of fine debris-flow material has been deposited since formation of the dam (photo 11). This deposit of debris-flow material is resting partly on the blocky dam material; the

depositional mass is terminated by a local canyon on the downstream face of the dam, which has developed due to erosion by the seepage springs that flow from the dam.
