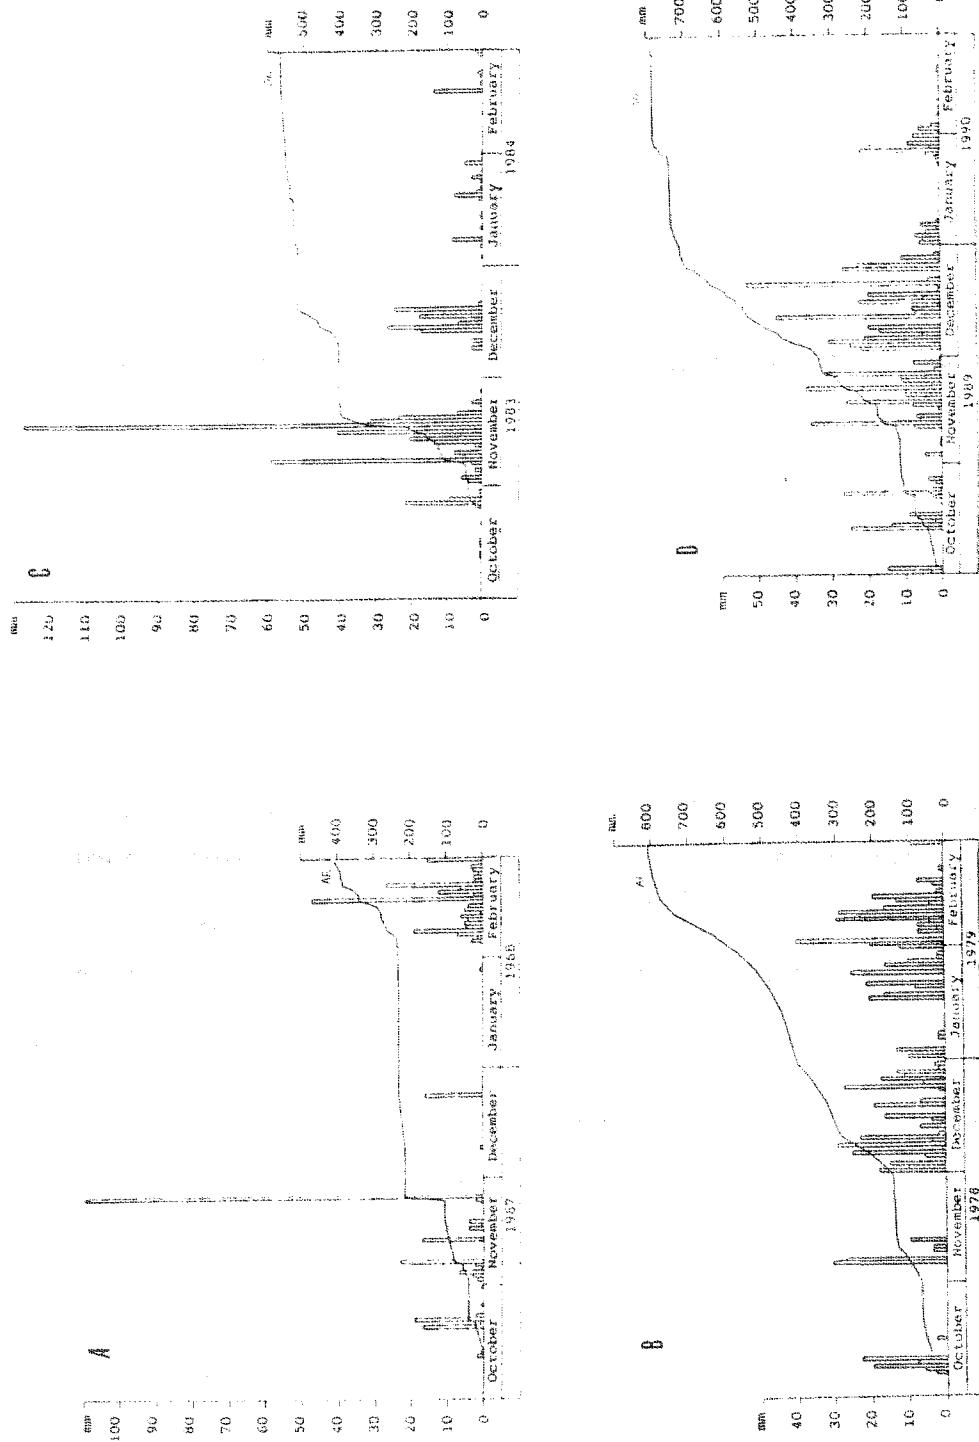
Fig. 4. Monthly rainfall distribution from G. L. M. (1967), H. S. (1983), A. T. (1989) and A. T. (1990) at Athabasca.

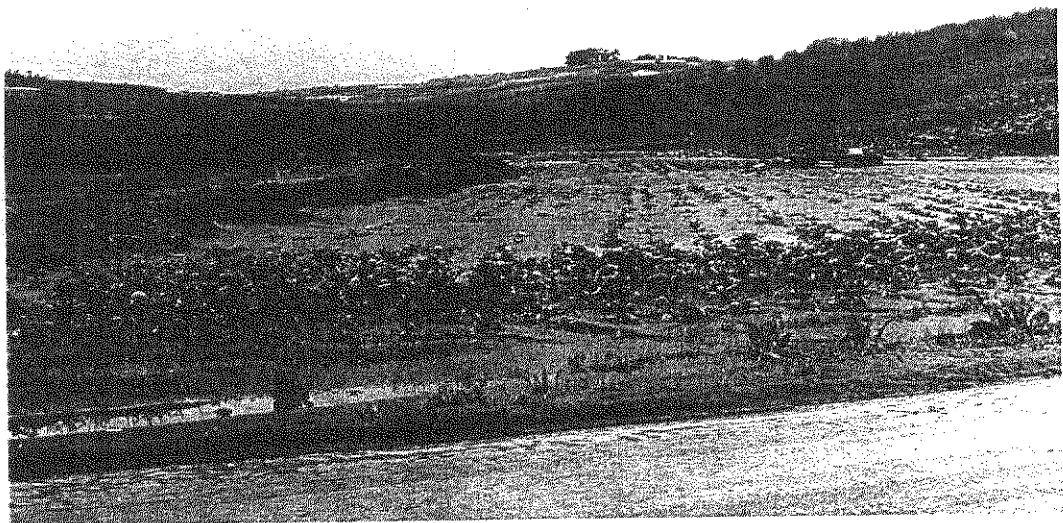
Photo 5 Alluvial fan at Nardupe (near Lourinhã), December 1989.

In badly consolidated materials the rill and gully erosion take place, namely when the topographic (slope degree) and vegetal cover conditions (low density) are propitious (photo 4). In lower slope degrees and in sandy clayish materials it occurs aggradation responsible for alluvial fan formation and farming destruction (photo 5)
