3.3. Visual study of the sites

The result of the test indicated that movements may be found among the external points. The calculated displacement may also originate from scale error, as mentioned in chapter 3.2. To see if any evidences of movement existed, a visual investigation was made. Both the external points and their surrounding areas were controlled.

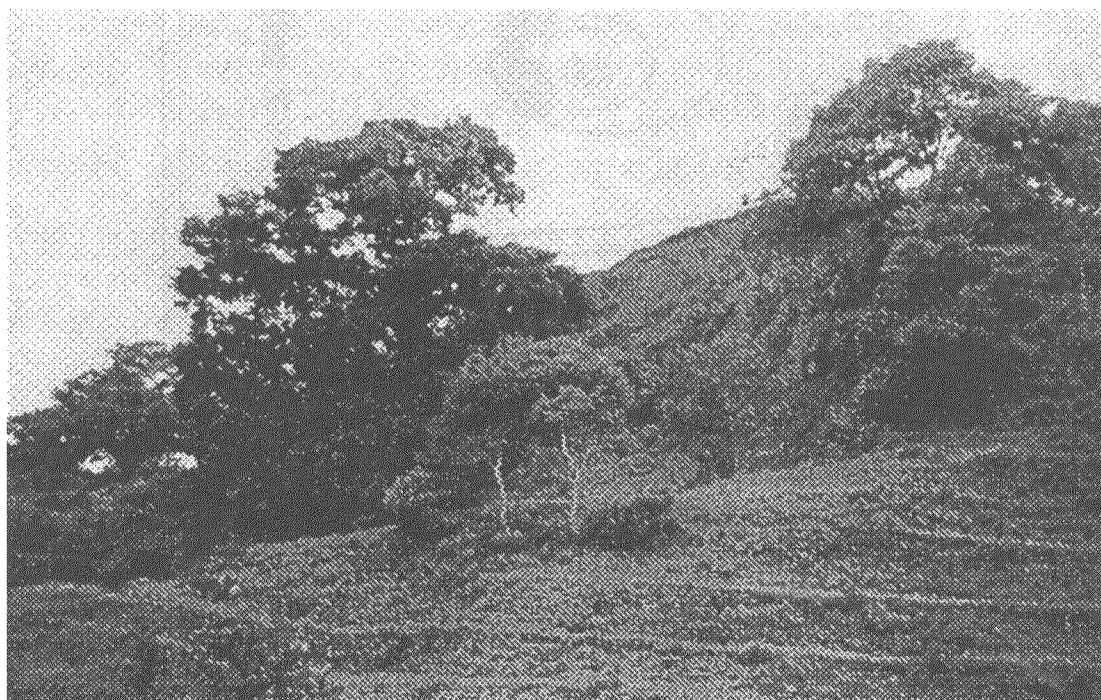
Picture 3.2. Ceme site.

The point is situated on a quite steep small hill in a meadow area. The hill is covered with grass and has parts of bare earth. The following observations were made:
