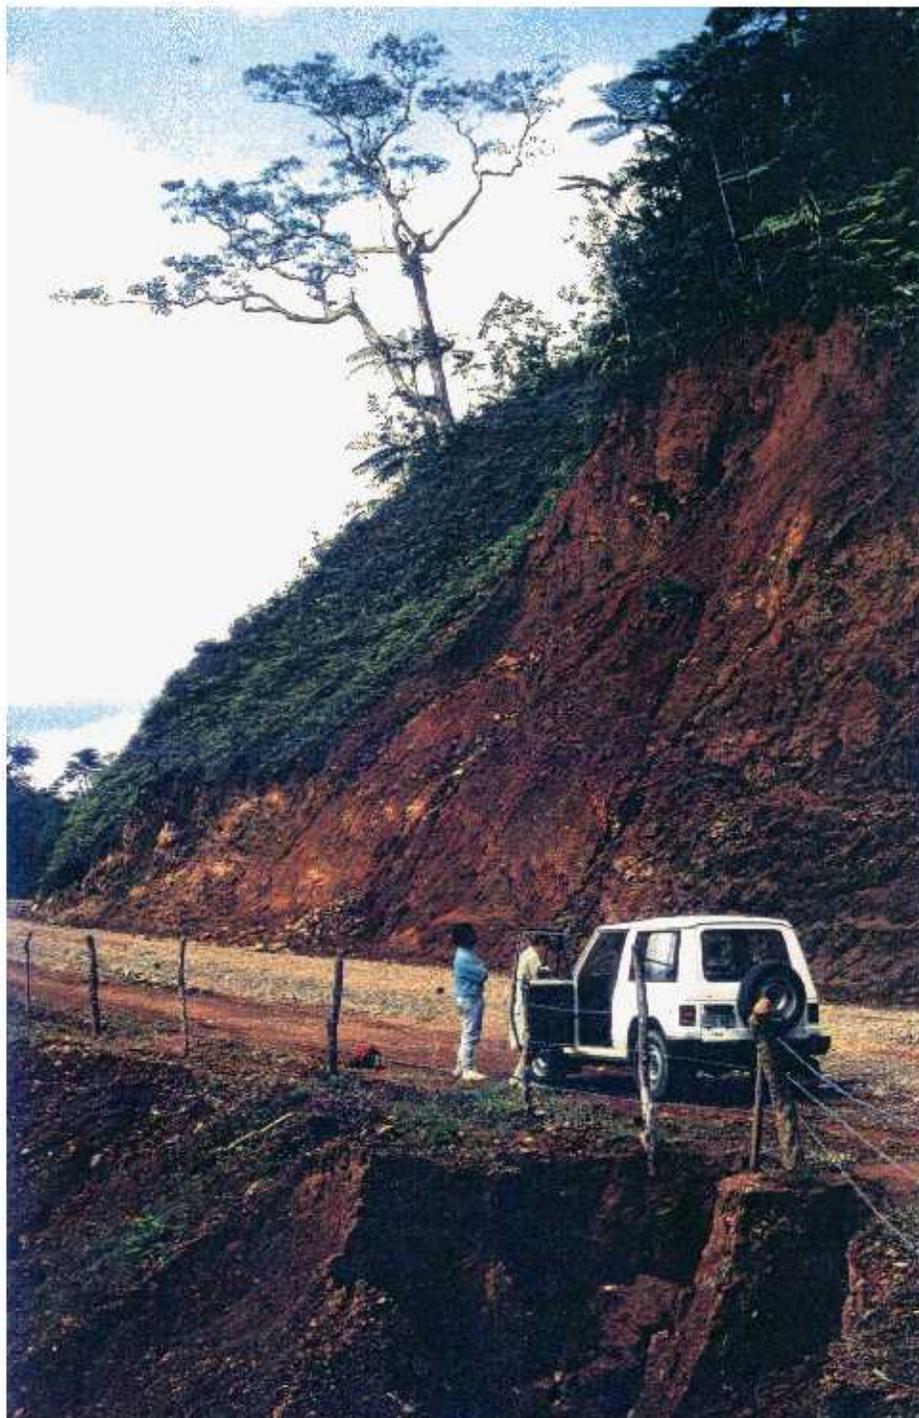
**Figure 2.8** Shallow planar translational debris slide in regolith overlying more competent weathered bedrock. Slide debris spilled onto road which has been subsequently cleared. Erosion and minor slipping in soil road fill is visible in foreground. (Location: Waindina River catchment, north east of Waivaka village)
