### **2.5.2 The Serua Hills landslides of 1980**

### 2.5.3 Factors controlling hillslope stability in south east Viti Levu

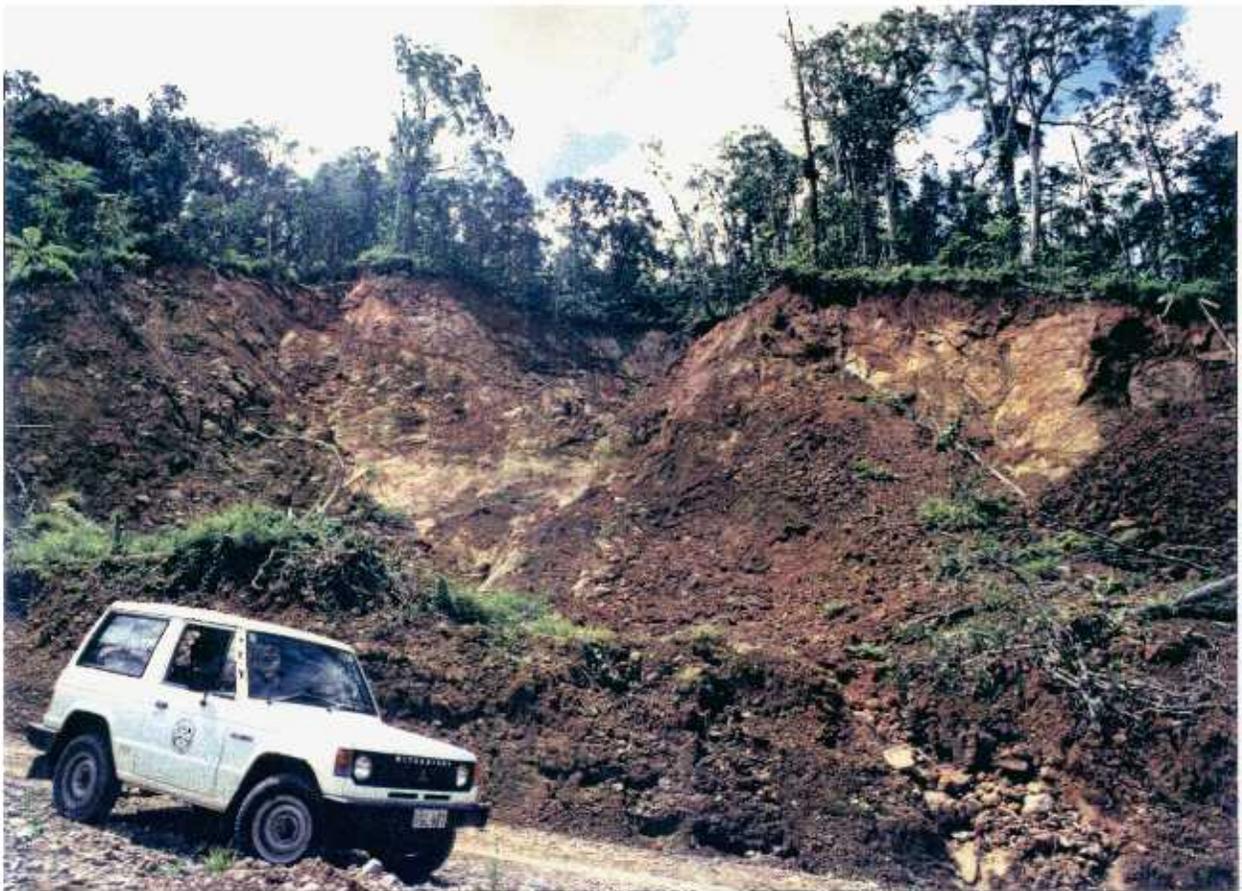
**Figure 2.9** Translational debris slide with movement initiated along steeply dipping planar discontinuities in highly weathered bedrock. (Location: Nambukavesi-Namosi road in Waindina River catchment)

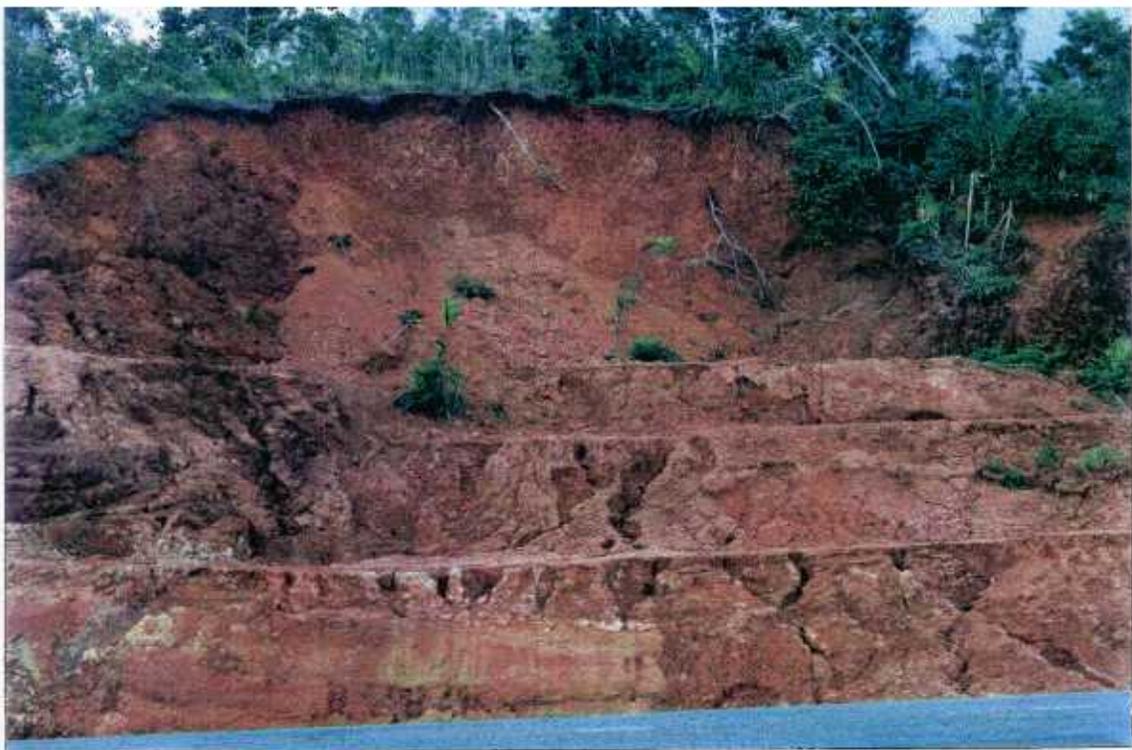
**Figure 2.10** Unstable road cutting near Galoa on the Suva-Nadi Highway. Failure is translational, involving residual soil sliding along an irregular, steeply-dipping interface with underlying weathered bedrock, and compounded by shallow rotational movements in the displaced debris mass.

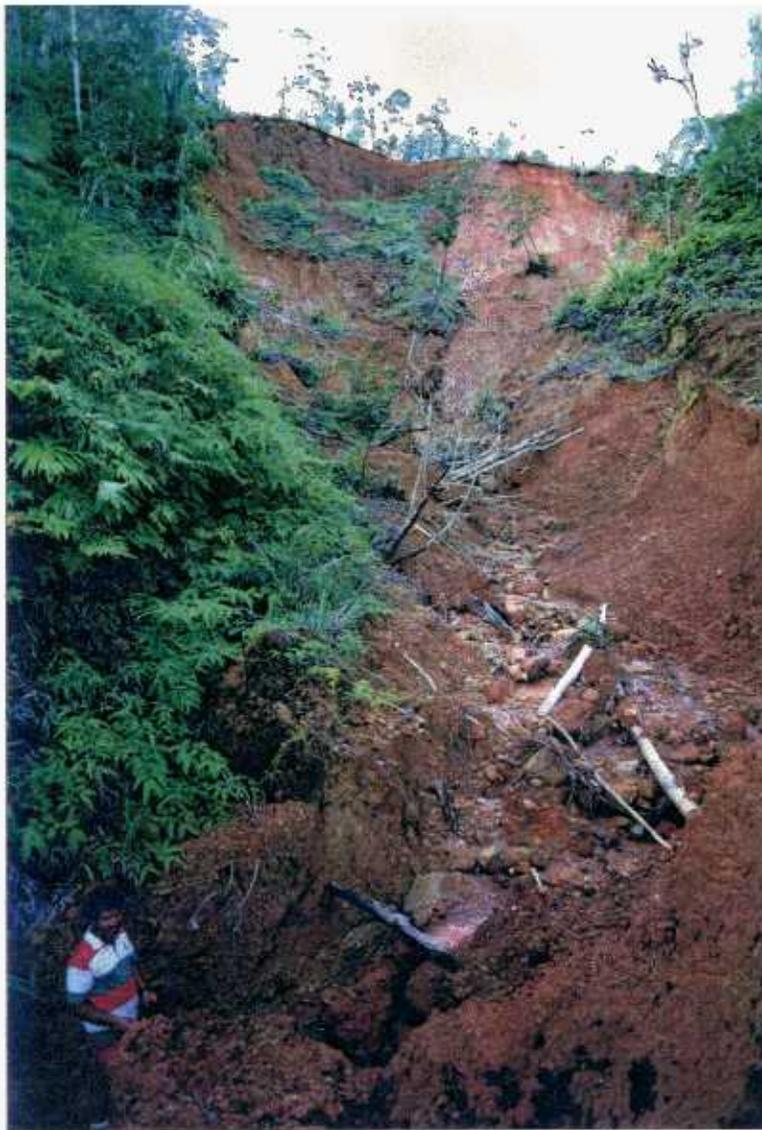
**Figure 2.11**  
Landslide headscarp and upper incised torrent track of the Wainigasau debris flow.

potentially very destructive. Below the headslide source area, they are usually characterised by a narrow elongated mid-portion ('flow track' or 'torrent track') and a bulbous toe or 'debris fan' developed where the slope gradient becomes low enough to arrest movement (Figures 2.11 and 2.12). The initial slide area is usually completely vacated of debris which can move with considerable erosive power. If the supply of saturated debris is sufficient and the slope steep enough, they may travel large distances, sustained and enlarged by further slides and bank collapses generated by their own erosion. Following cyclone Wally, Howarth *et al.* (1980) and Lawson (1993) describe the widespread development of debris flows initiated on both steep planar hillslopes and within drainage lines or slope depressions. In the majority of cases, the flows developed from initial slides on upper slopes close to the ridge line. The torrent tracks of these flows often form elongate, bare stretches of soil or exposed rock of variable dimensions depending on local topography, the nature of the underlying slope materials and the erosive power of the flowing debris. Torrent tracks range from steep-sided channels eroded into underlying regolith to debris-covered stretches along which only vegetation has been stripped.

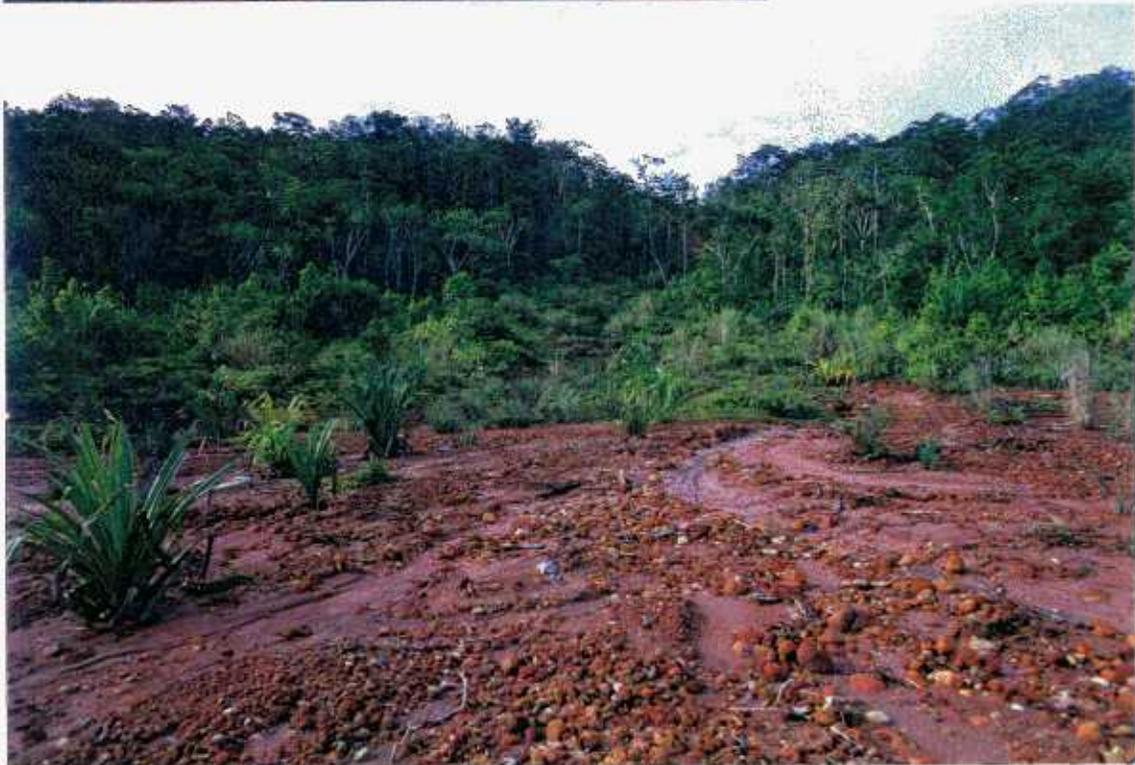
**Figure 2.12** View looking upslope from distal end of the Wainigasau debris flow towards torrent track and headslide. The debris fan, comprising residual soil, cobbles and boulders, is gradually becoming revegetated.

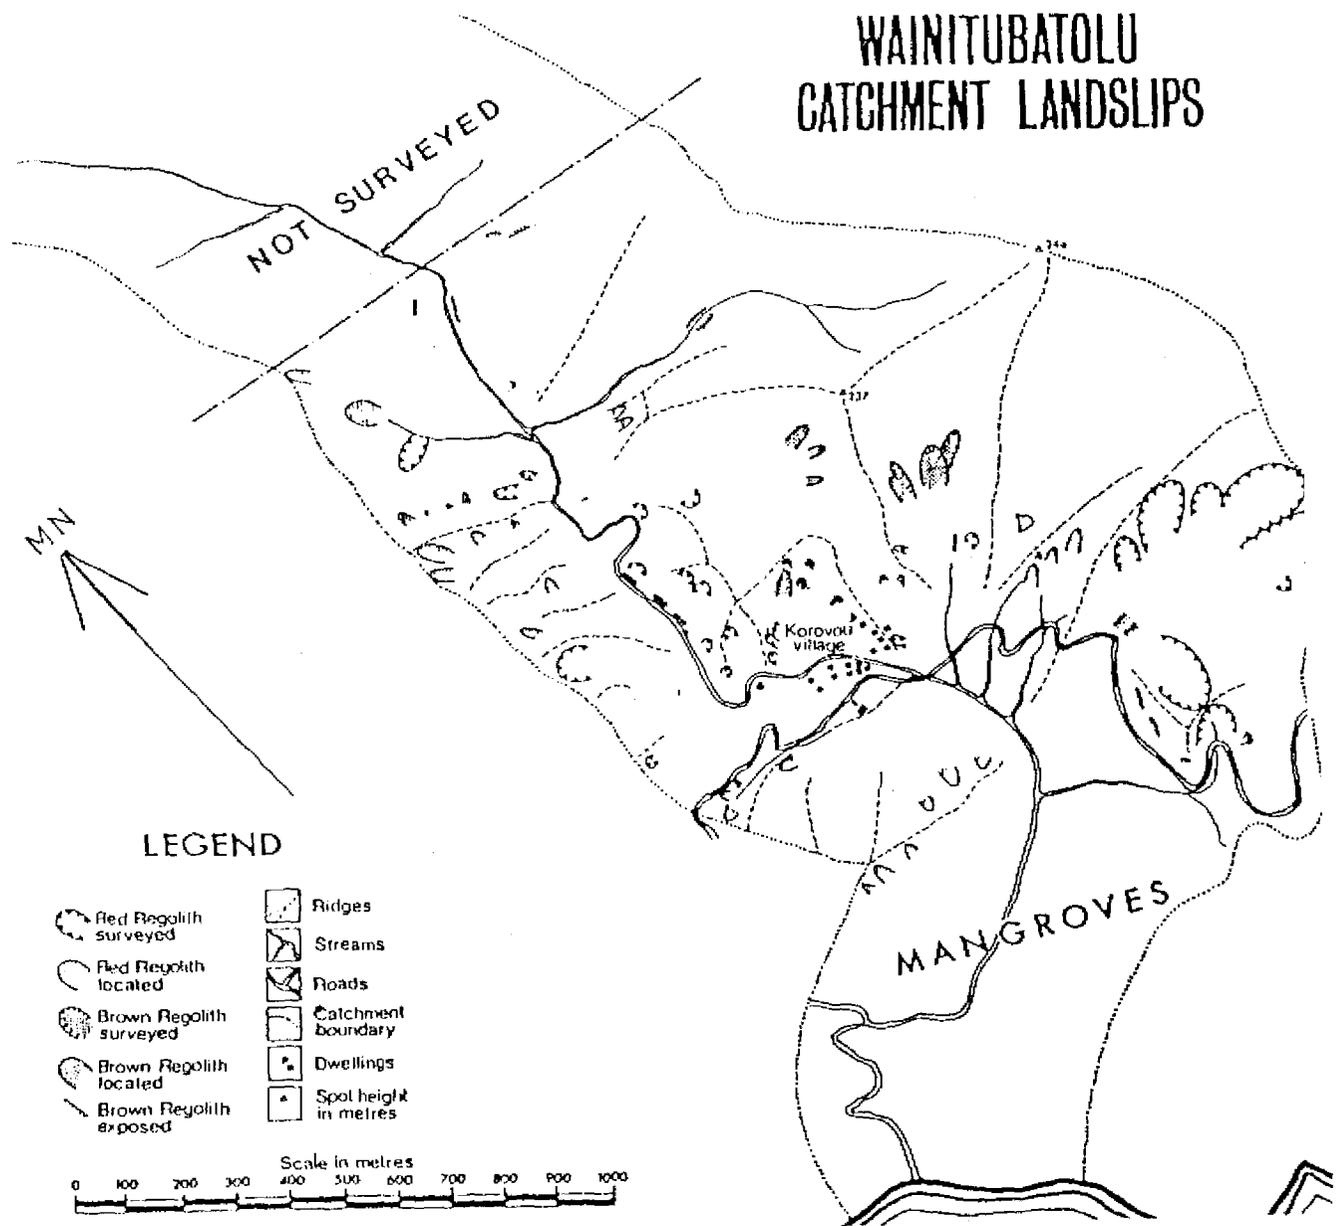
**Figure 2.13**

Distribution of landslides in the Wainitubatolu catchment (reproduced after Howorth, Crozier and Grant, 1981).

The Howarth *et al.* (1980) report also included a detailed examination of the Wainitubatolu catchment, a sub-site within the above area. This was one of the areas most severely affected by landslide activity. Their map of landslips is reproduced here as Figure 2.13. The study addressed the question of the location of slope failure and presented a model to explain landslide occurrence within the catchment. Up to 74 landslides, mainly debris flows, were recorded. In many cases, landslide depth corresponded to regolith thickness. As is characteristic of rainfall-induced surficial landslides, the mass movement occurred where the landform or configuration of the bedrock surface facilitated the concentration of slope water. More than half of the landslides originated in slope depressions or drainage lines, with initial failure taking place on an upper slope, ridge or summit.

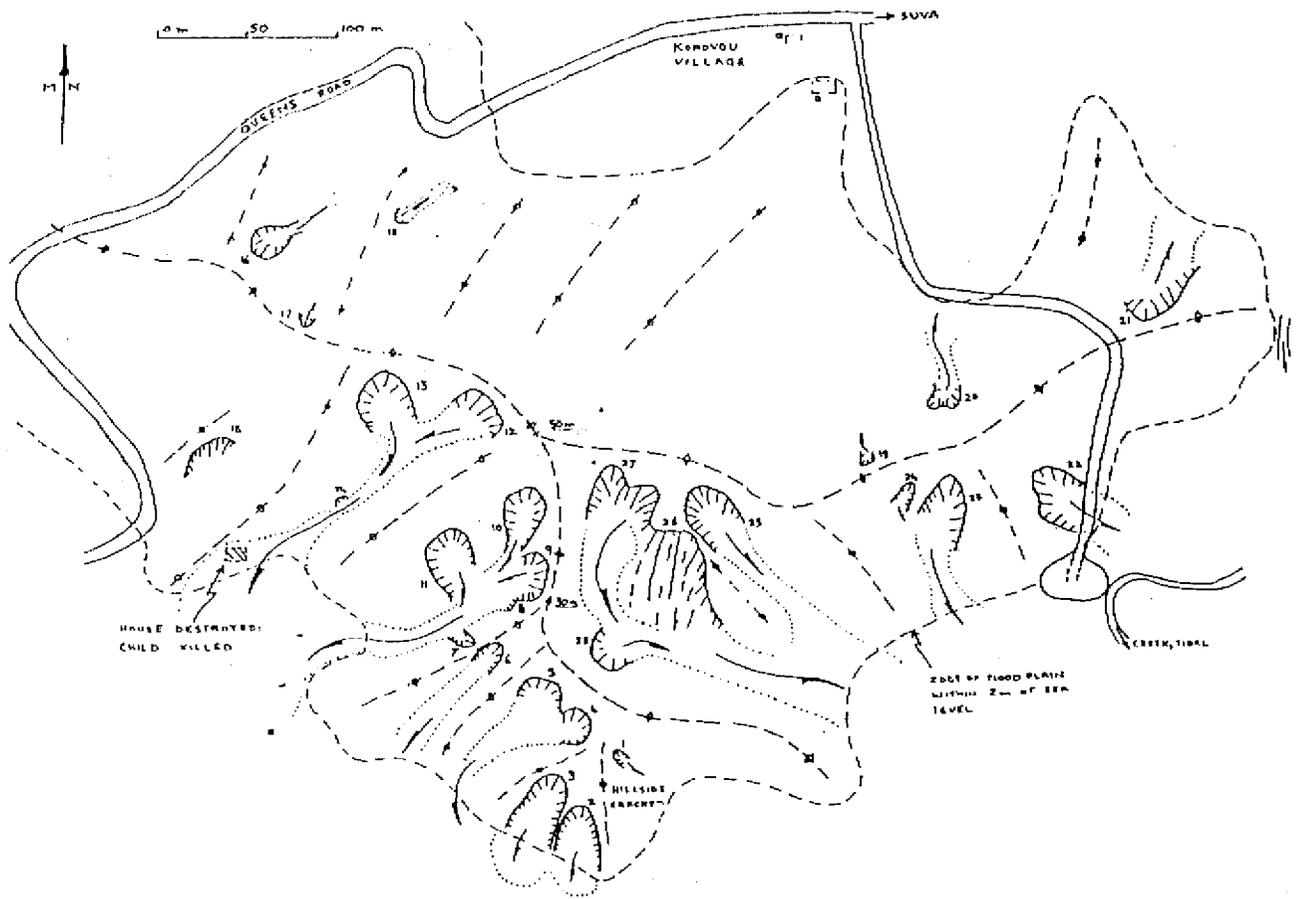
**Figure 2.14** Map of landslides in the Korovou area (reproduced after Howorth and Prasad, 1980).

Details of the morphology and distribution of 28 landslides in the Korovou village area associated with the same cyclone event were documented by Howorth and Prasad (1981). Their map of landslides is reproduced here as Figure 2.14. The area is formed of a single ridge of volcanic bedrock mantled by thick red soils. This study is similar to the earlier one of Howorth *et al.* (1980) in that it concentrates on the detail of landslide morphology and mass movement i.e. position of failure, dispersal of debris and details of the soil (regolith) profiles.
