# URBAN GEOLOGIC PROBLEMS ASSOCIATED WITH THE MIXCO FAULT ZONE

Sally Widhelm Bilodeau<sup>1</sup>

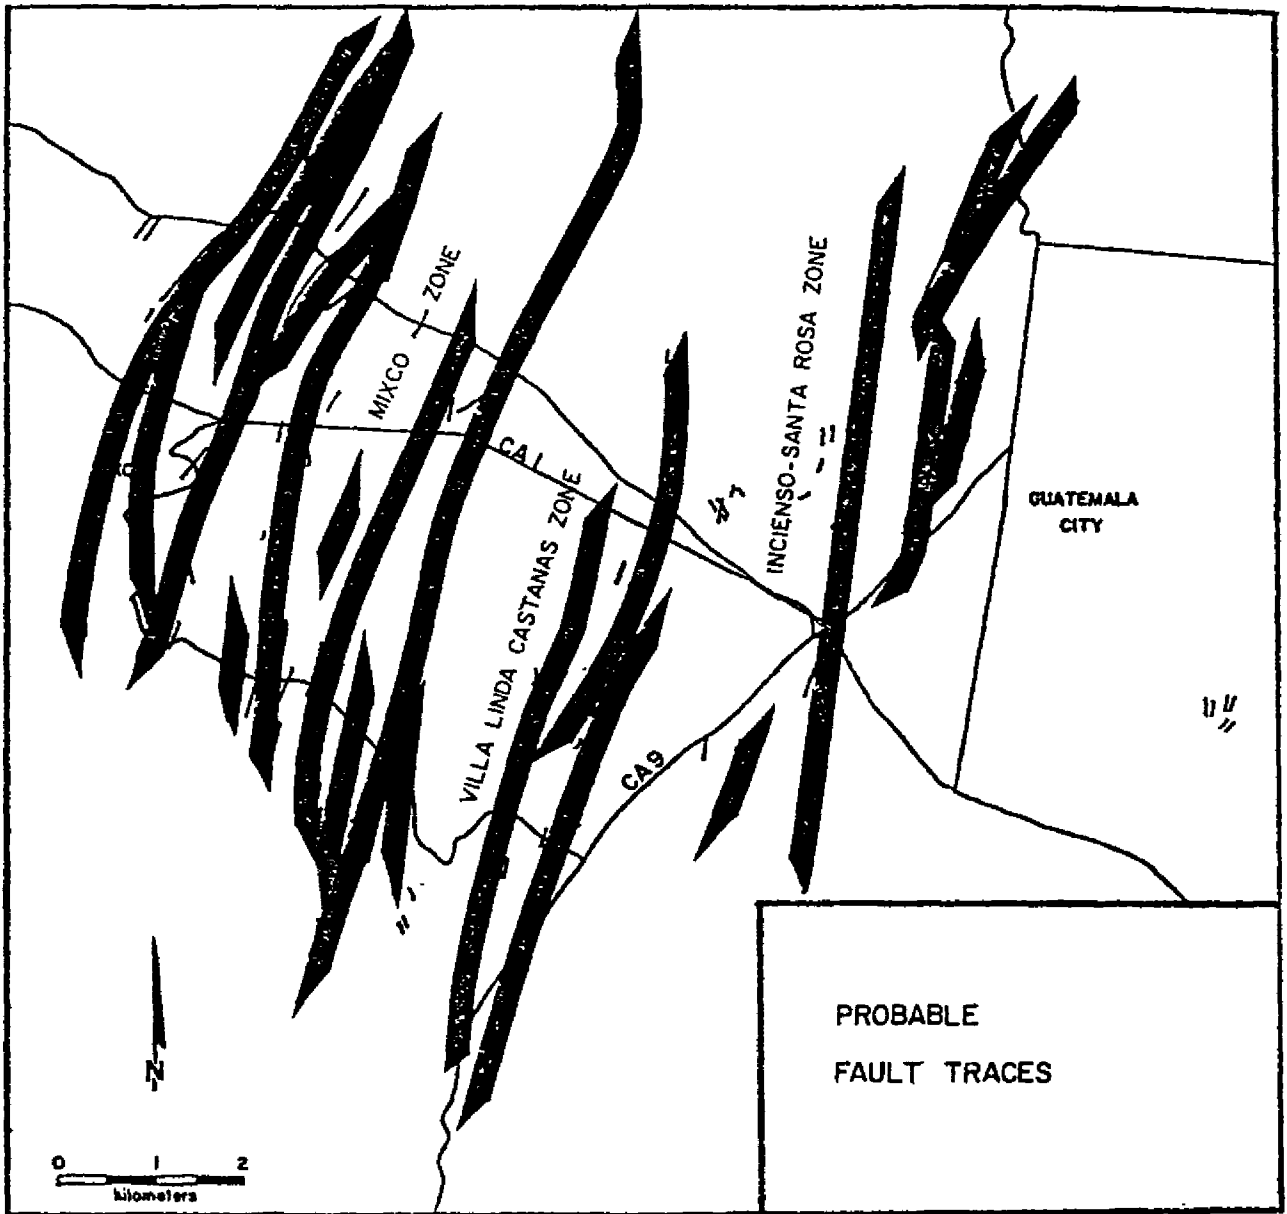
FIGURE 1- FRACTURE MAP  
 EARTHQUAKES OF FEBRUARY 1976  
 GUATEMALA VALLEY

As illustrated on Figure 1, the mapping done immediately after the earthquake was reconnaissance in nature, and many of the ruptures noted crossing the main roads were not followed or were not evident beyond the limits of the concrete and asphalt. The resulting map is therefore somewhat discontinuous and, in some places, nonrepresentative. In addition, there is no distinction on the map between true fault ruptures and simple ground cracking, which may not be related to fault movement at depth. Some ruptures are clearly aligned in such a manner as to suggest continuity; for example, those north of the main intersection of CA 1 and CA 9. Others are so randomly oriented as to suggest non-faulting origins such as those along the eastern margin of the map (Figure 1). Utilizing the rupture patterns and other topographic indicators, an interpretation regarding probable fault traces can be made, as illustrated on Figure 2. Previous investigators (Plafker, et al., 1976) have divided the fault ruptures into three broad zones, considered to be subsidiary fault traces to the master Mixco trace. These zones have been tentatively named the Mixco Zone, the Villa Linda - Castanas Zone, and the Incienso - Santa Rosa Zone. Interpretations of the subsurface projections of these fault traces are illustrated on Figure 3. As can be seen, they are all considered to be related to the main Mixco fault at depth, but due to the extensional nature of the faulting, they tend to branch near the surface and disrupt a broad zone. There is evidence in several areas that some of these subsidiary fault traces have moved repeatedly in the in the past. Fault scarps up to 15 meters high as well as offsets in excess of 7 meters in buried pumice layers are known to exist along some of the 1976 rupture zones, clearly indicating previous movements have taken place.

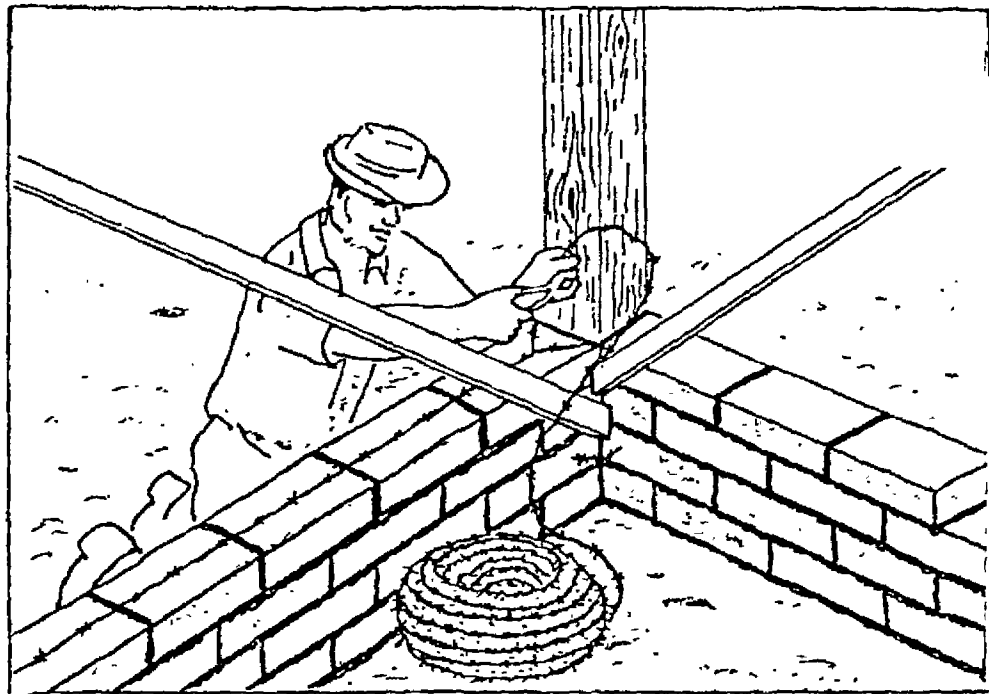
FIGURE II  
FIELD TESTING OF ADOBE

(Jobart and Marzolla, 1976). For example, mixing the mud, straw, and sand to make adobe bricks in proper proportions so that a good, sturdy brick results. Simple field tests, as shown on Figure 11, can verify brick quality. Brick dimensions and orientation are also important. Structurally reinforcing the interior walls with available materials like barbed wire and wood can help reduce damage and serve to tie the building together (Figure 12). Choosing a roof composed of light weight, not heavy, material is also critical to favorable seismic response (Figure 13). Communication and education of the people building such structures are important if future losses from earthquakes are to be minimized. The illustrations used in Figures 11 to 13 come from a small instruction booklet designed to communicate with pictures, not words. Booklets like it were distributed throughout Guatemala as rebuilding began. A continuation of this education process should be encouraged as the memories of the devastating effects of the earthquake are forgotten.
