Choluteca

Description of Problem

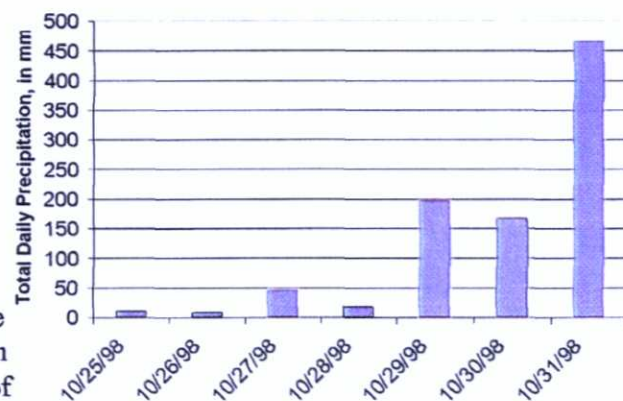
During the period of 27 – 31 October 1998, Choluteca received 893 mm (35 inches) of rainfall associated with Hurricane Mitch, most falling on the 29th – 31st. The heavy rainfall caused extensive flooding, erosion, and sediment deposition in the Choluteca area. In addition to the loss of many bridges and roads, it is estimated that 4,400 homes were destroyed and 6,600 homes damaged in the Department of Choluteca.
