Pespire

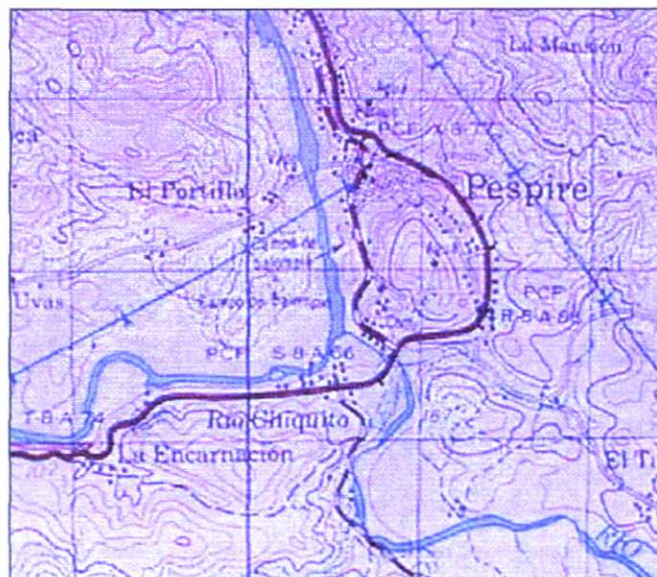
Flooding from the Rio Nacaome and Rio Chiquito, which enters the Rio Nacaome immediately downstream of Pespire, caused extensive flooding, destruction of homes, and sediment deposition in the city following Hurricane Mitch. Reported rainfall amounts were 893 mm (35 inches) in downstream Choluteca and 254.1 mm (10 inches) in upstream Tegucigalpa.

Extensive flooding and sediment deposition occurred in low lying areas of Pespire along the Rio Nacaome and Rio Chiquito.

- *(Short Term)* It is recommended that those areas closest to the river which were destroyed during the flood not be re-built. These flat areas showed evidence of extremely high velocities and flood depths, and as an active part of the floodplain should not be re-inhabited.
- *(Short Term)* Those housing areas located on the lower slopes of Pespire and damaged by the flood may be repaired/rebuilt. These areas should expect to be flooded periodically, but the flooding should occur infrequently
- *(Short Term)* It is not recommended that any dredging of the river channel be accomplished at Pespire.
