LANDSLIDES ASSOCIATED WITH THE LUZON EARTHQUAKE

6.1 Introduction

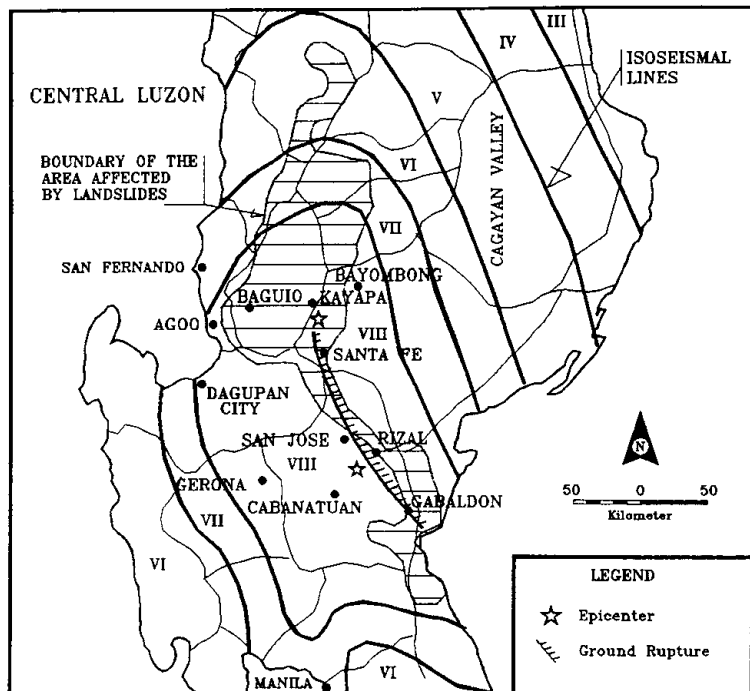
Fig. 6.1 - Isoseismal Map of Luzon 1990 earthquake and location of the area affected by landslides. Intensities are based on the Rossi-Forel Scale (Punongbayan and Torres, 1990).

The area affected by slides (Fig. 6.1) has been estimated on the basis of PHIVOLCS data and information from various other sources, as well as the author's visits to the Caraballo Mountains (along Dalton Pass Road) and Baguio Province (along Kennon and Halsema Roads, Marcos Highway and the road to Ambuklao Dam).

The Caraballo Mountain slopes, in general, behaved the same way as part of the Cordillera, with numerous shallow slides. This can be attributed to the presence of uniformly weathered zones in both ranges, associated with low topographic contrast. Figure 6.1 shows isoseismal lines based on the Rossi-Forel scale (Appendix C), landslide distribution and the location of major ground rupture and epicenters. Slides predominantly occurred in the Intensity VIII and VII zones, though there was a marginal involvement of the zone VI which appears to mark the damage threshold. Zone VIII includes major and minor ground ruptures, the epicenter near Rizal and the probable second epicenter near Kayapa.

The distribution of landslides is shown in Fig. 6.1 which also includes isoseismal lines. Slide types in the Southern Cordillera mountains were classified as follows:

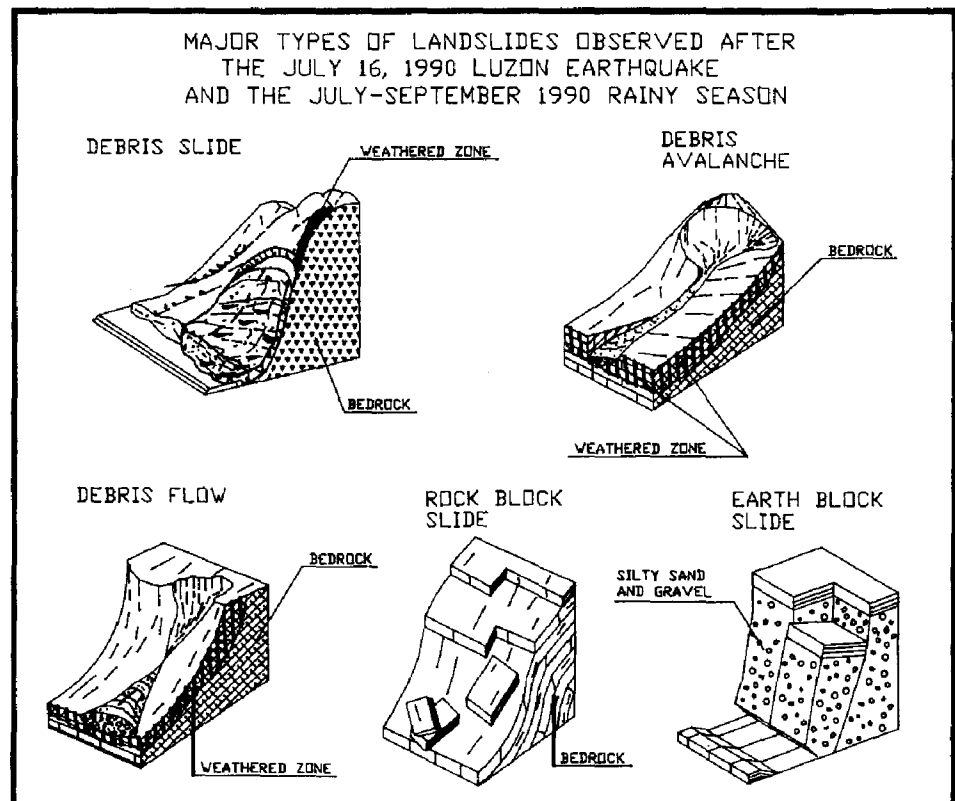
The classification of landslides proposed by Varnes (1978) has been adopted (Fig. 6.6) top and terms are based primarily on the type of movement and secondarily on the type of material. The figure in brackets, which follows each landslide class in the next sections, represents a percentage of total landslides by type of material. The value is an indicative estimate derived from visual inspection of a number of sites covering about 280 sq. km in Southern Cordillera and 150 sq. km in Caraballo Range. Considering that the latter range is smaller and morphologically more uniform, the percentages of slope movements are comparatively more representative for the Caraballo Mountains. The most common types of landslides are illustrated in the lower part of Figure 6.6.

Fig. 6.6 - Varnes classification (1978) of slope movements (top) and most common types of slope instability phenomena in Luzon (bottom) triggered by the earthquake and the rainy season which followed soon after.
